ATTACHMENT 1

OSIM INSPECTION REPORTS & BCI FORMS

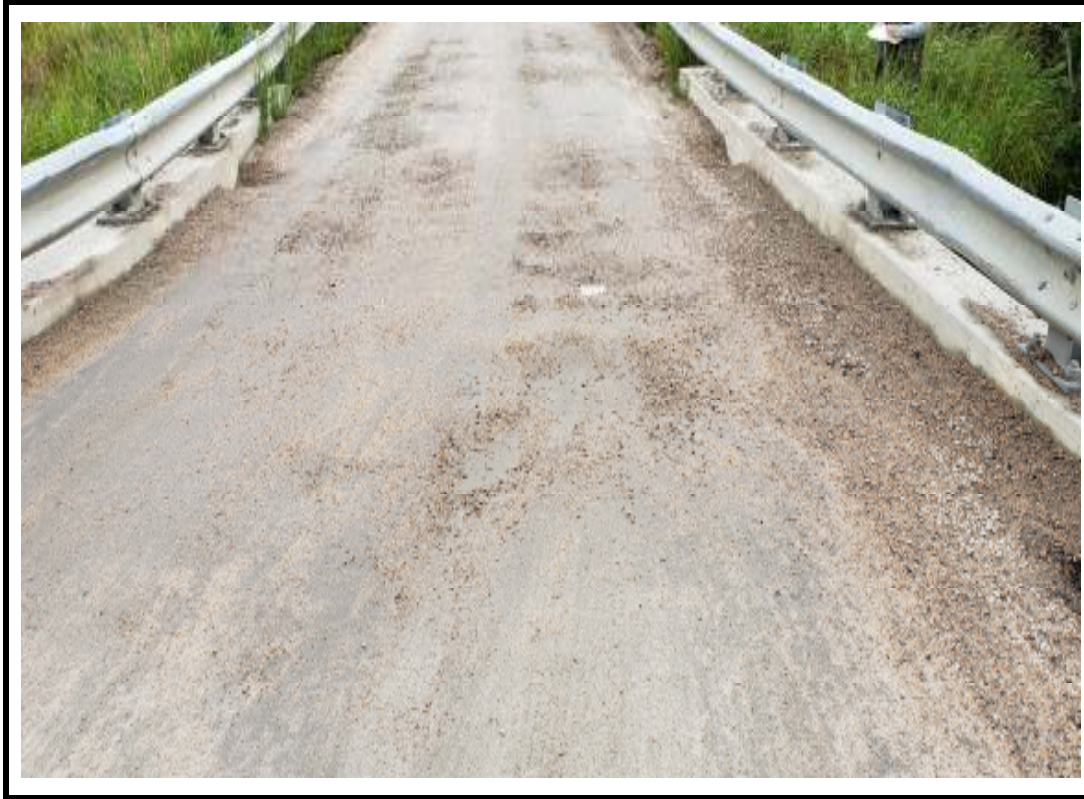
Photo 7 Potholes and loose gravel noted on deck wearing surface

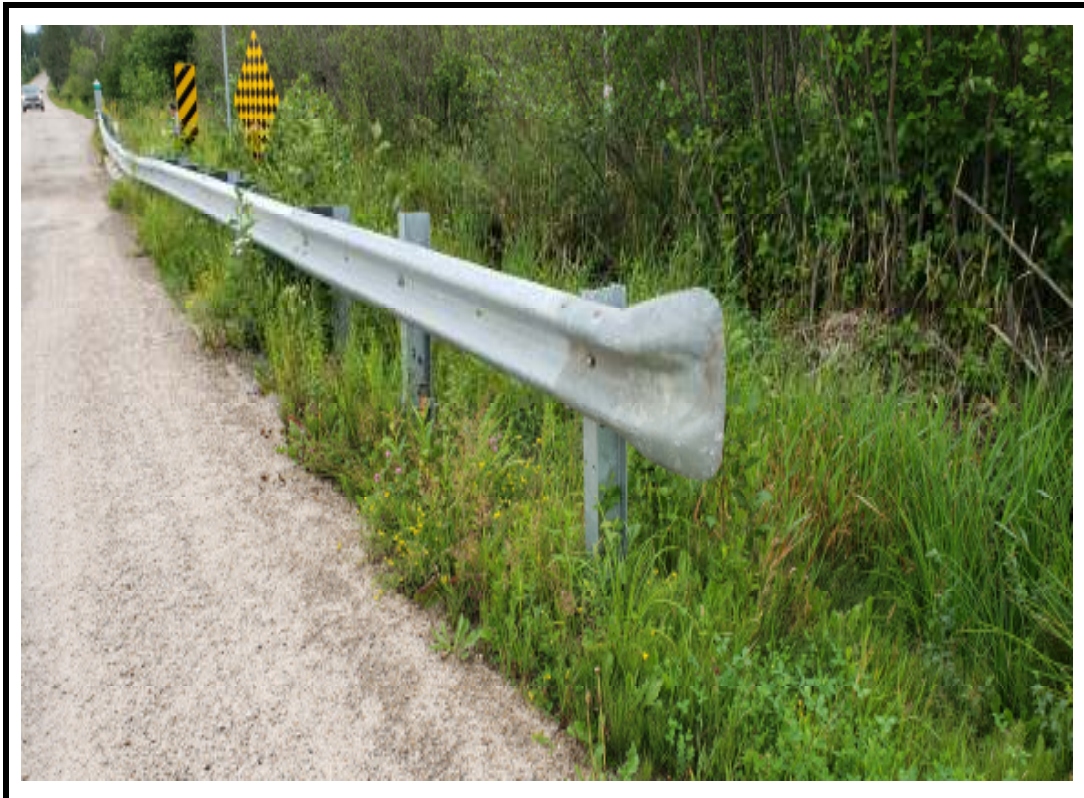
Photo 8 Substandard end treatment noted on southwest corner

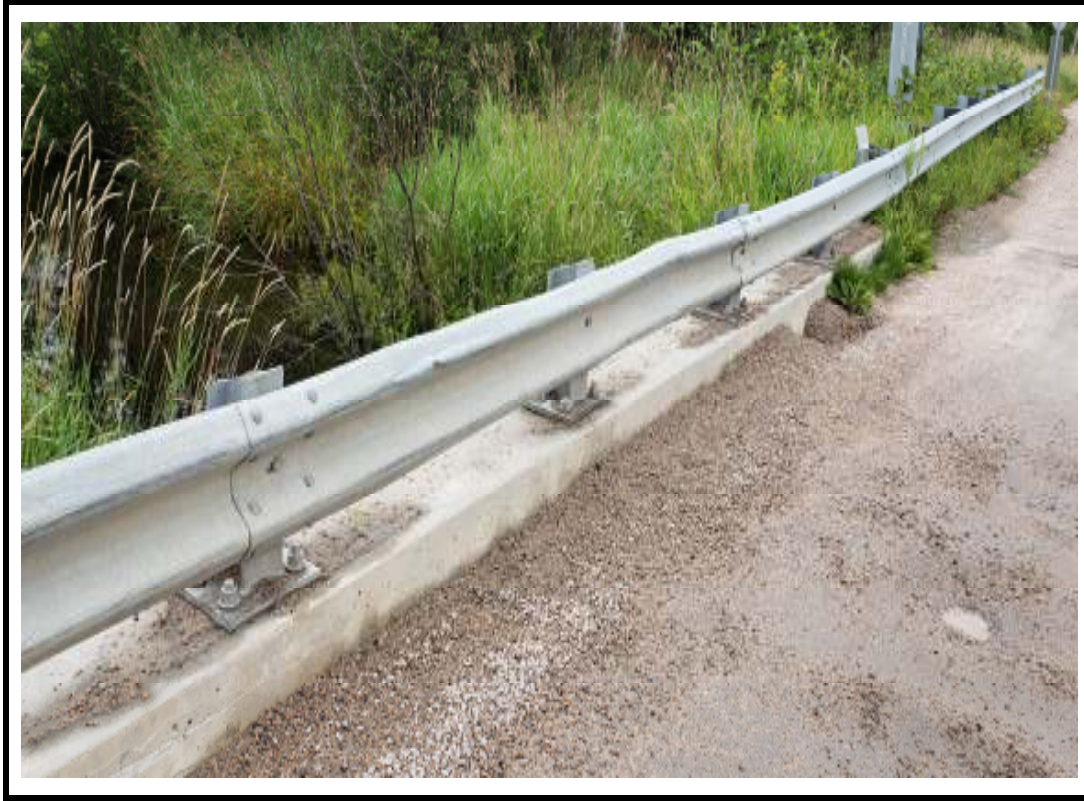
Photo 9 Collision damage noted on north deck barrier

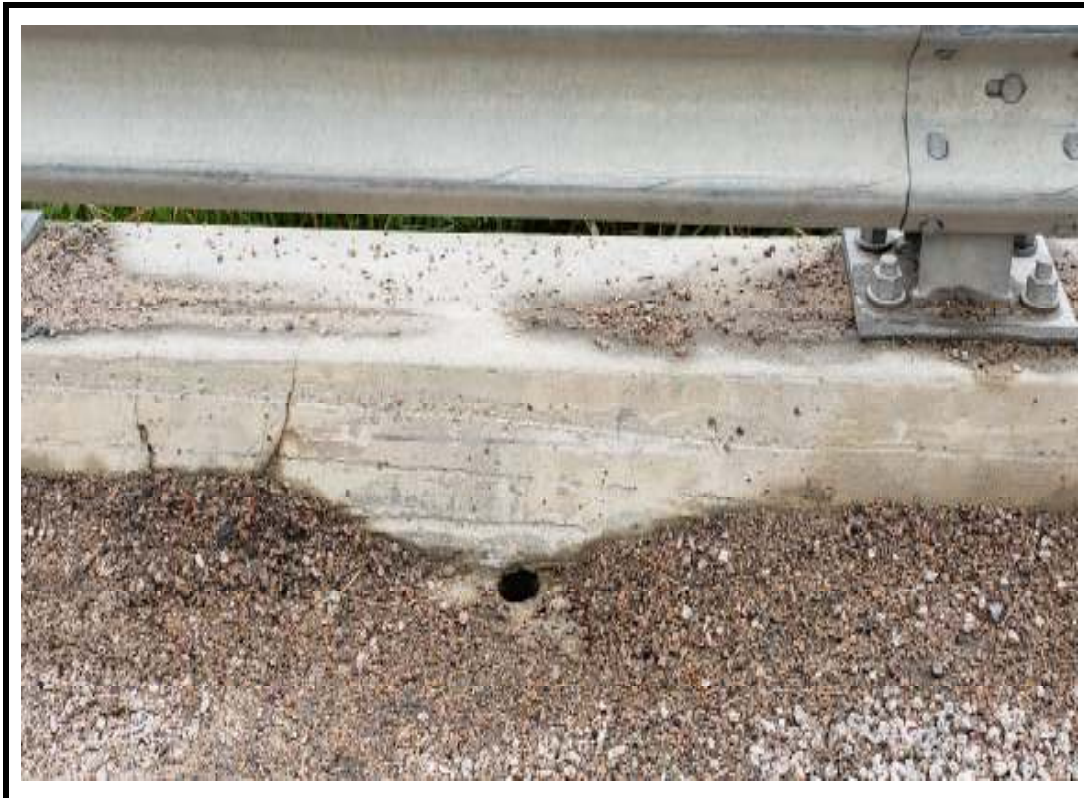
Photo 10 Snowplow damage with narrow cracks noted on curb

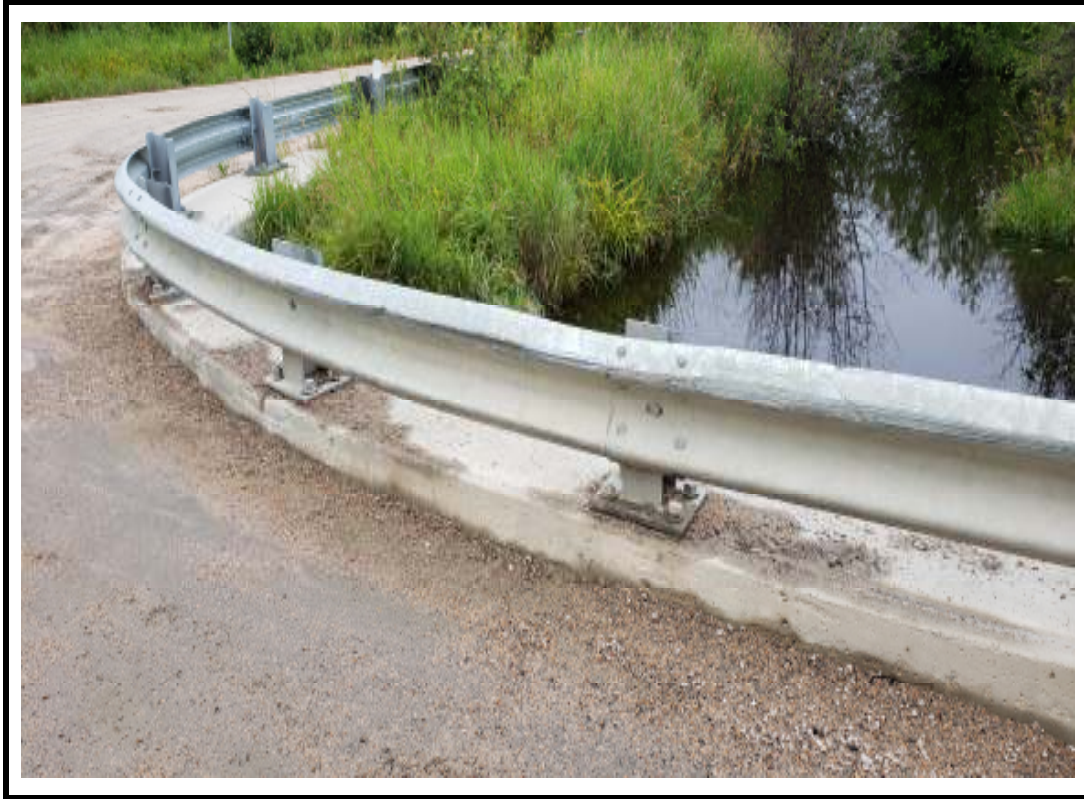
Photo 11 Gravel accumulation noted at the edge of wearing surface

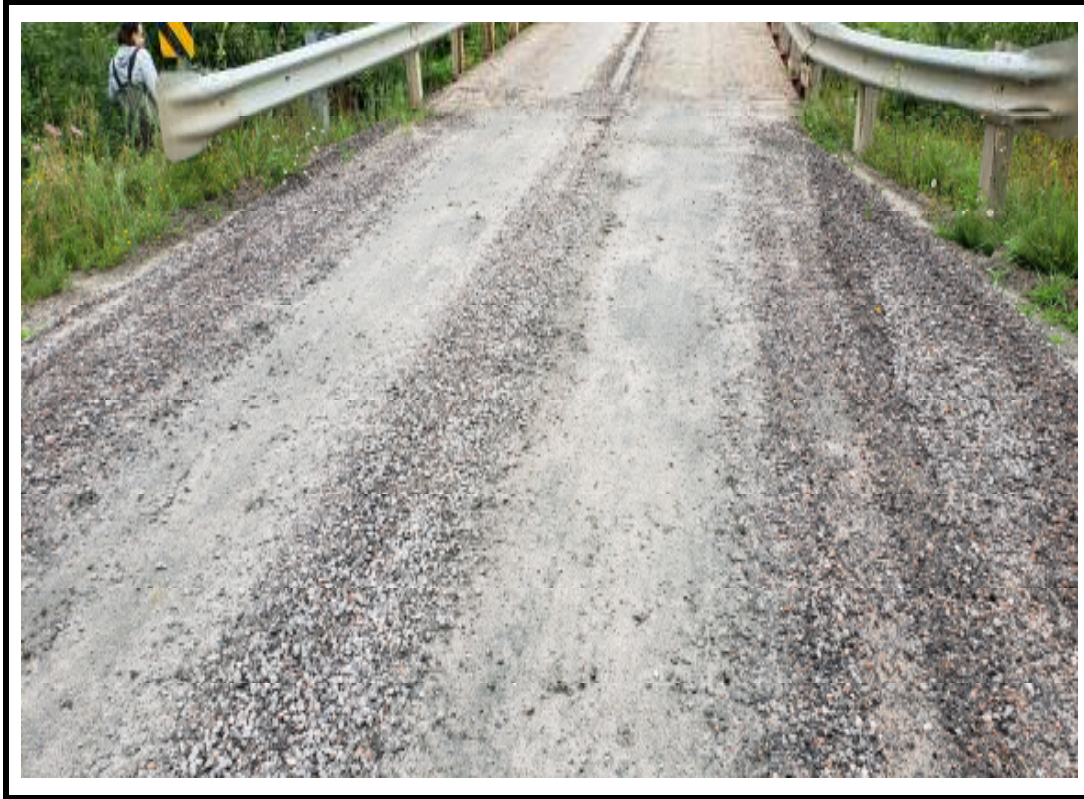
Photo 7 Loose gravel and potholes noted on wearing surface

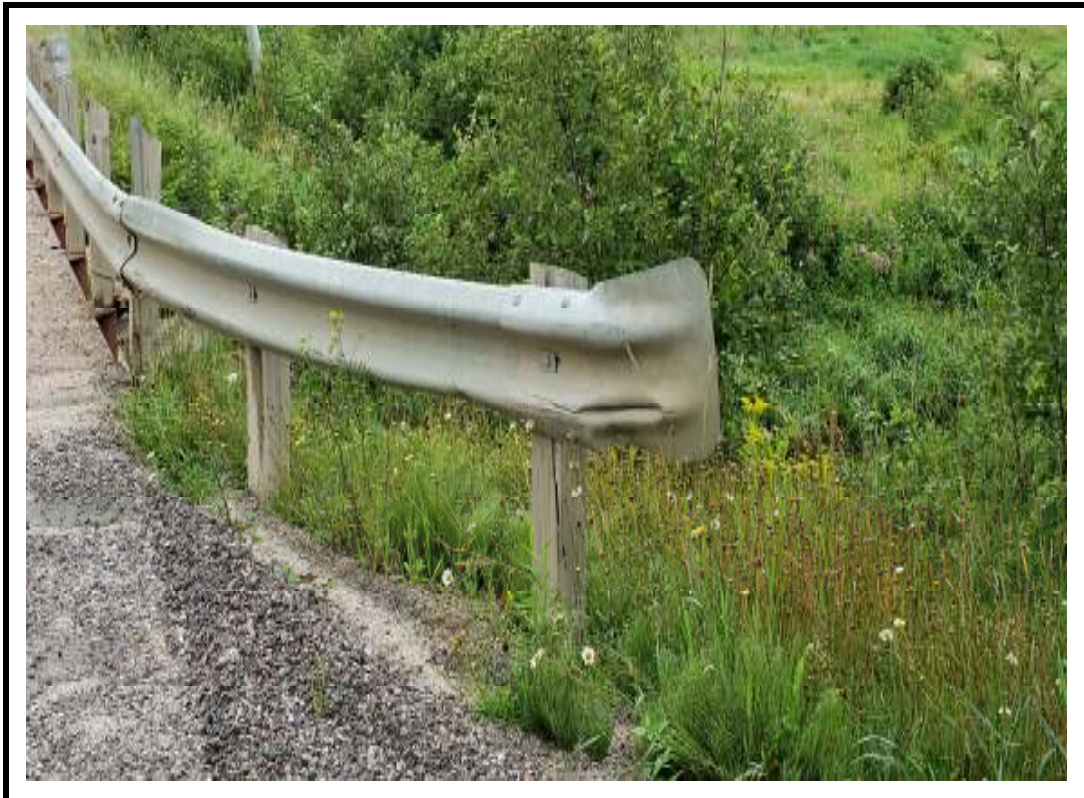
Photo 8 Collision damage noted on northeast end treatment

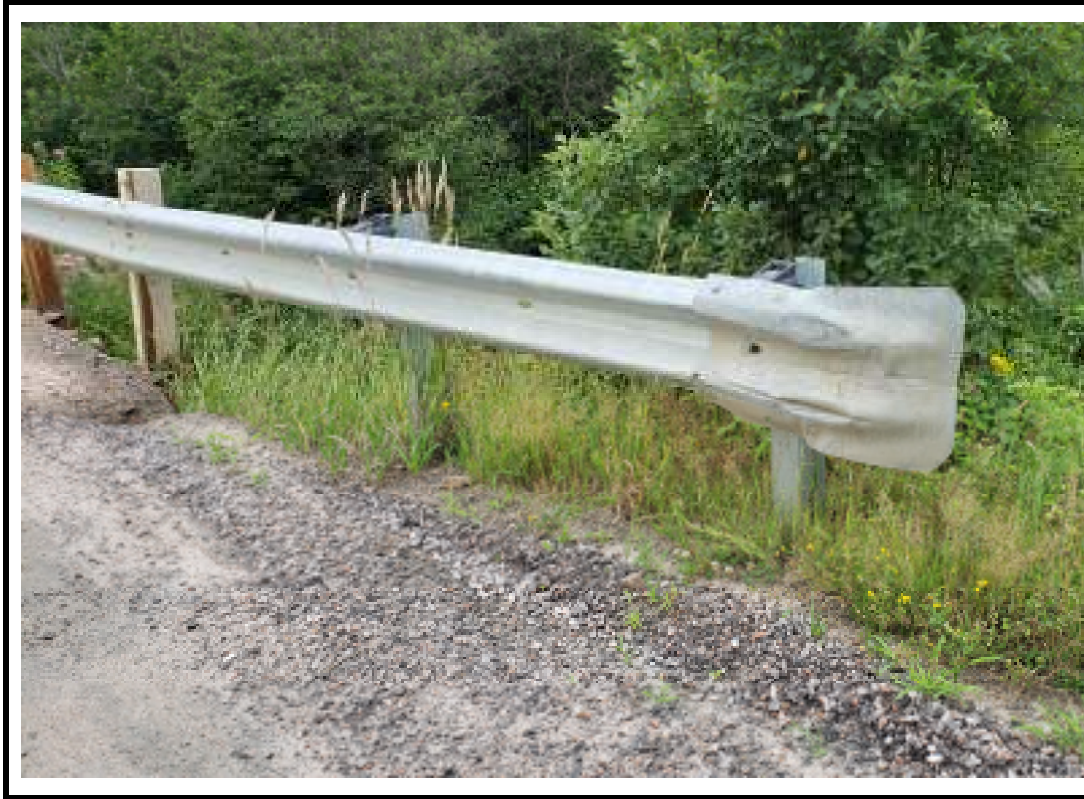
Photo 9 Collision damage on substandard end treatment on southwest corner

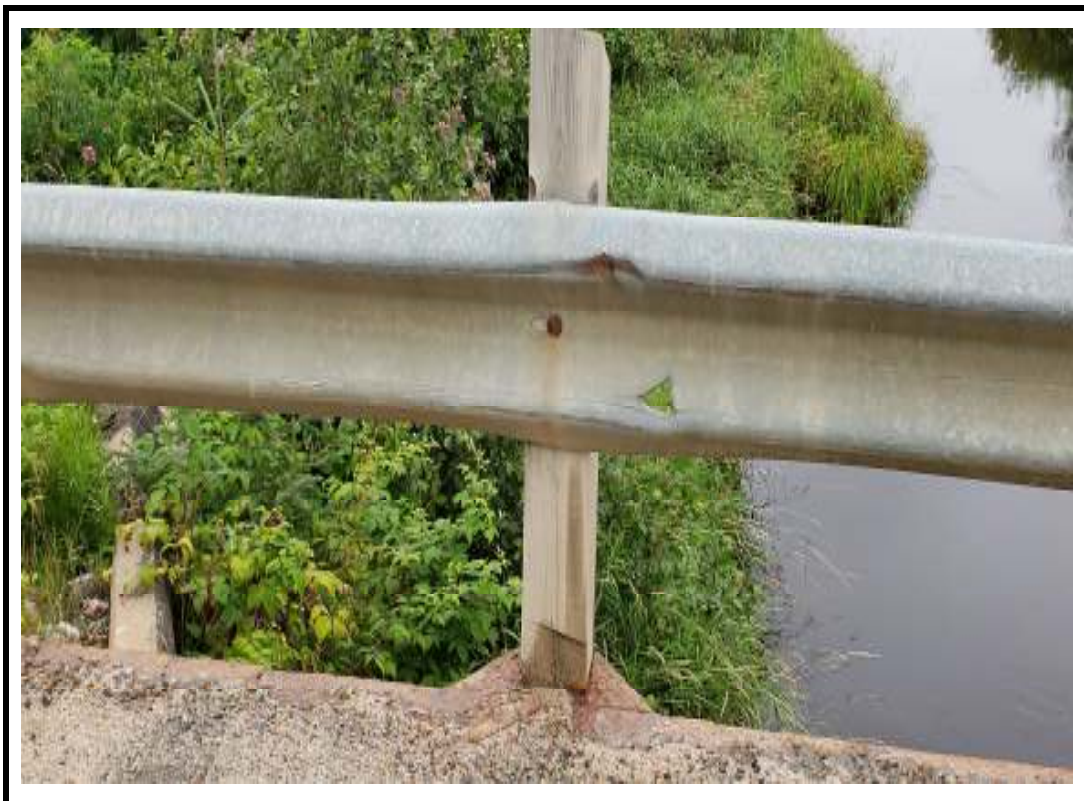
Photo 10 Corrosion and perforation noted on deck barrier

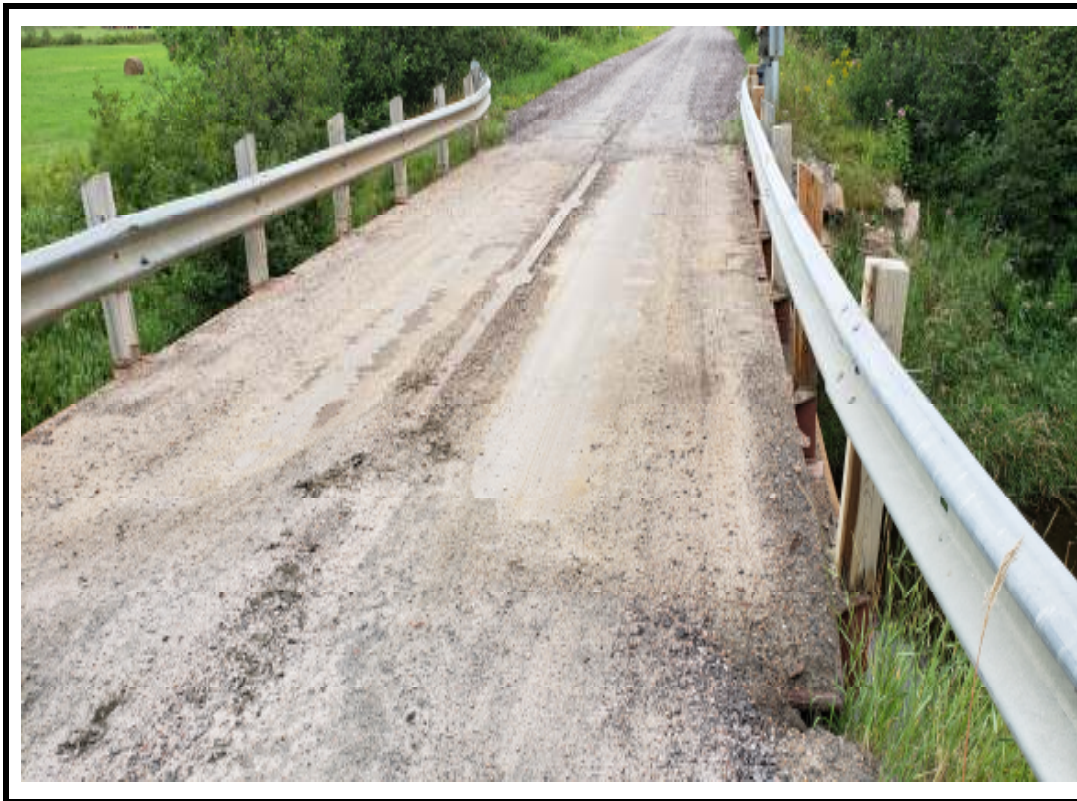
Photo 11 Gravel accumulation noted at center and edge of deck wearing surface

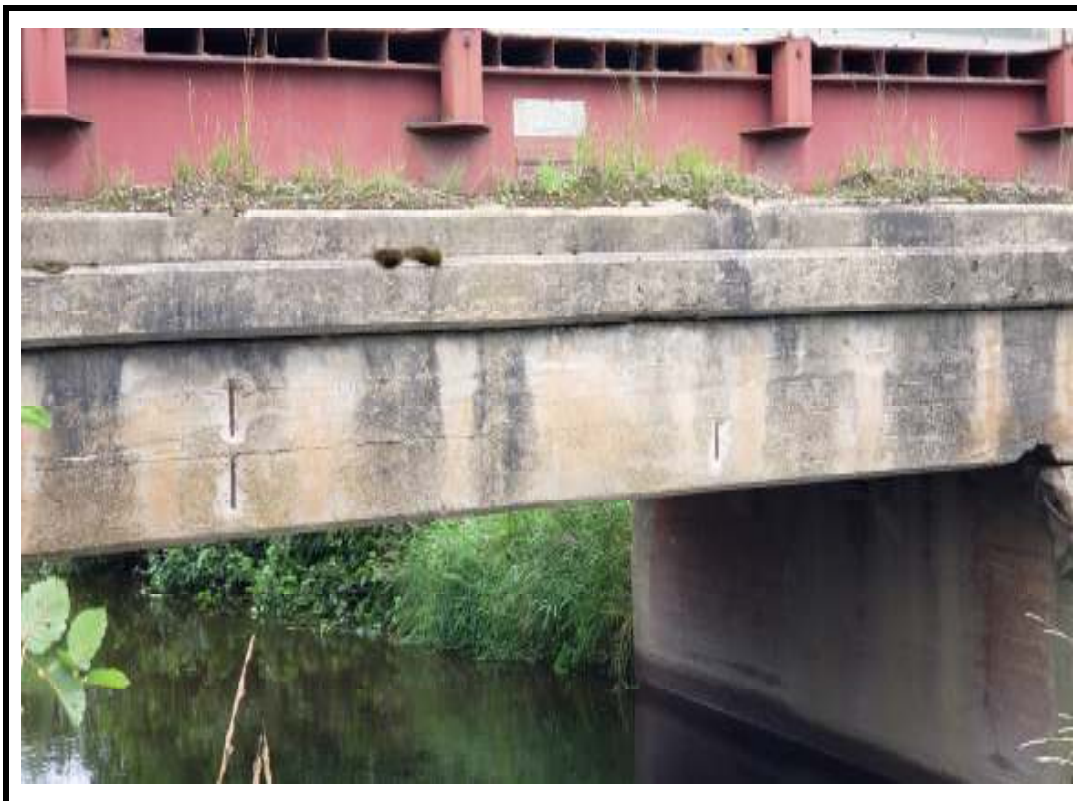
Photo 12 Previous structure still present at the time of inspection

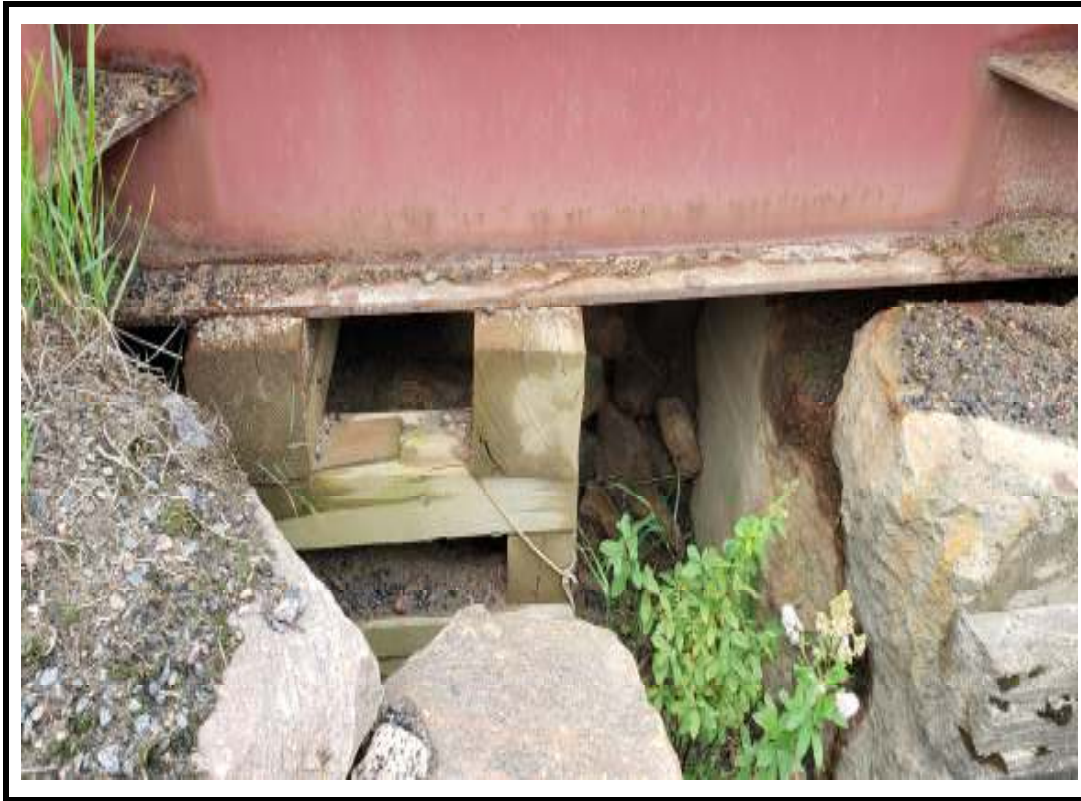
Photo 13 Cracks noted on wooden crib at northeast corner

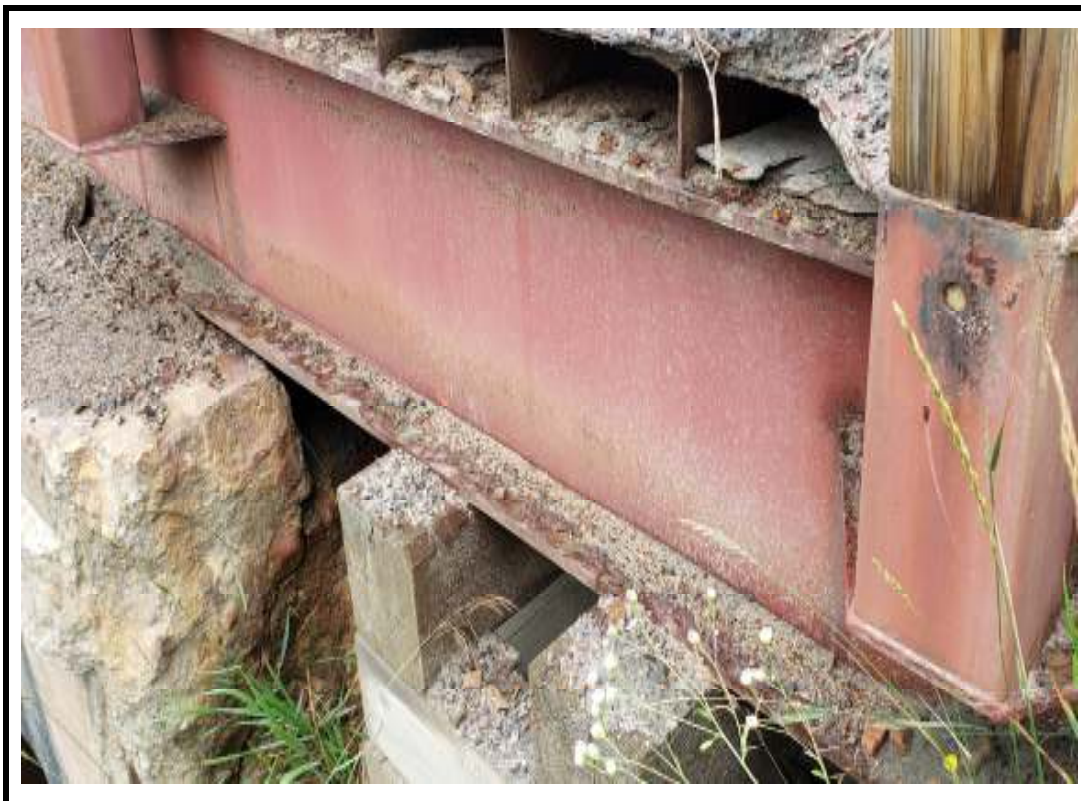
Photo 14 Moderate corrosion with pitting of coating noted on exterior beams at southeast corner

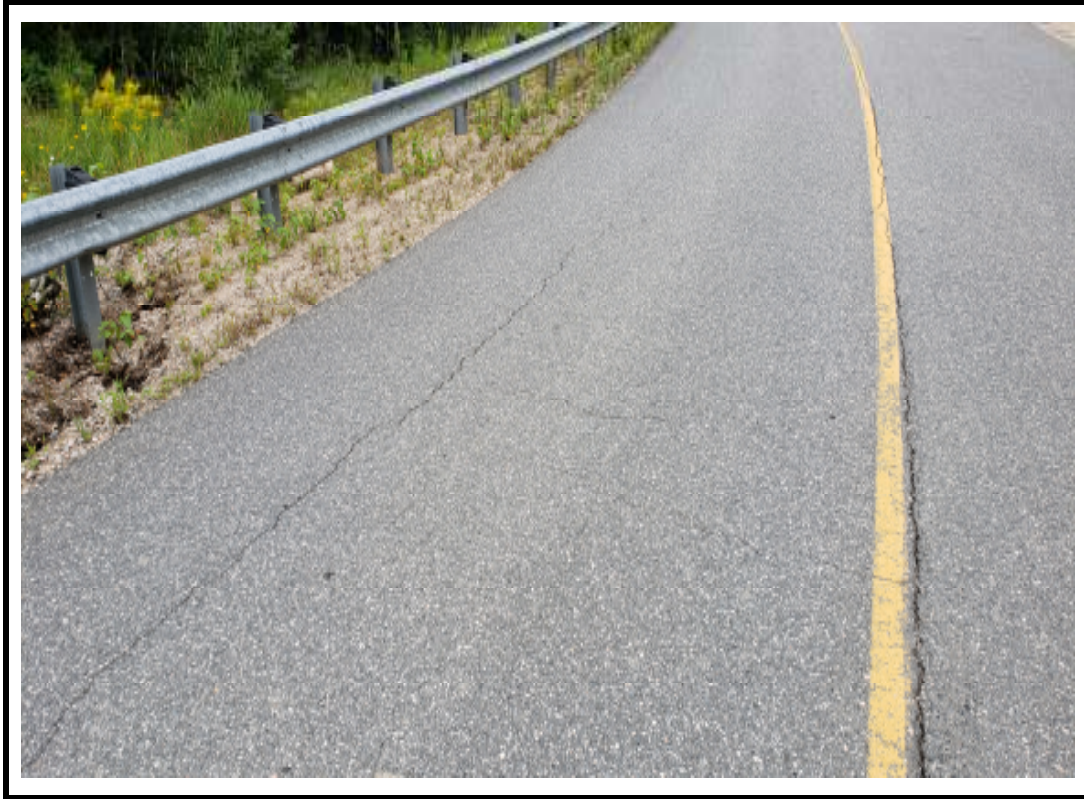
Photo 7 Vertical cracks noted along centerline and edges of approach wearing surface

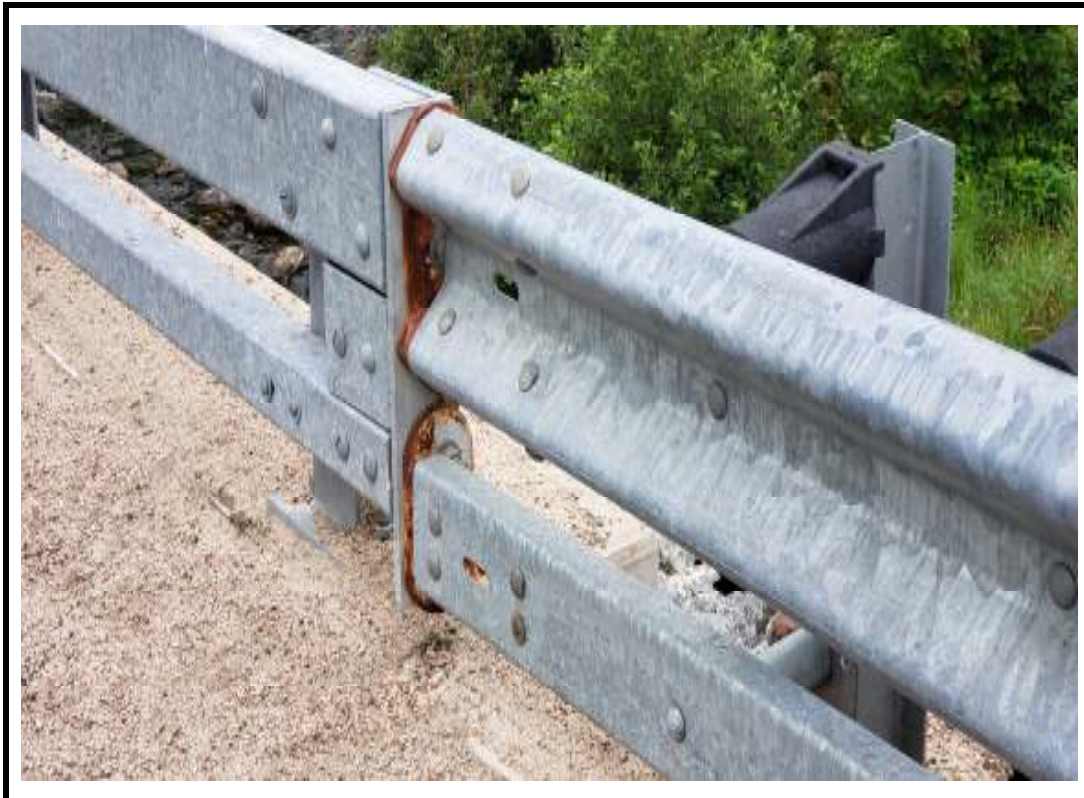
Photo 8 Corrosion noted at connection between approach barrier and traffic barrier

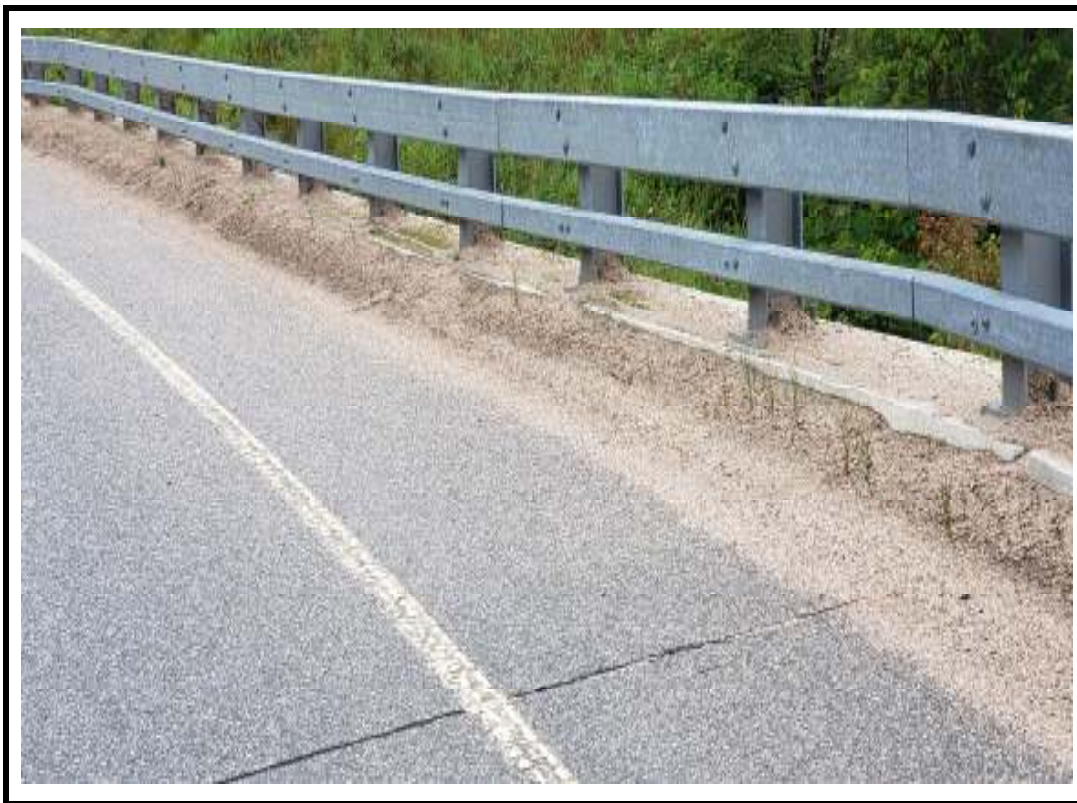
Photo 9 Debris accumulation noted at the edge and over the traffic barrier

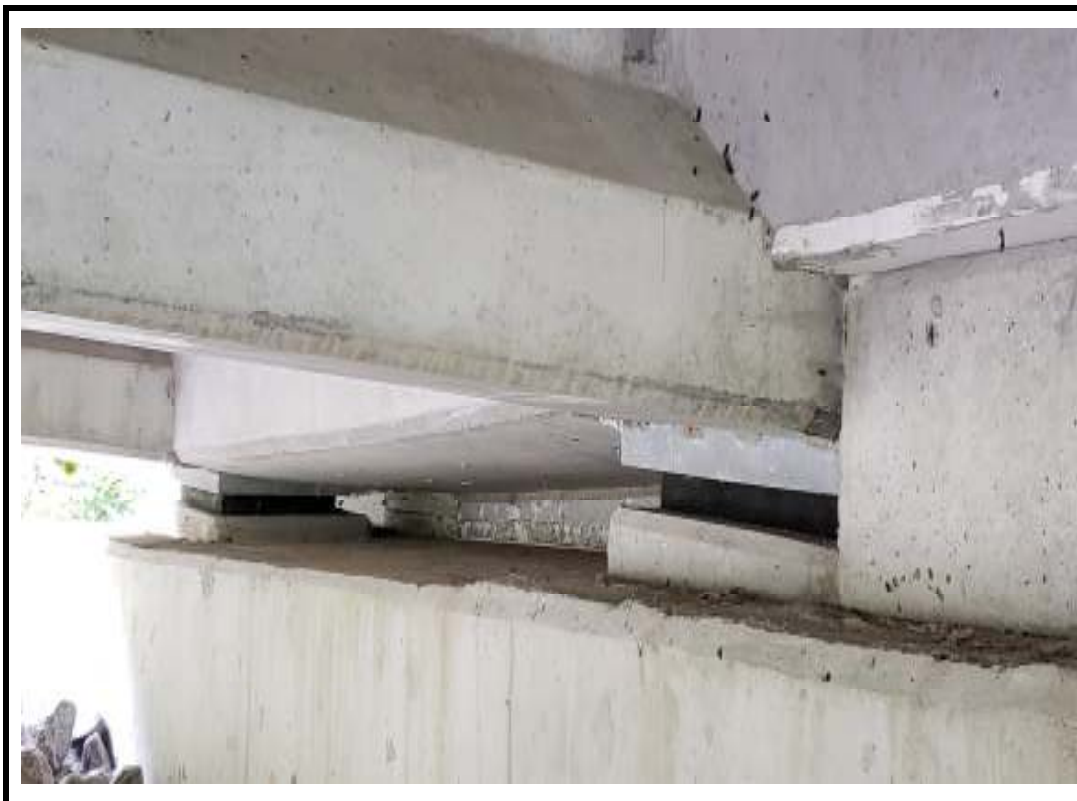
Photo 10 Bearing pad at west abutment wall

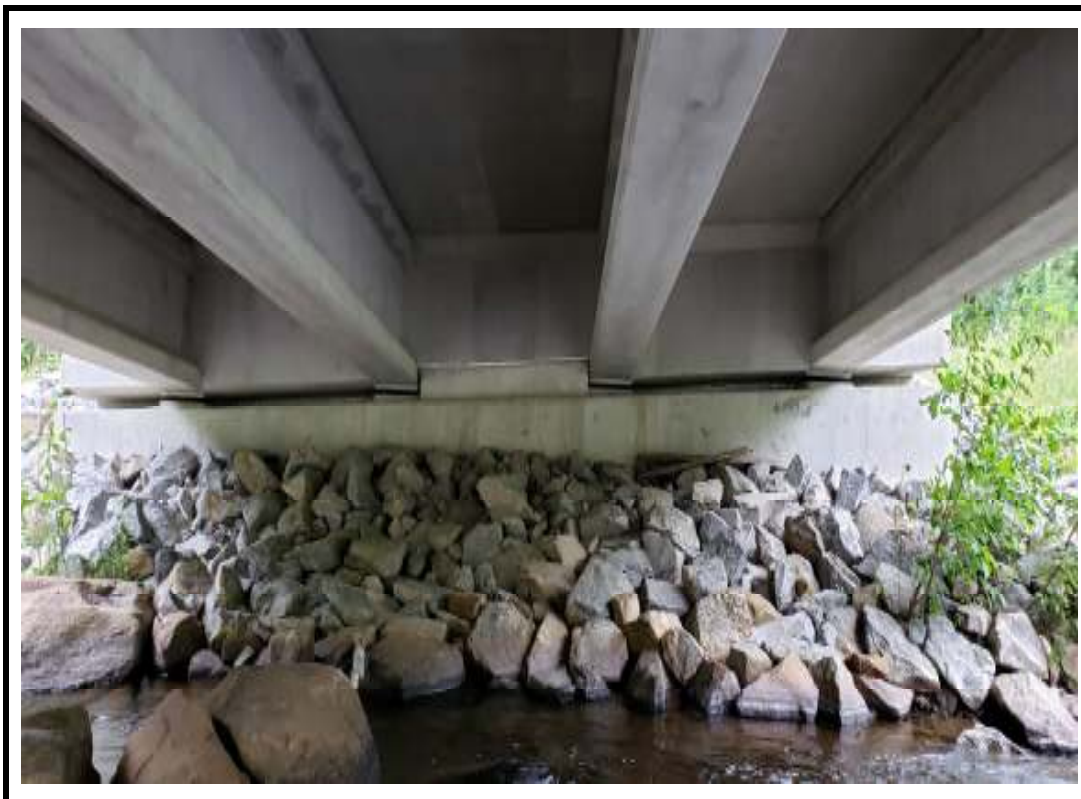
Photo 14 West abutment wall

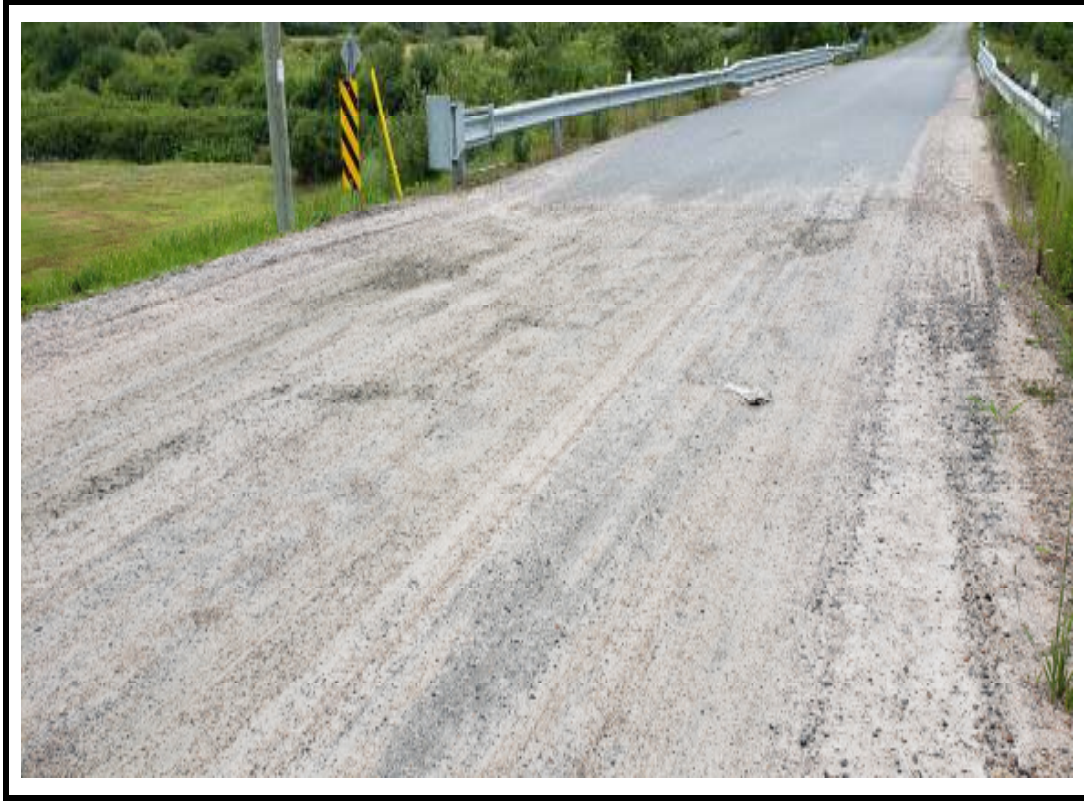
Photo 7 Potholes and loose gravel noted on approach wearing surface

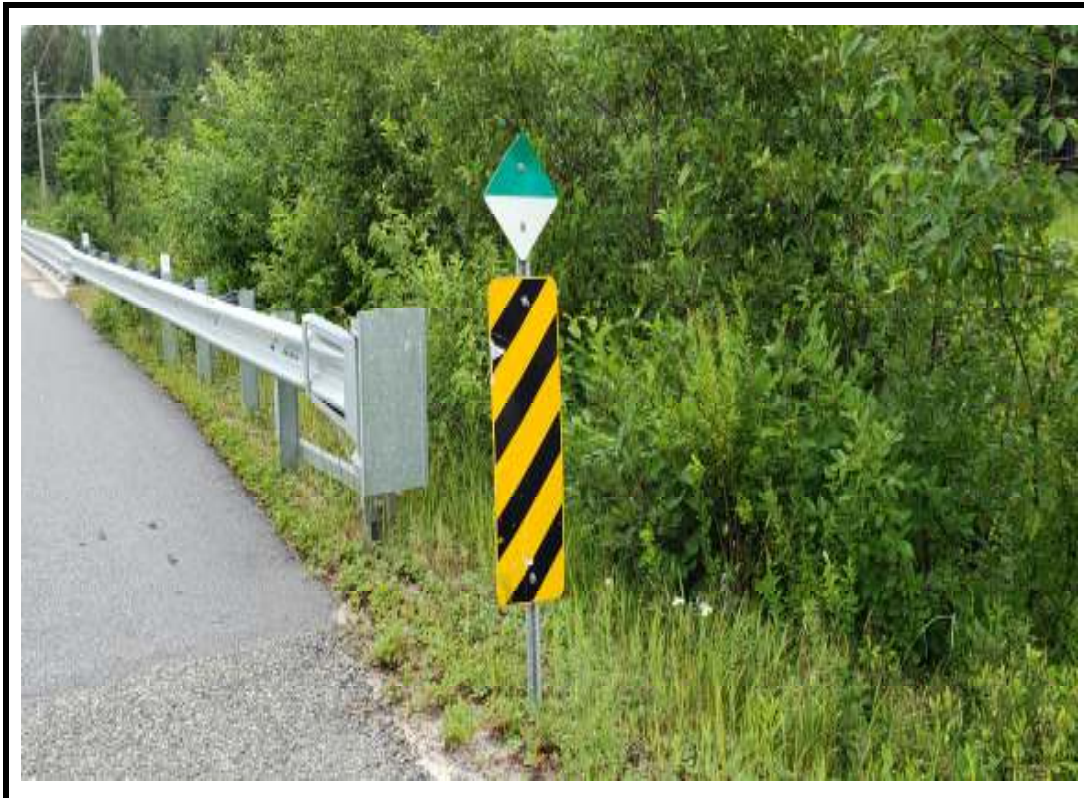
Photo 8 Small dents and abrasion noted on southeast hazard sign

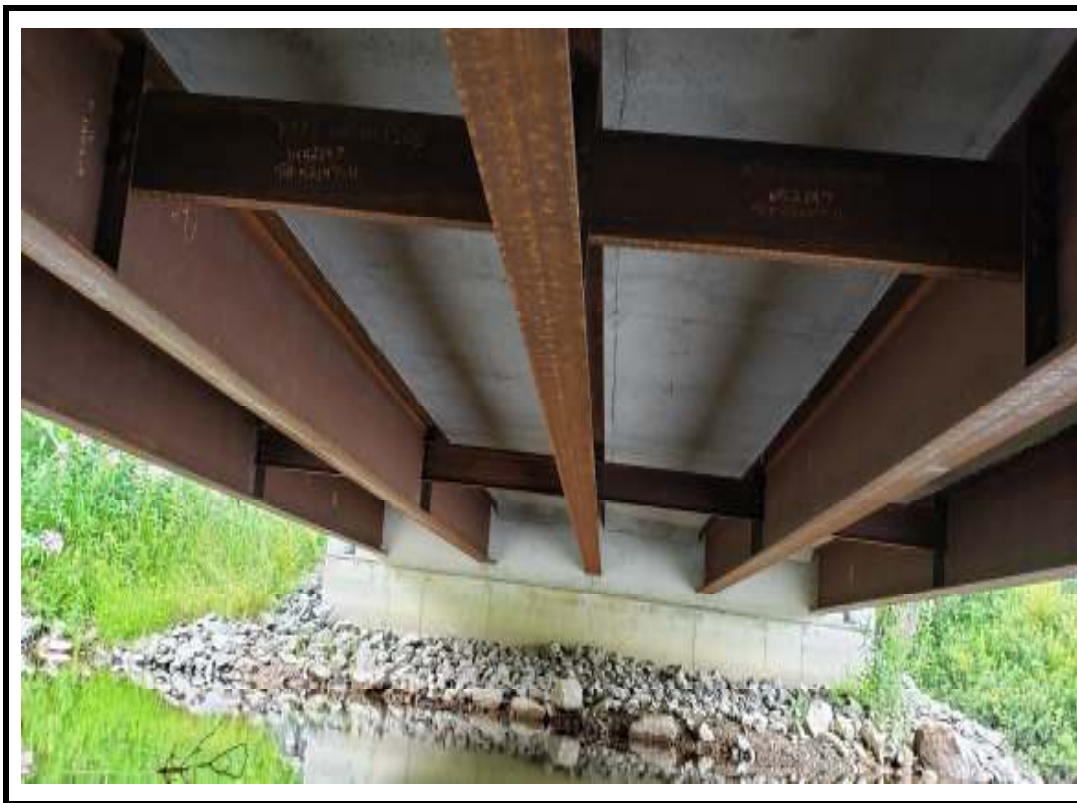
Photo 9 North underside of structure

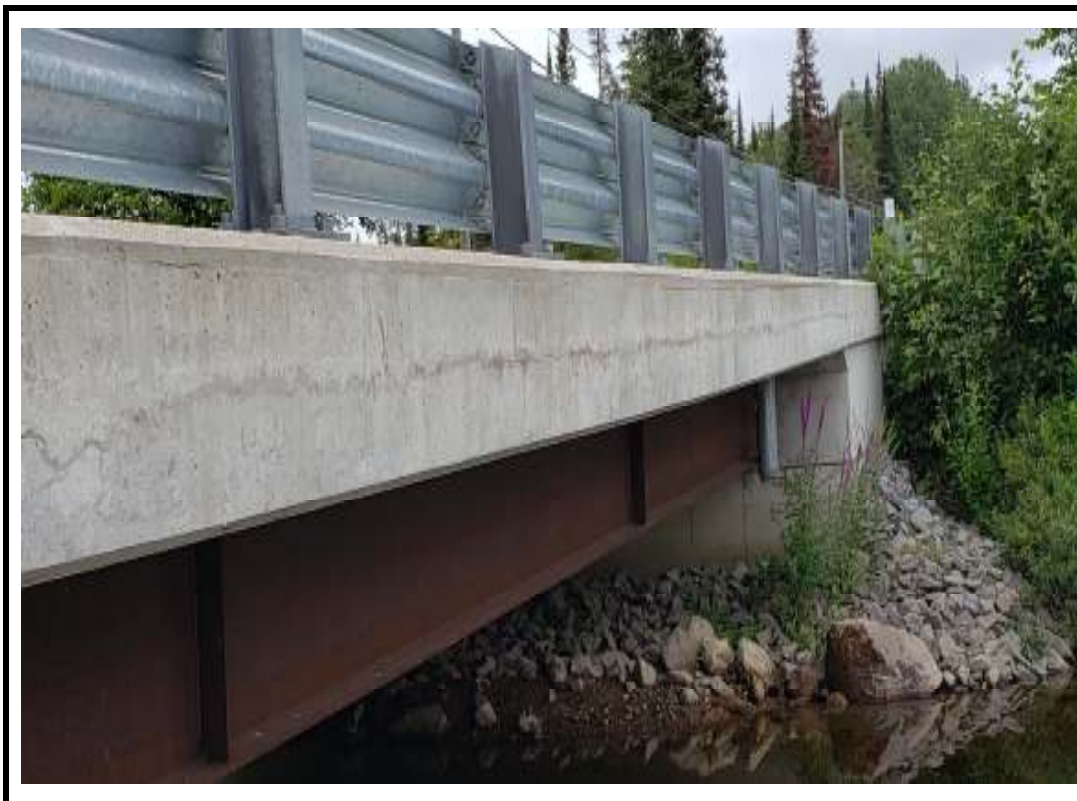
Photo 10 Narrow cracks and scaling noted on east fascia

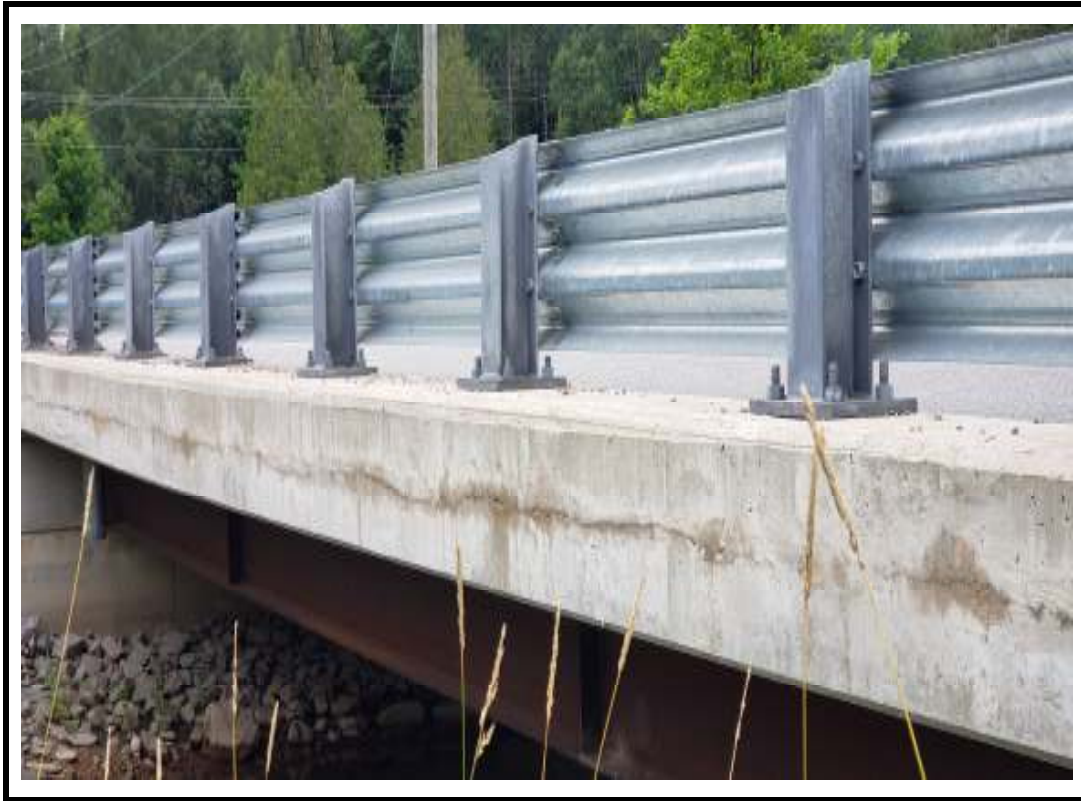
Photo 11 Longitudinal narrow racks with damp stains noted on west fascia

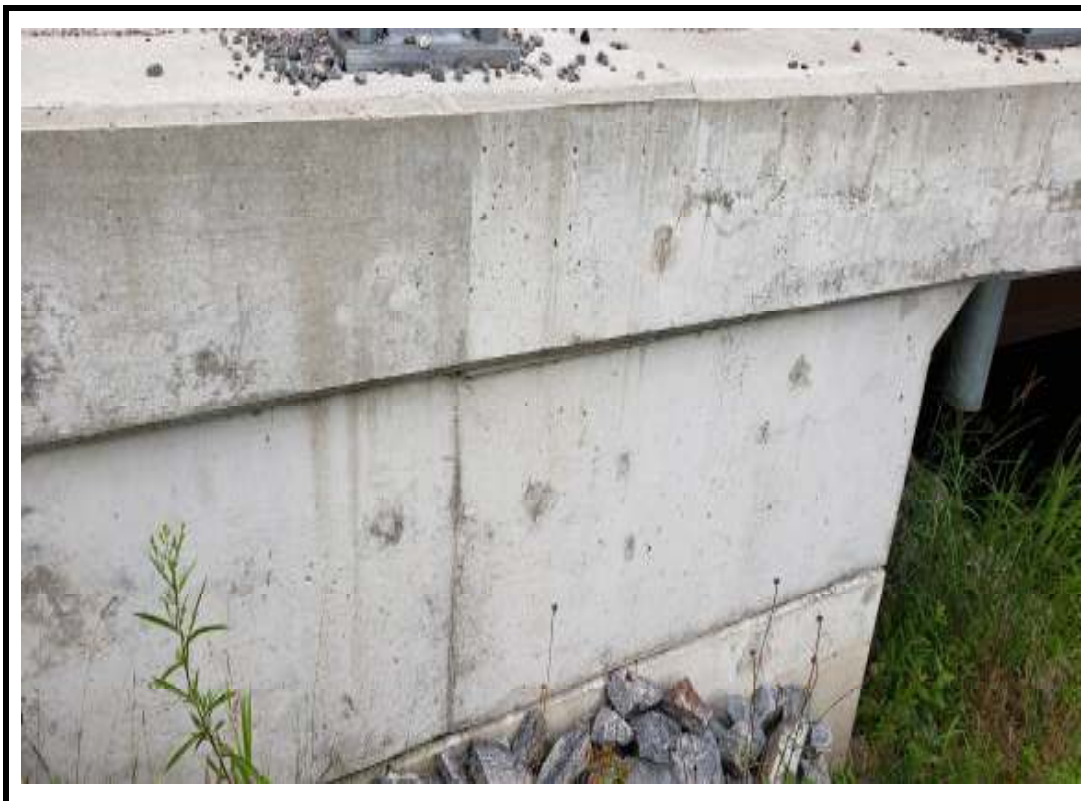
Photo 12 Southeast wingwall

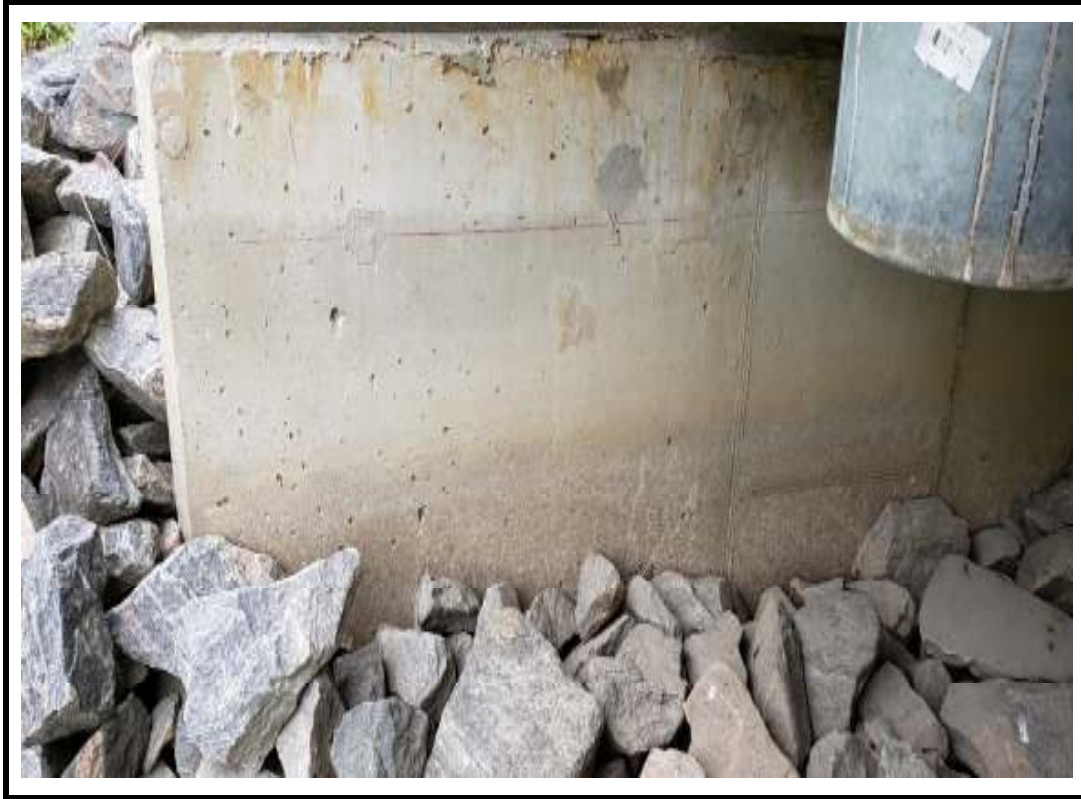
Photo 13 Concrete disintegration and scaling noted on abutment wall

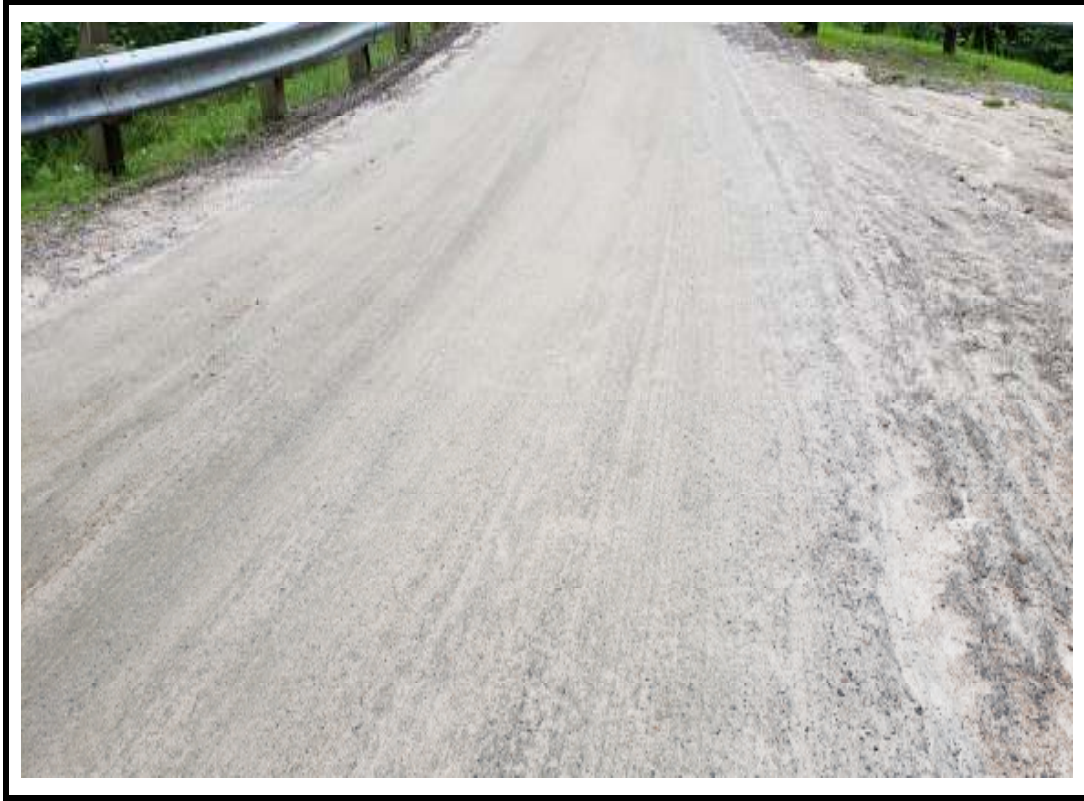
Photo 7 Tire rutting and small potholes noted on approach wearing surface
