ATTACHMENT 1

OSIM INSPECTION REPORTS & BCI FORMS

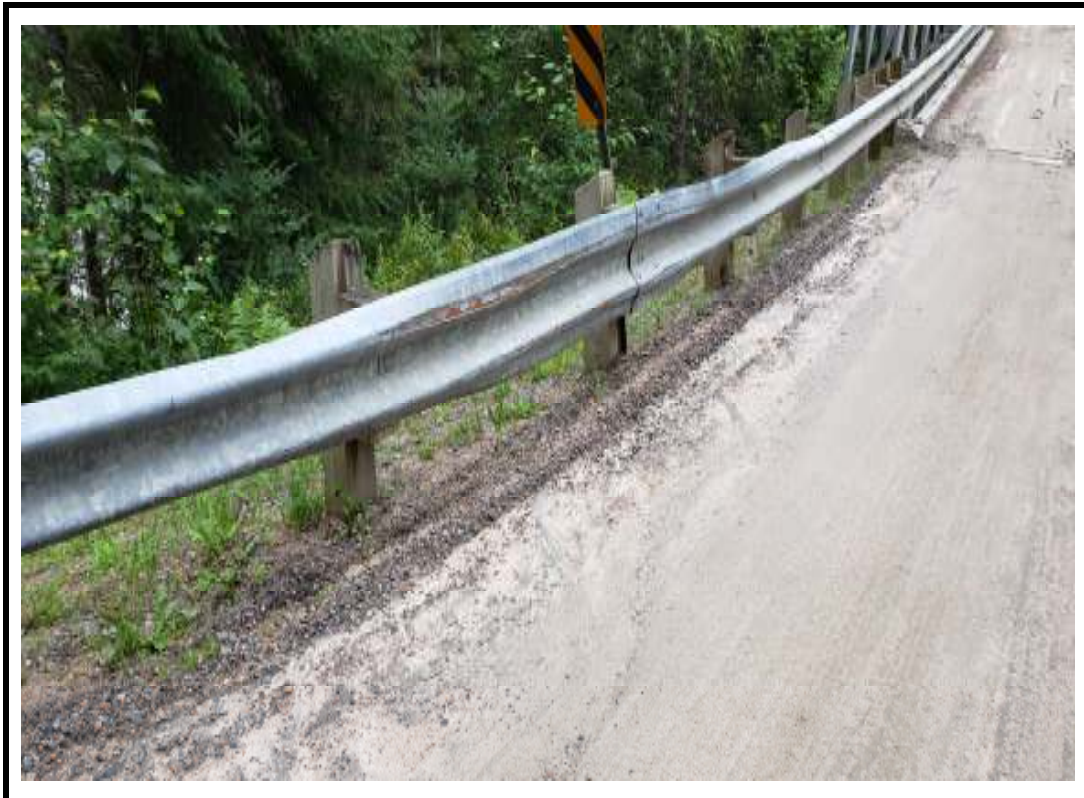
Photo 8 Collision damage observed on southeast approach barrier

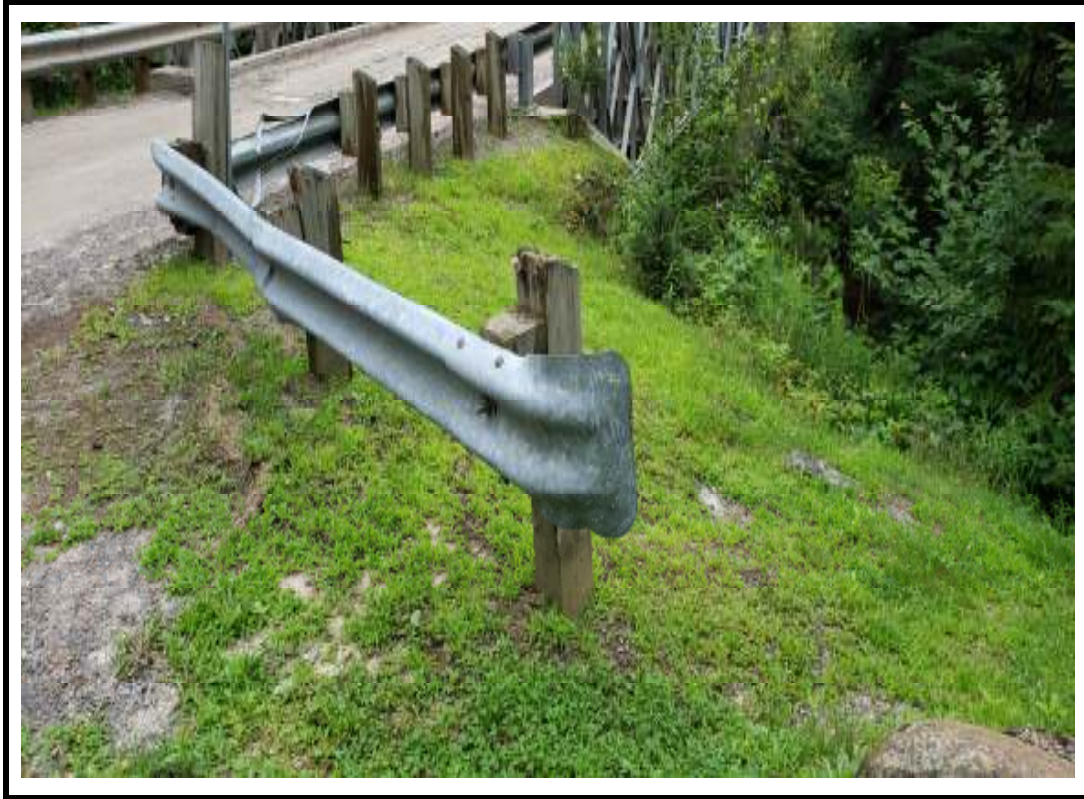
Photo 9 Substandard end treatment with damaged approach barrier at northeast corner

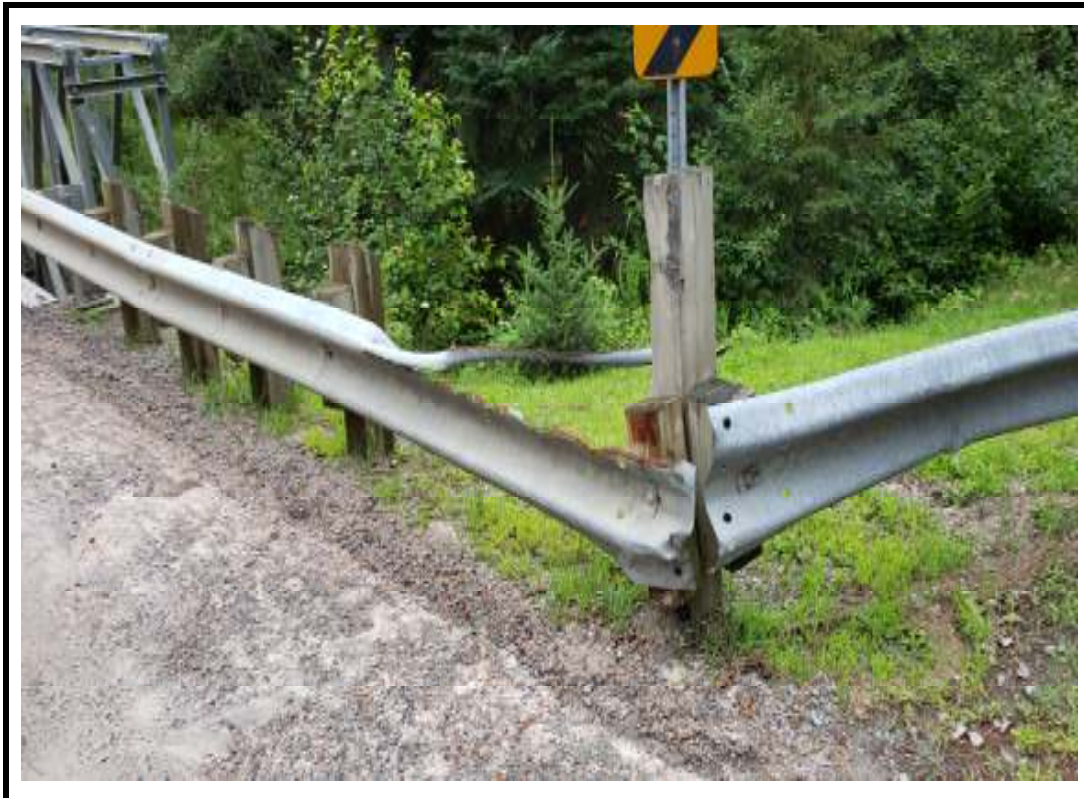
Photo 10 Damage with corrosion noted on thrie steel beam on northeast approach barrier

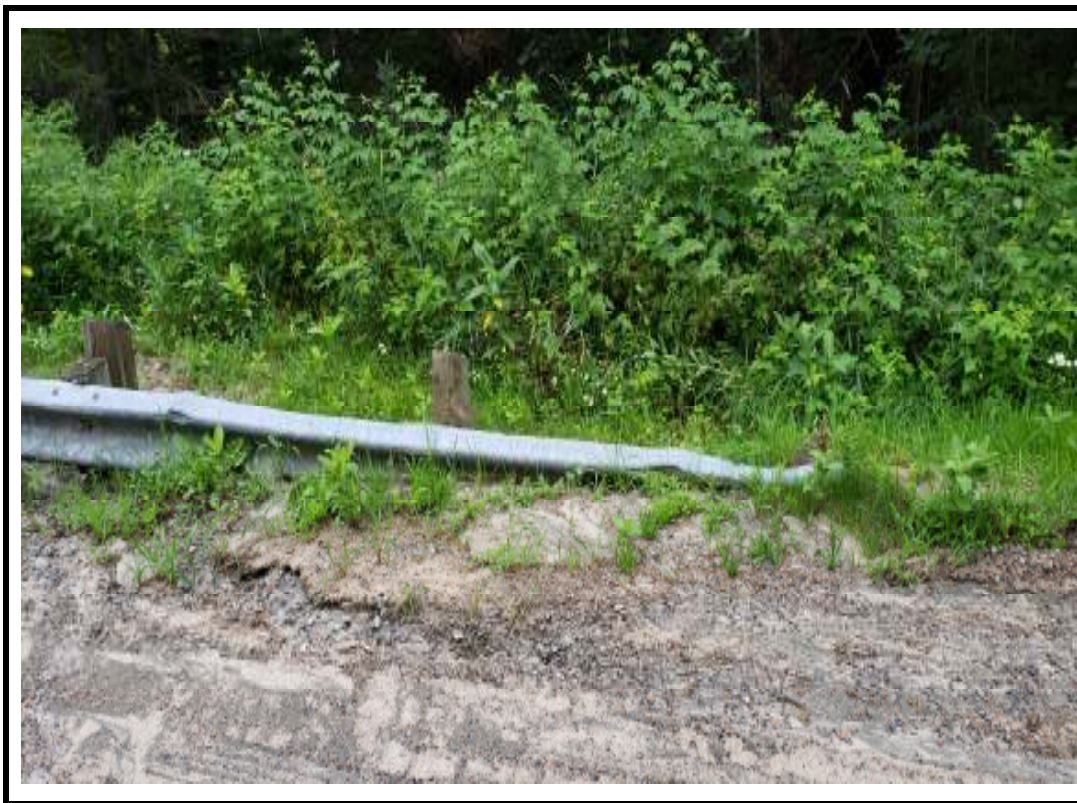
Photo 11 Southwest end treatment was buried into ground

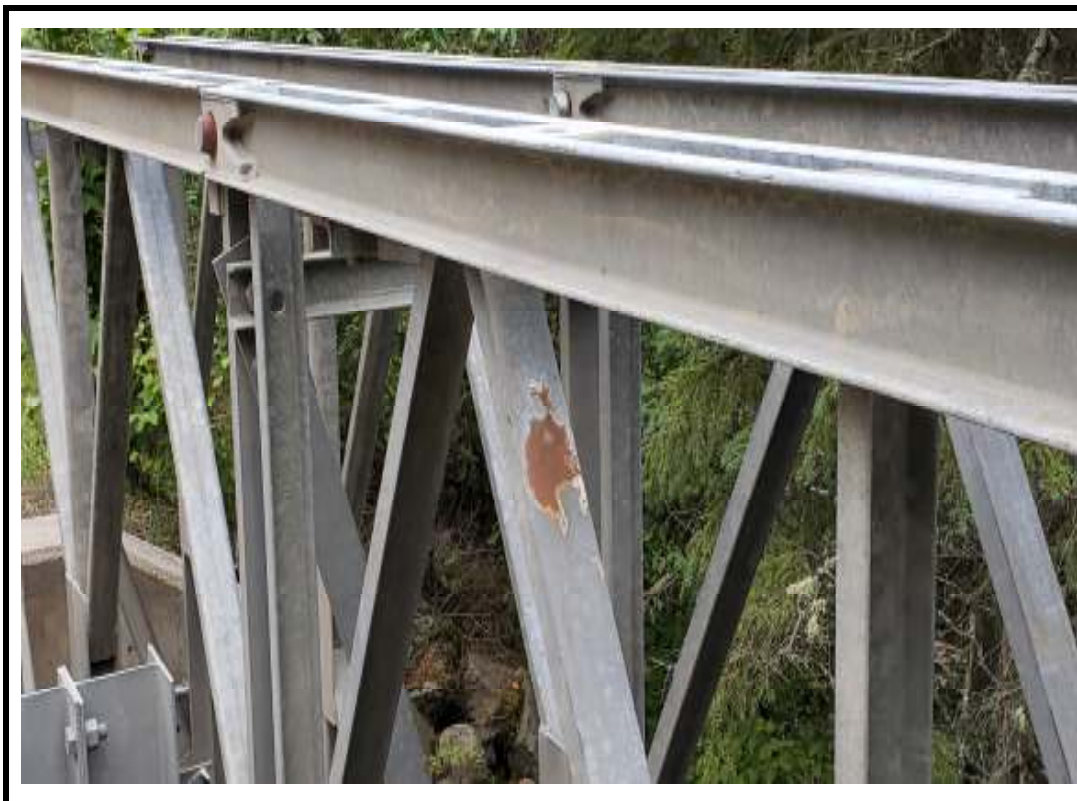
Photo 12 Corrosion noted on diagonal member of bailey panel on bridge barrier

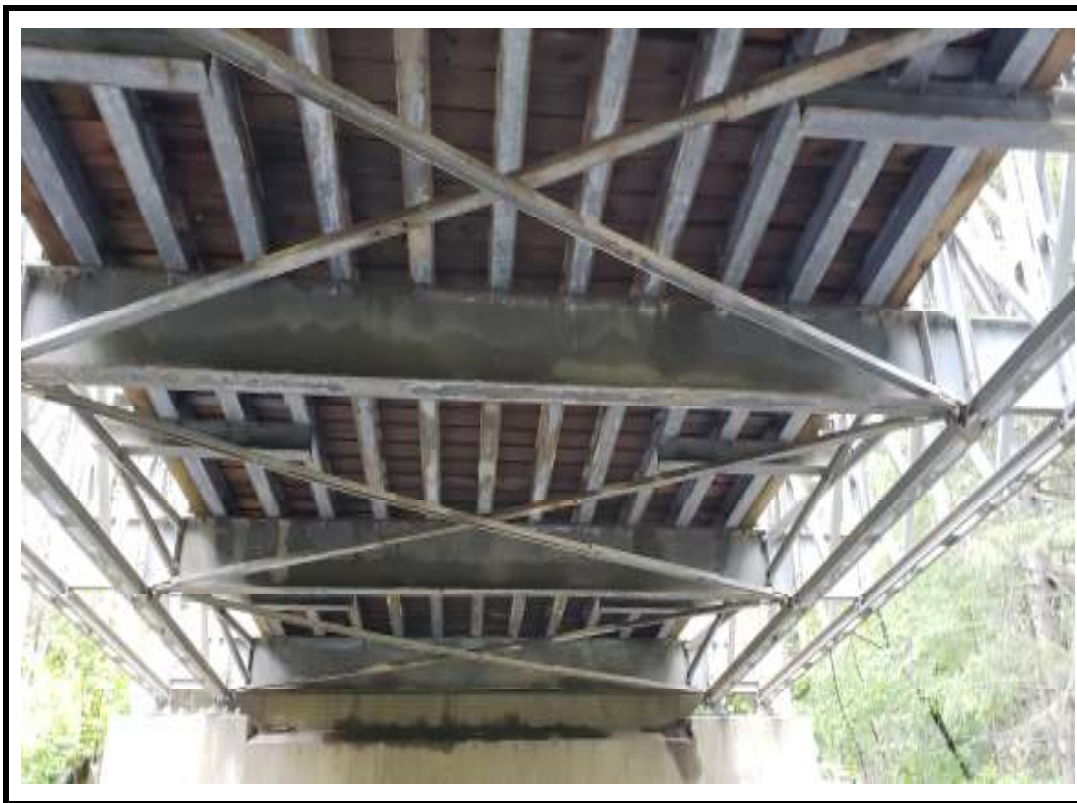
Photo 13 East underside of structure

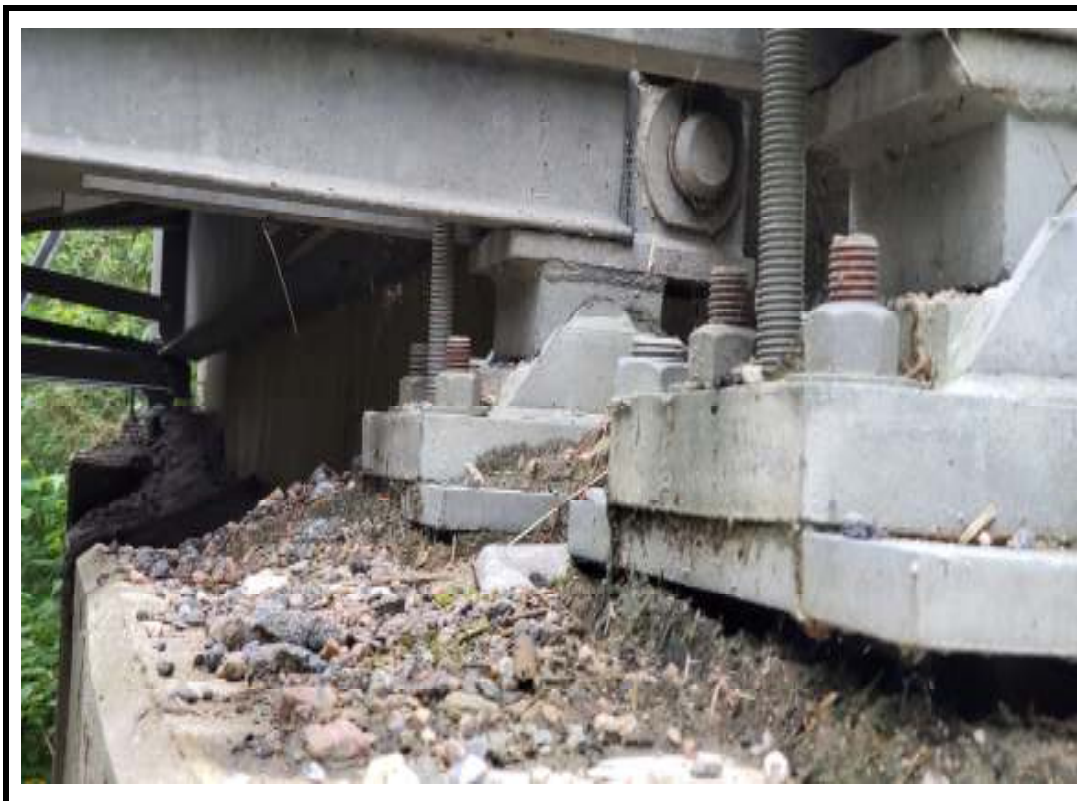
Photo 14 Debris accumulation observed around bearing pad

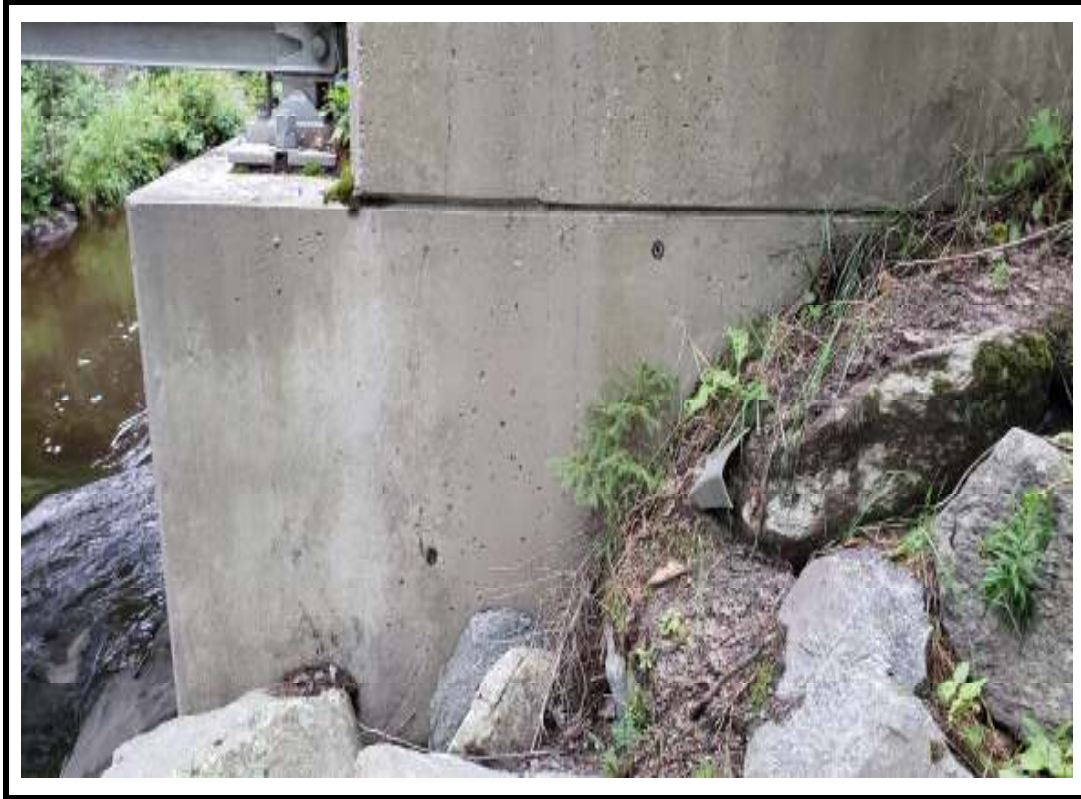
Photo 15 Southeast wingwall

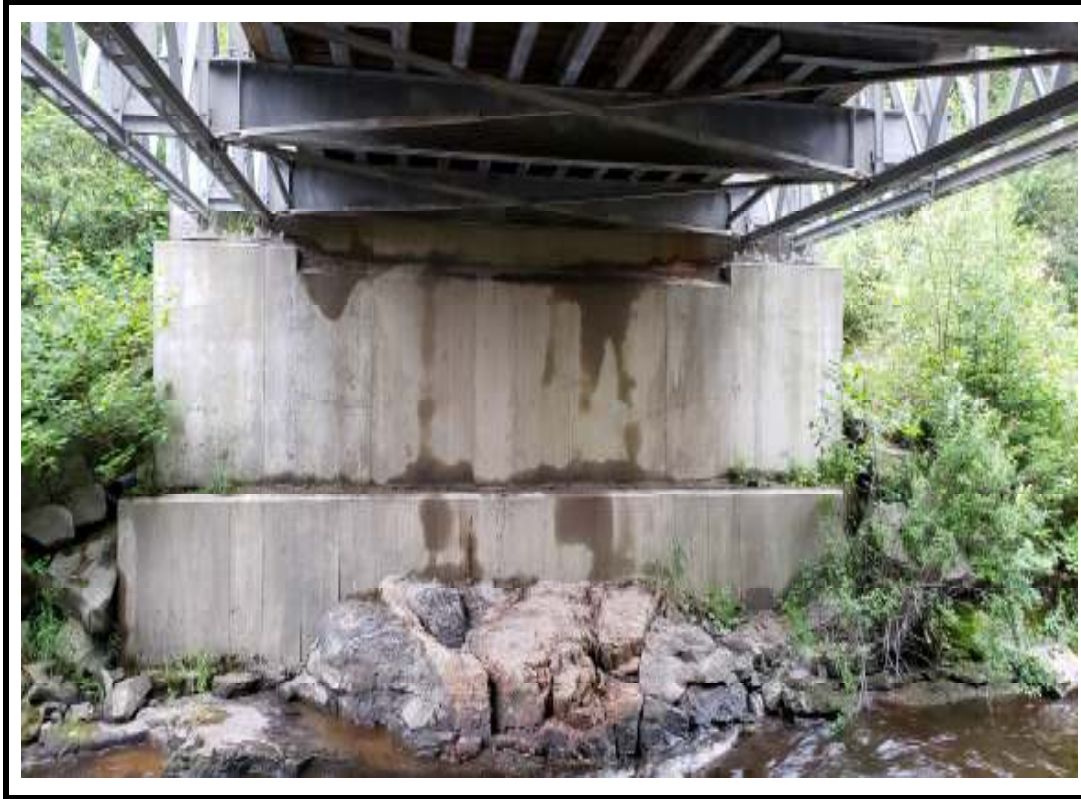
Photo 17 West abutment wall

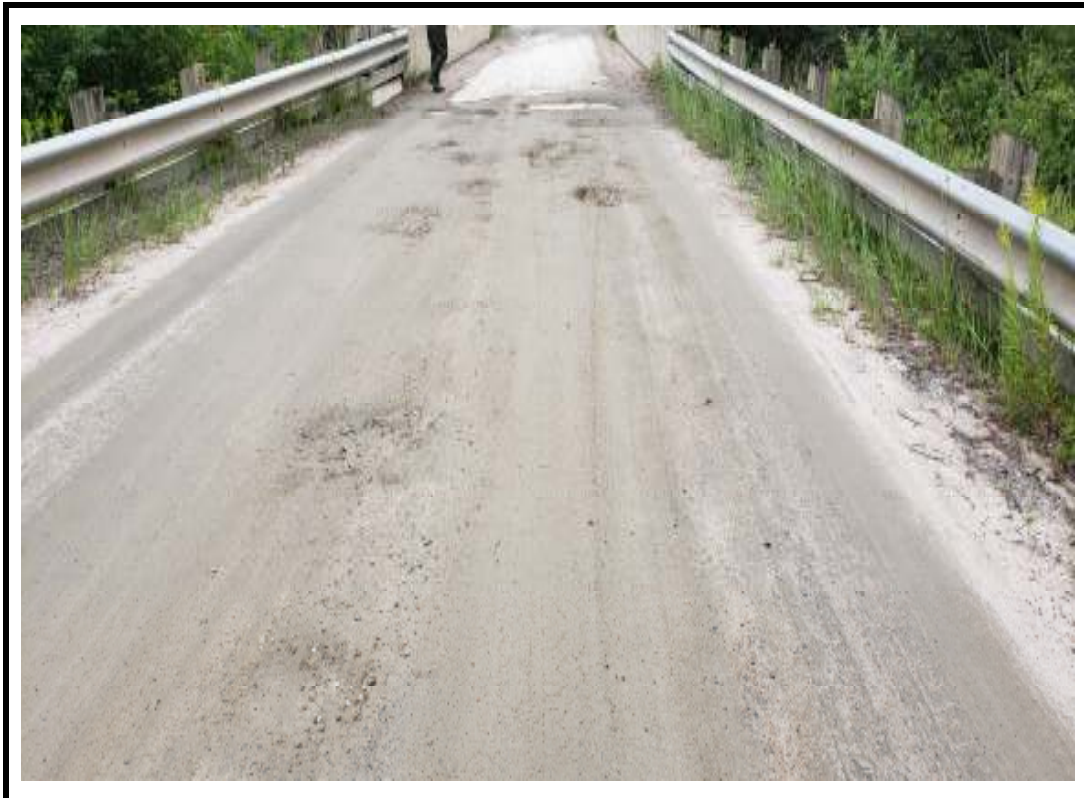
Photo 8 Large potholes and tire rutting noted on approach wearing surface

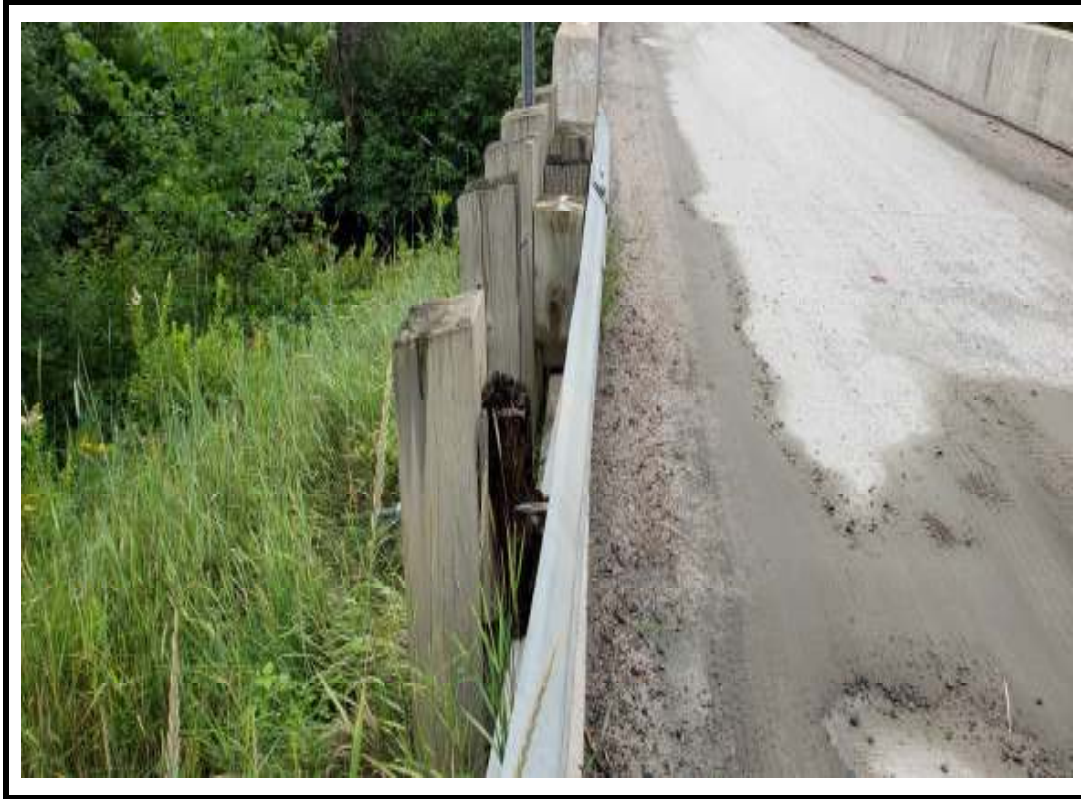
Photo 9 Spacer connected with approach barrier at northeast completely weathered

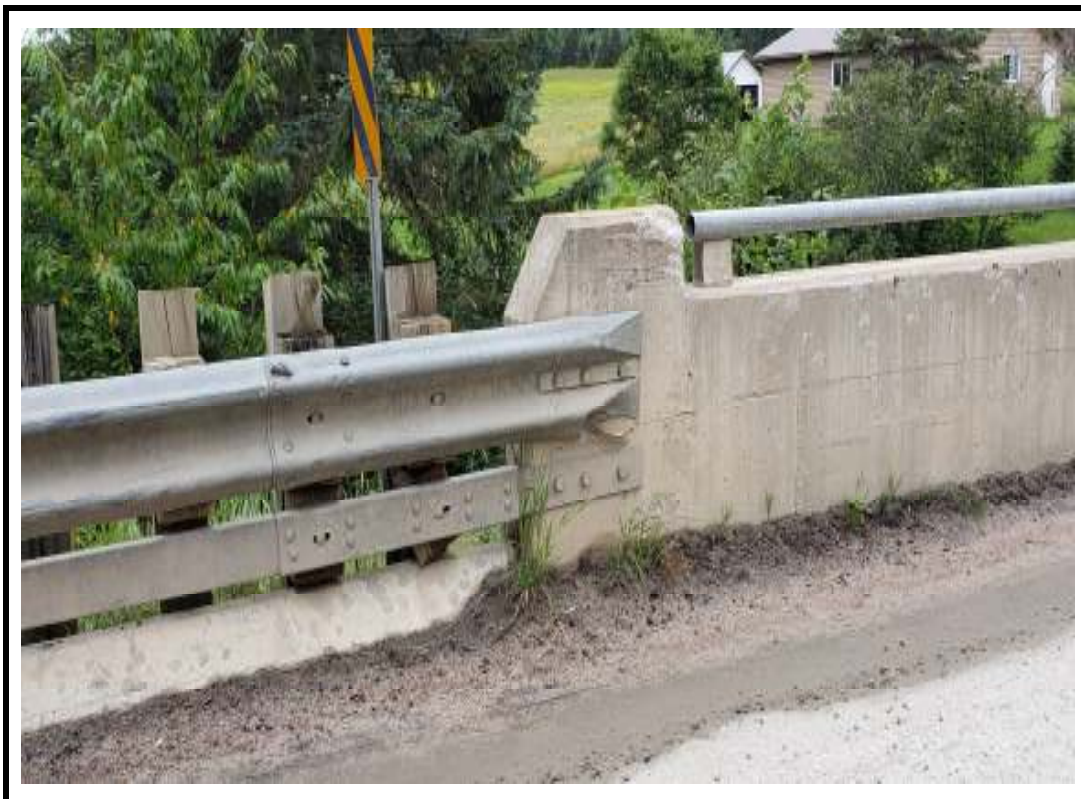
Photo 10 Collision damage noted at connection between approach and deck barrier

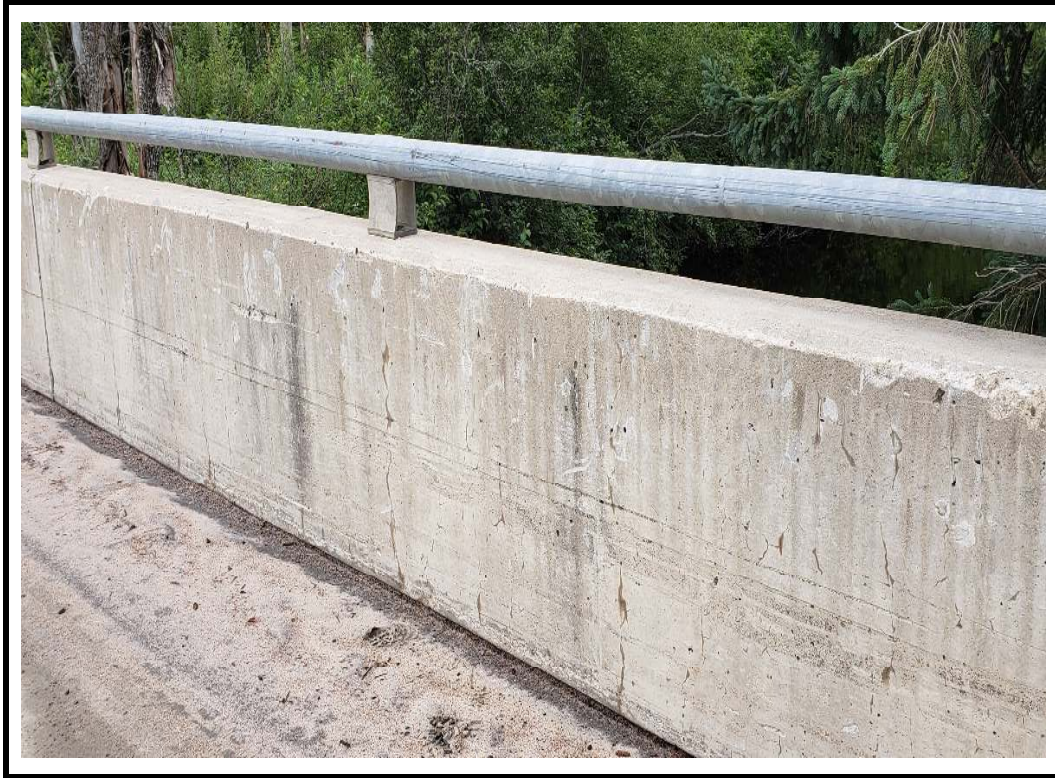
Photo 11 Narrow cracks with damp stains noted on parapet wall

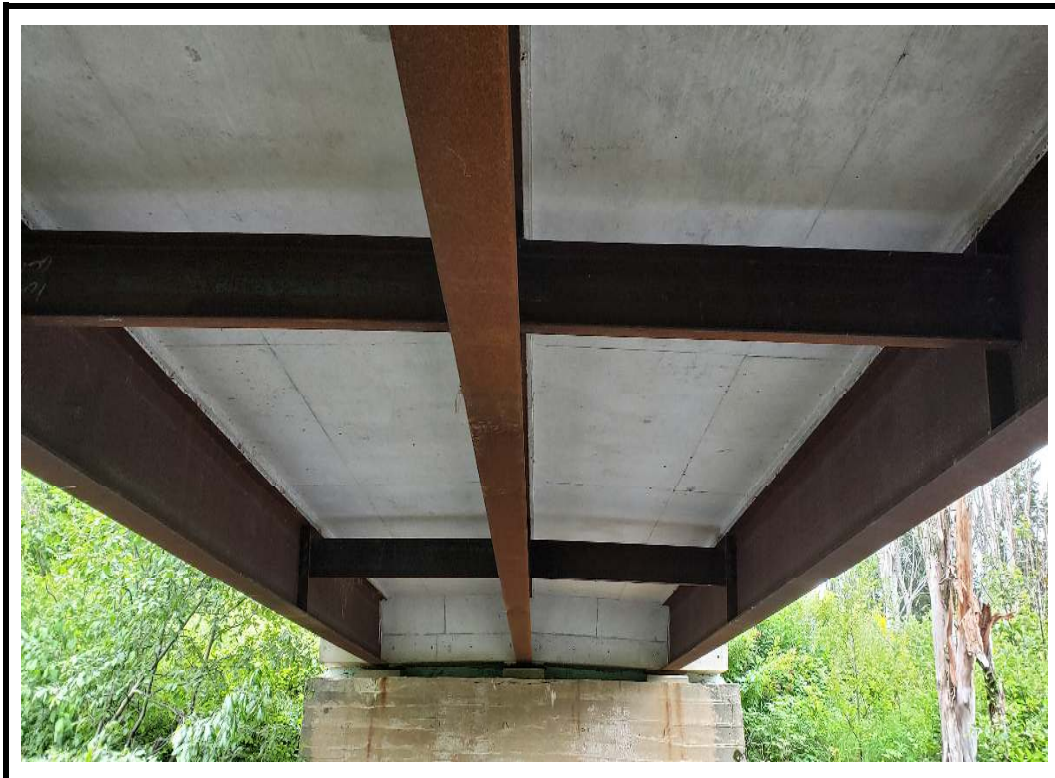
Photo 12 West underside of structure

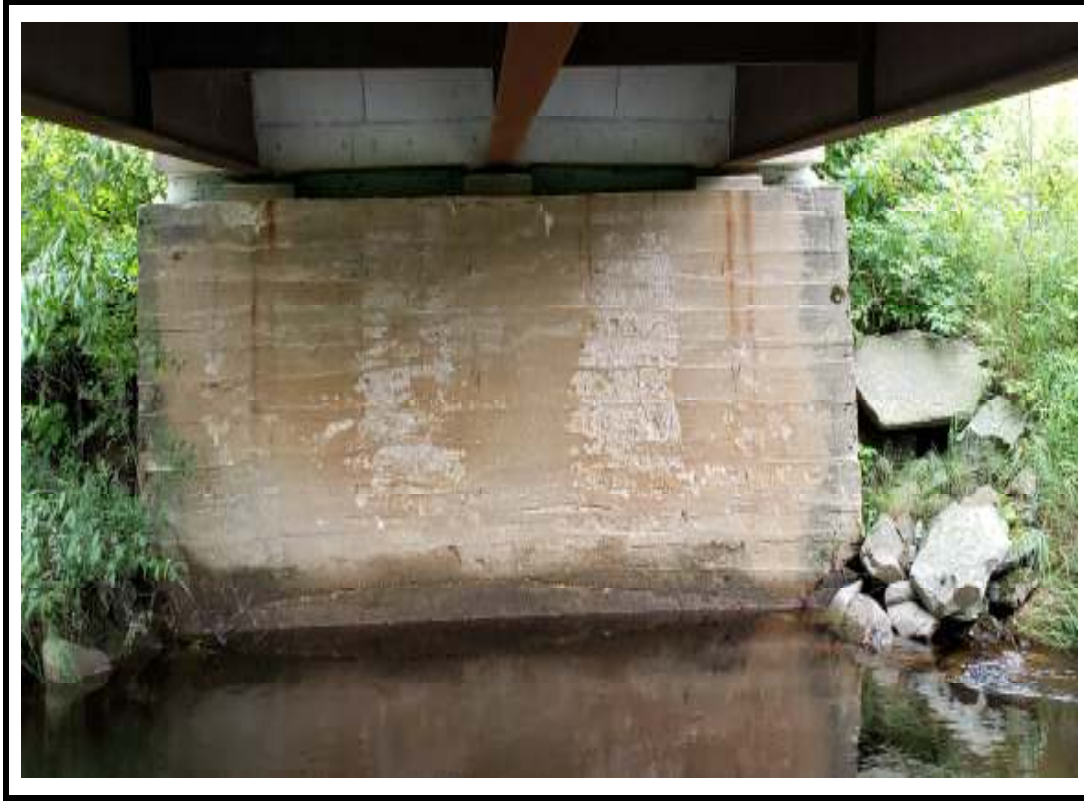
Photo 15 Moderate scaling, honeycombing and spall noted on south abutment wall

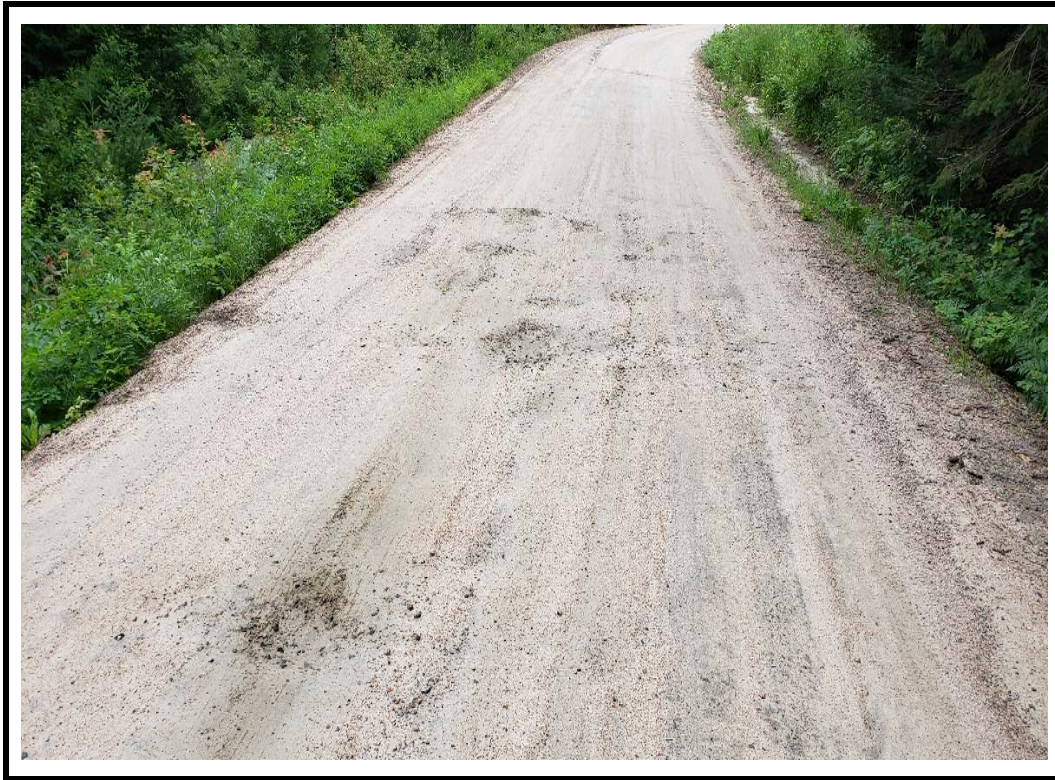
Photo 7 Potholes and loose gravel noted on wearing surface

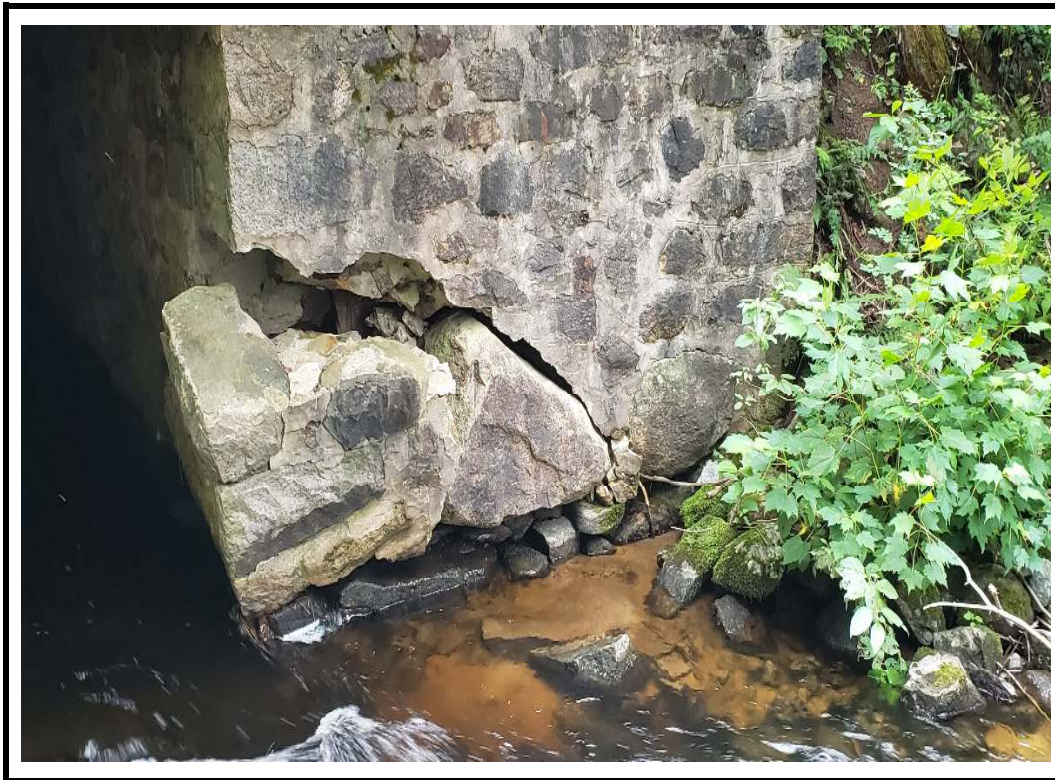
Photo 8 Large spall with disconnected portion noted at interface of north abutment wall and wingwall (prior to 2020 rehabilitation)

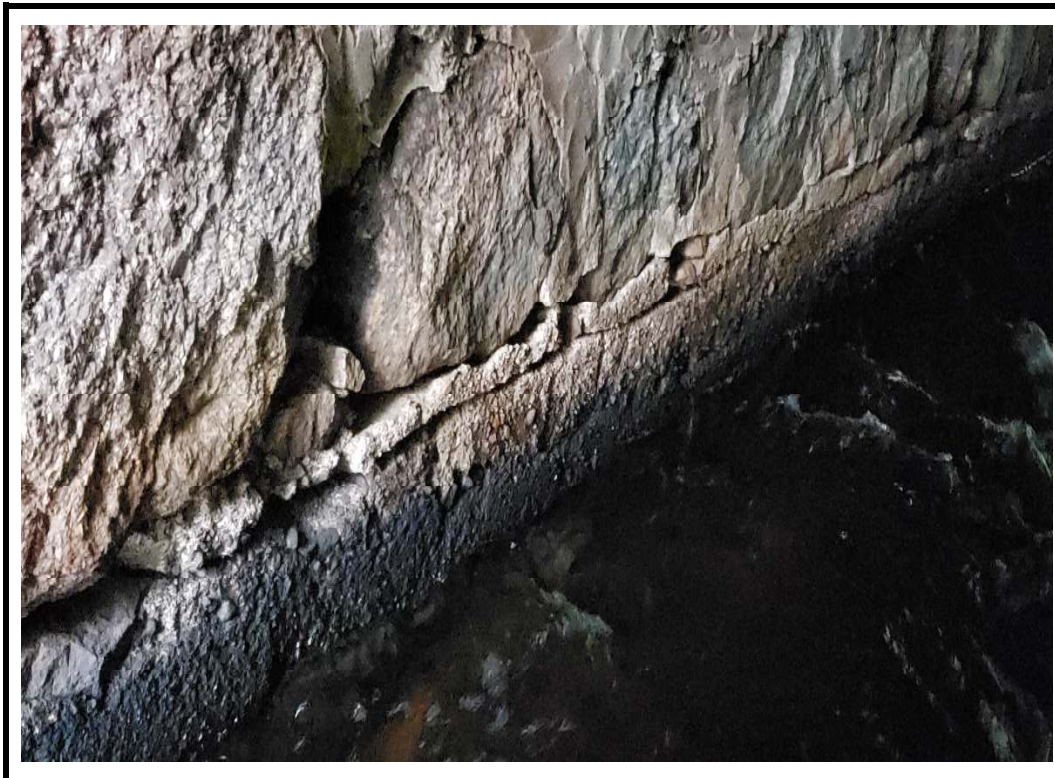
Photo 10 Moderate honey combing noted at base of abutment wall along waterline (prior to 2020 rehabilitation)

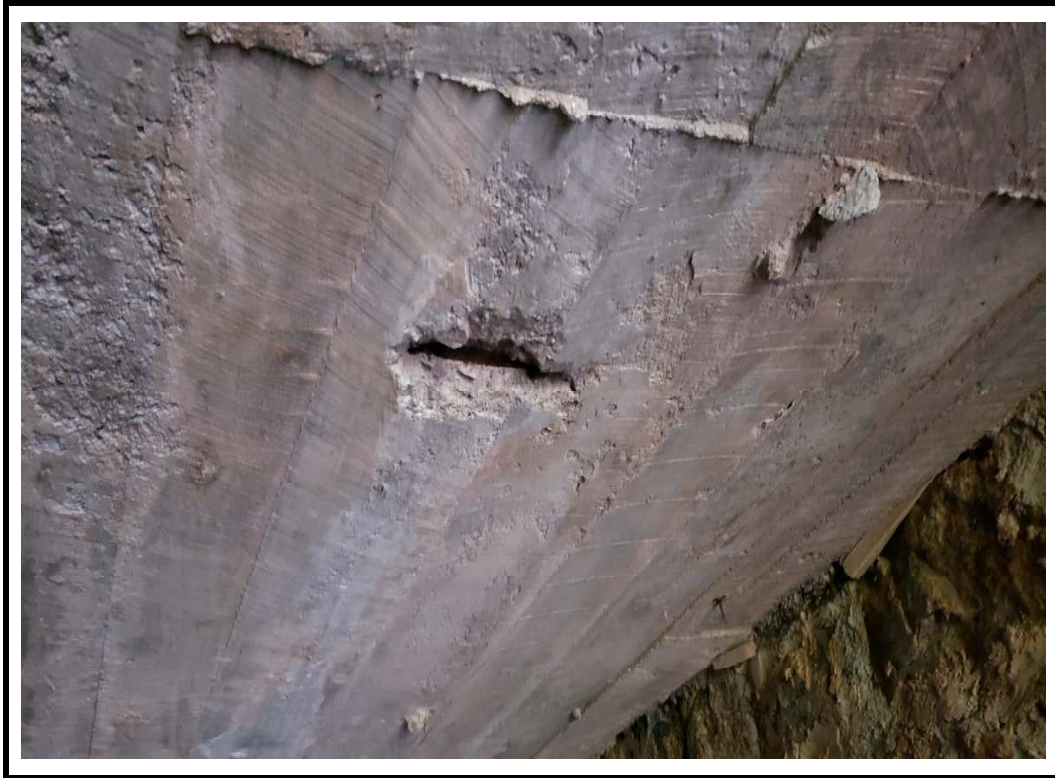
Photo 11 Spalls with exposed corroded reinforcement noted on soffit

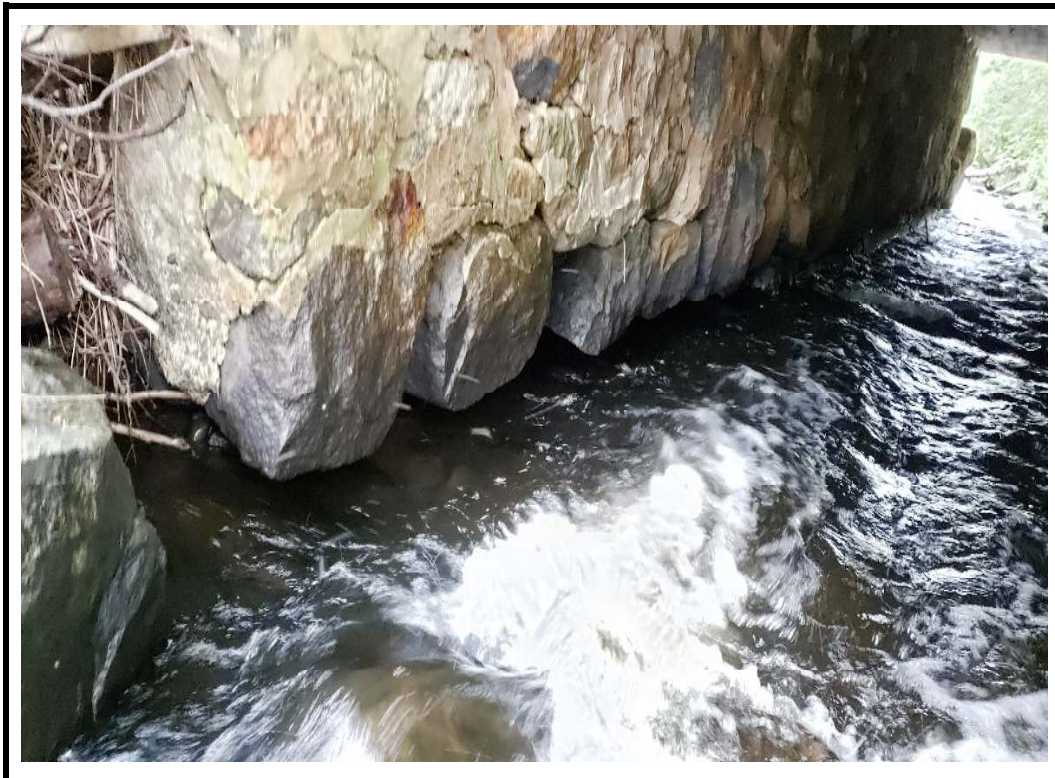
Photo 12 Undermining noted on south abutment wall at west end (prior to 2020 rehabilitation)
