**Township of Strong
D.M. Wills Project No. 24-9217**

**2018 Municipal Structure
Inspection Program**

Summary Report

September 2018

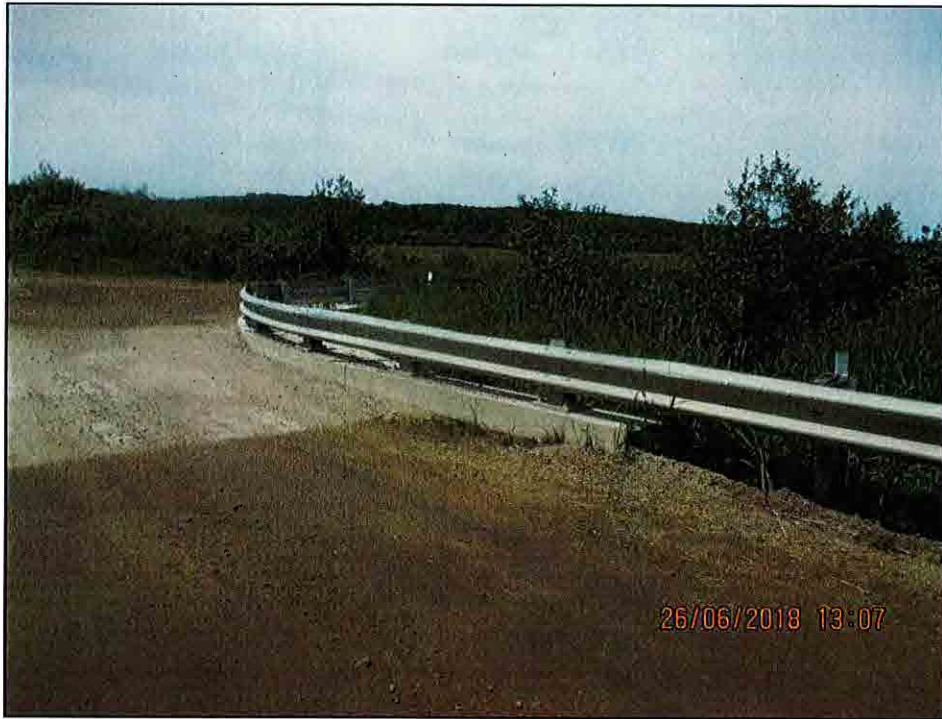
North railing

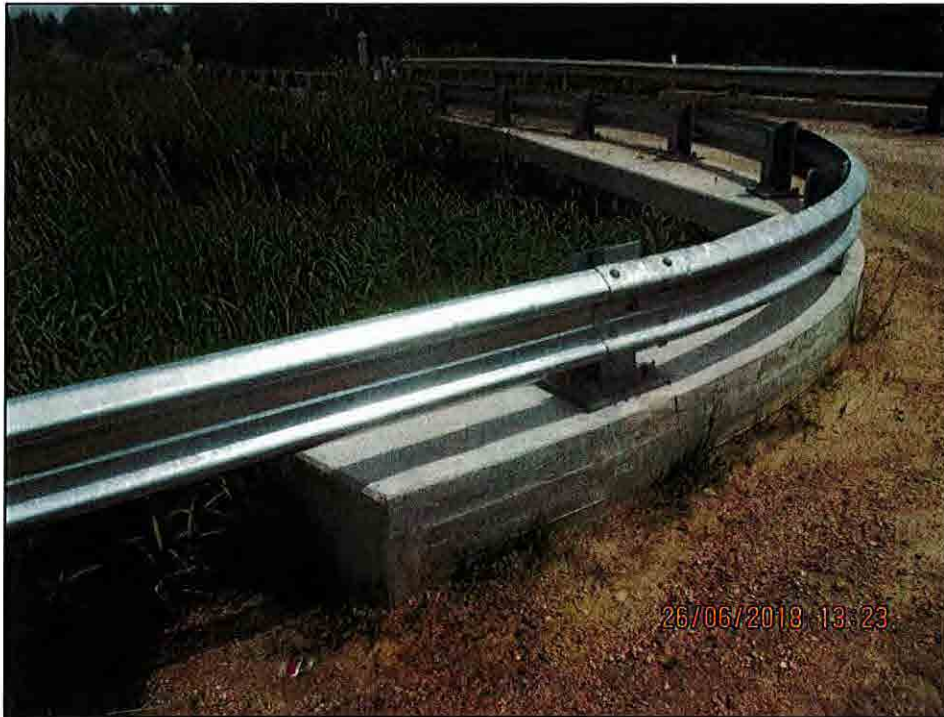
North railing

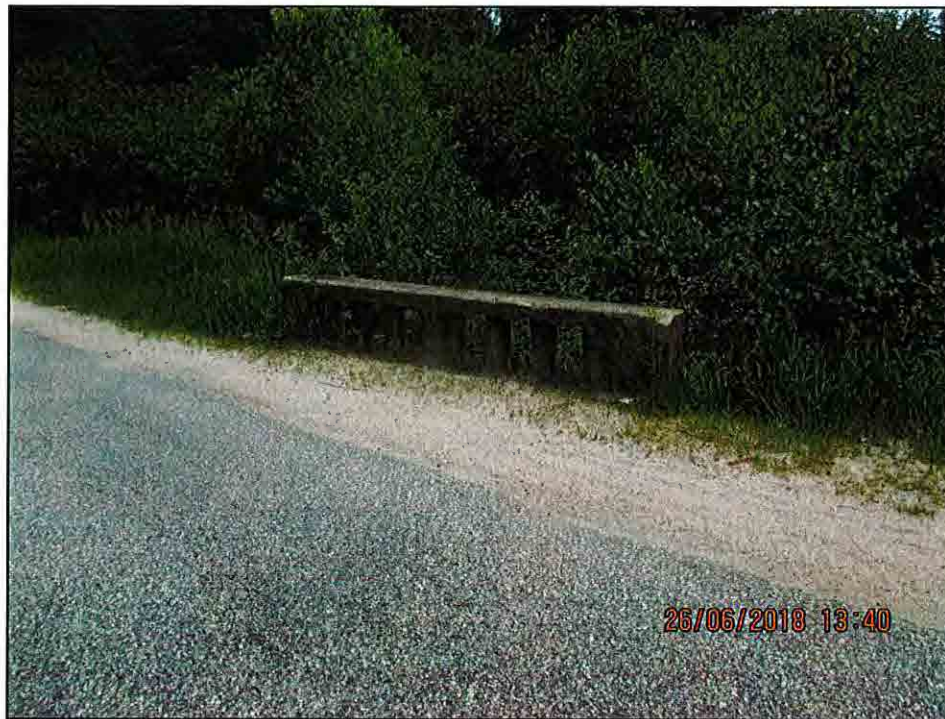
South barrier wall

Recommended Work
 Install steel beam guide rail.

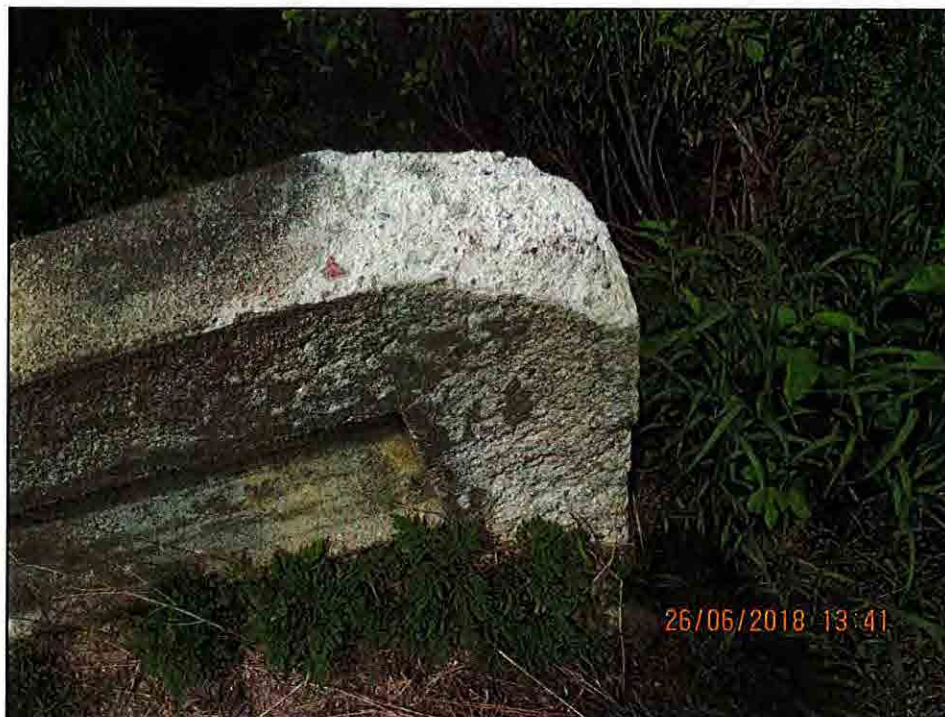
Spall at Northeast

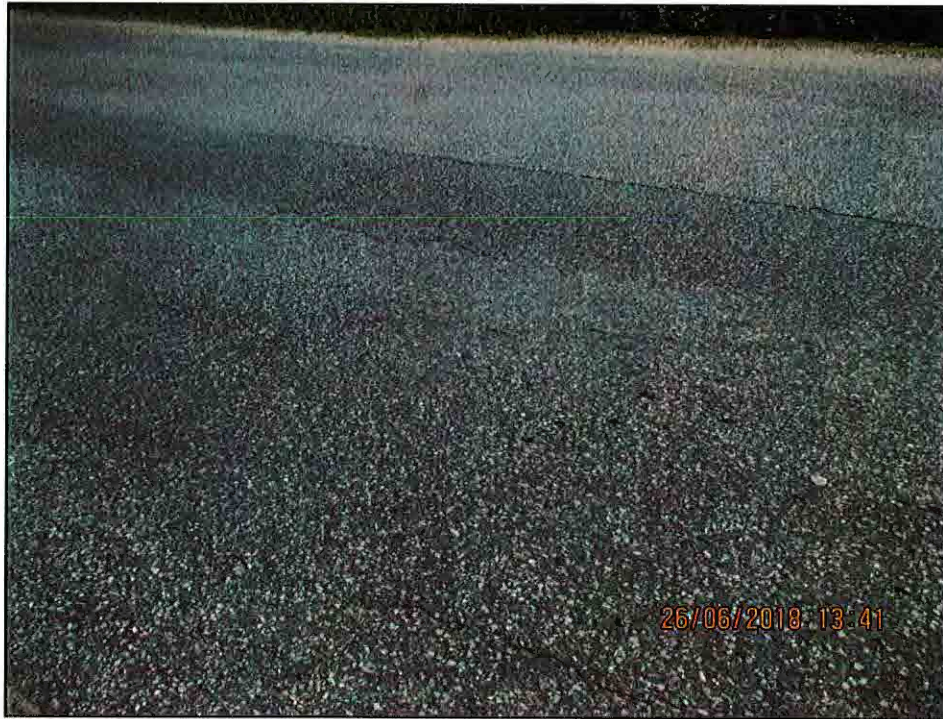
Cracks on wearing surface

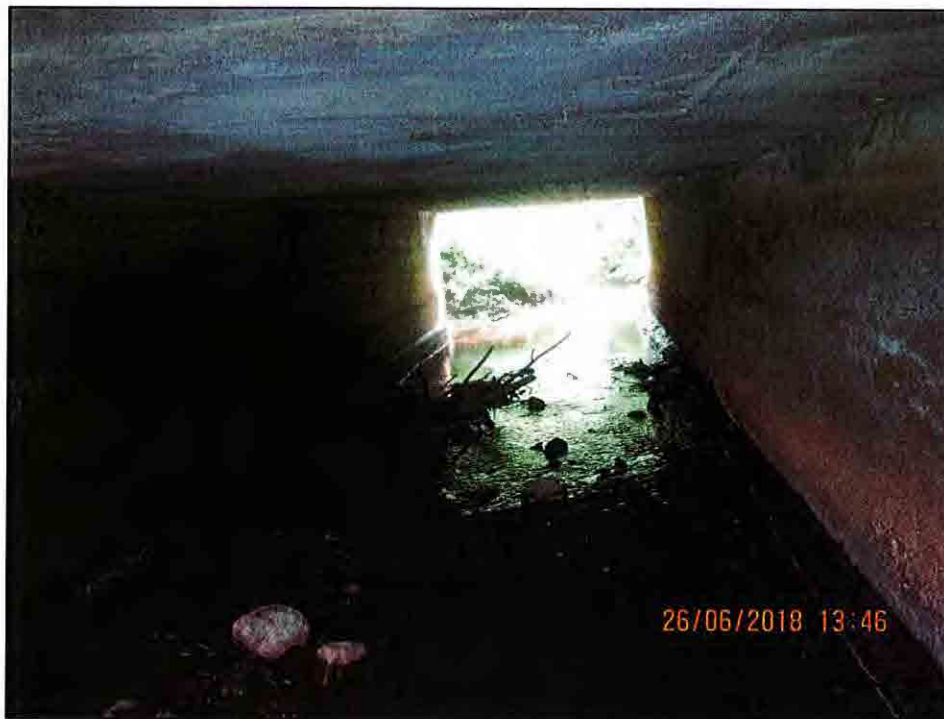
Barrel looking South

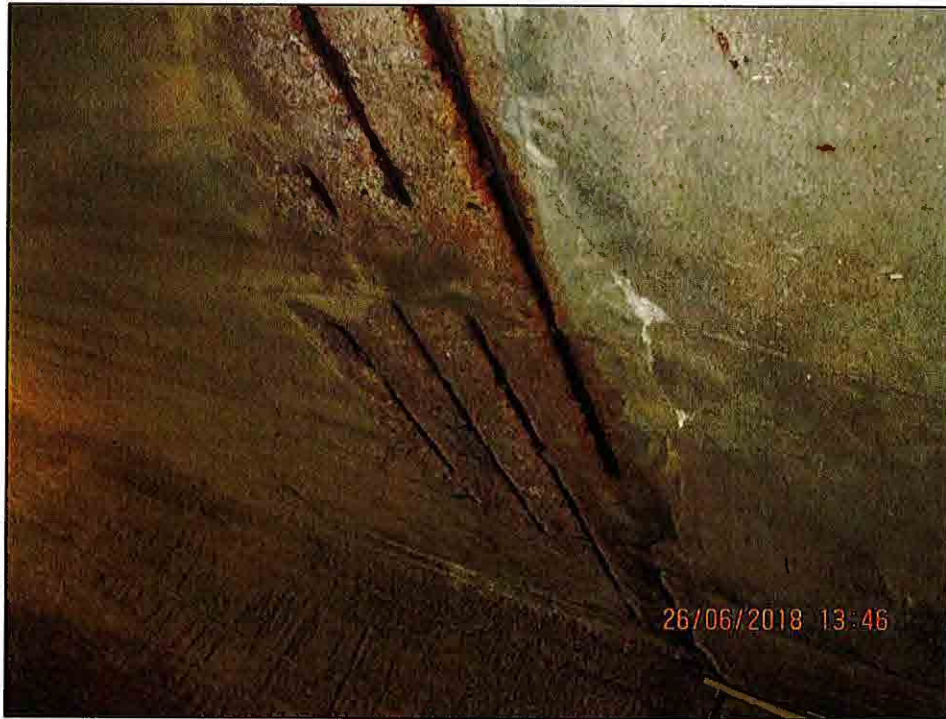
Spall at soffit

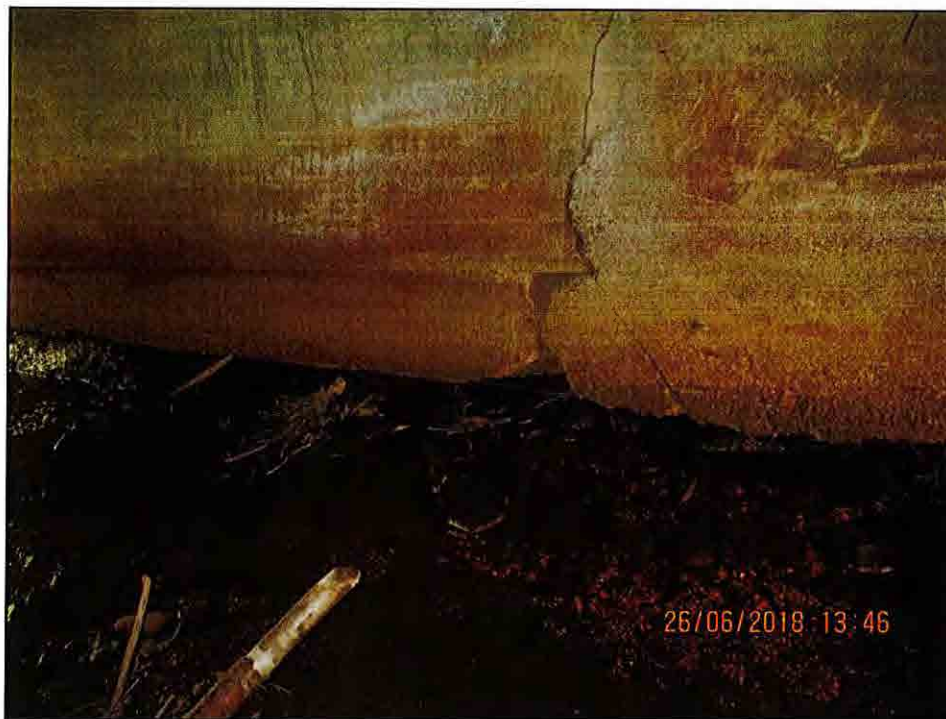
Concrete disintegration of abutment wall

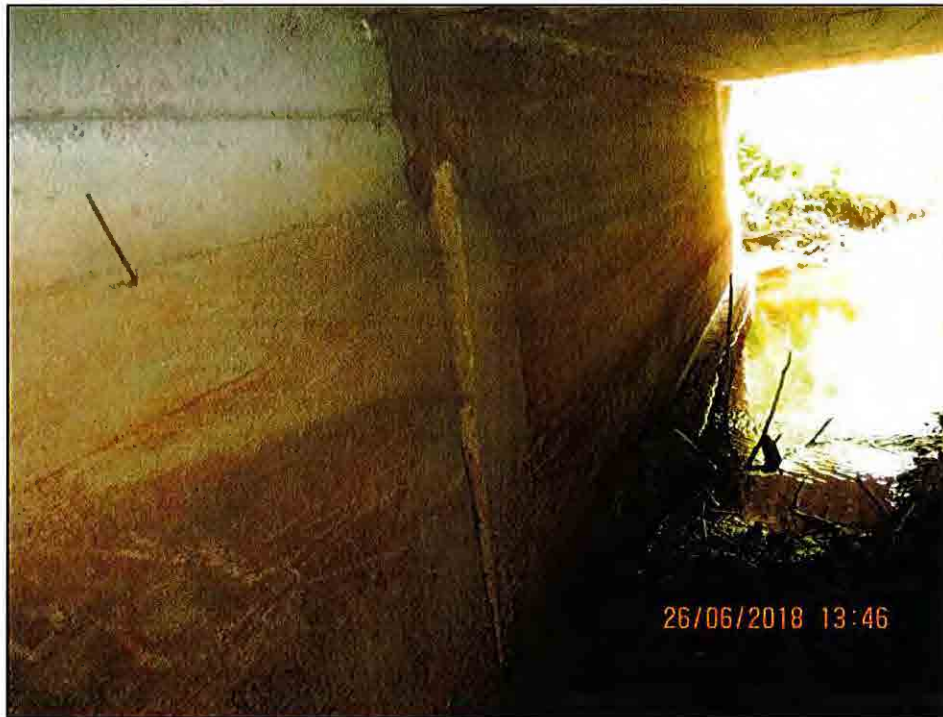
Concrete disintegration of abutment wall

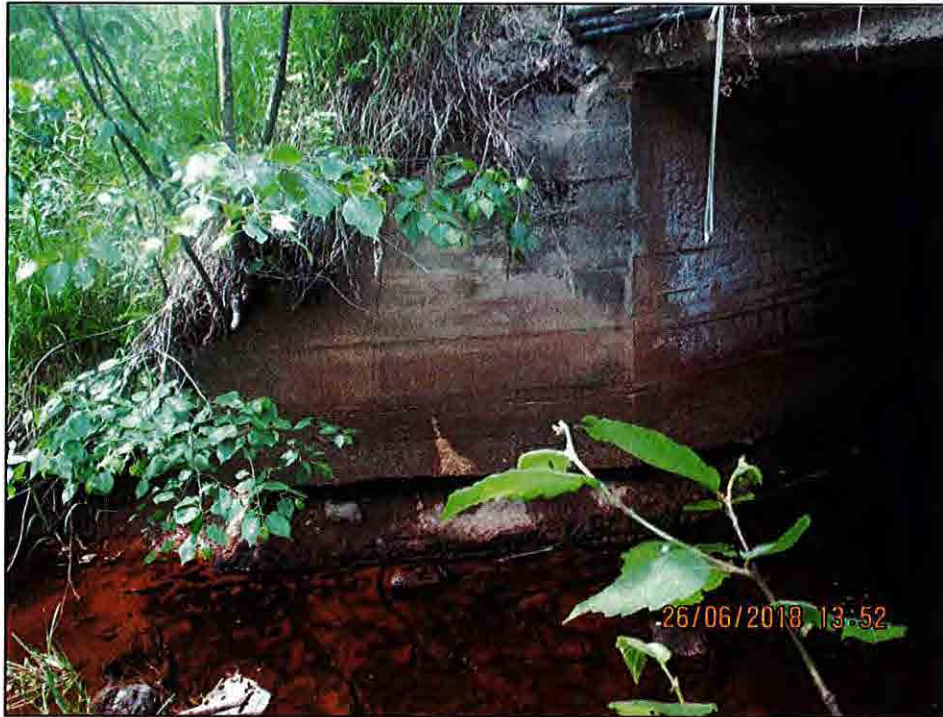
Severe undermining and scouring at Southwest wing wall

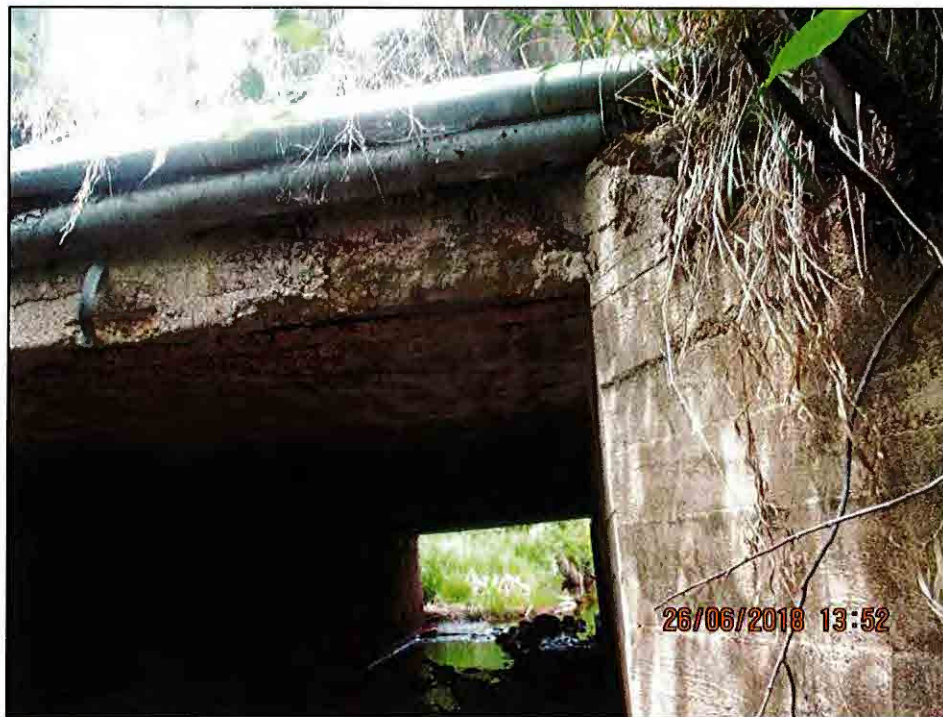
Severe spall at soffit (South end)

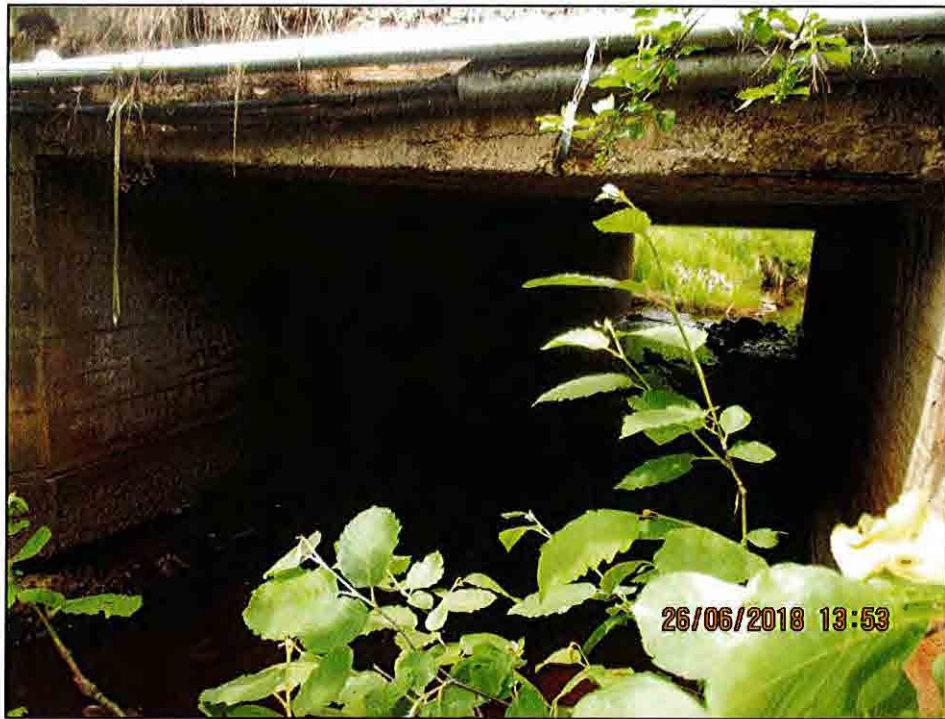
Outlet (South end)

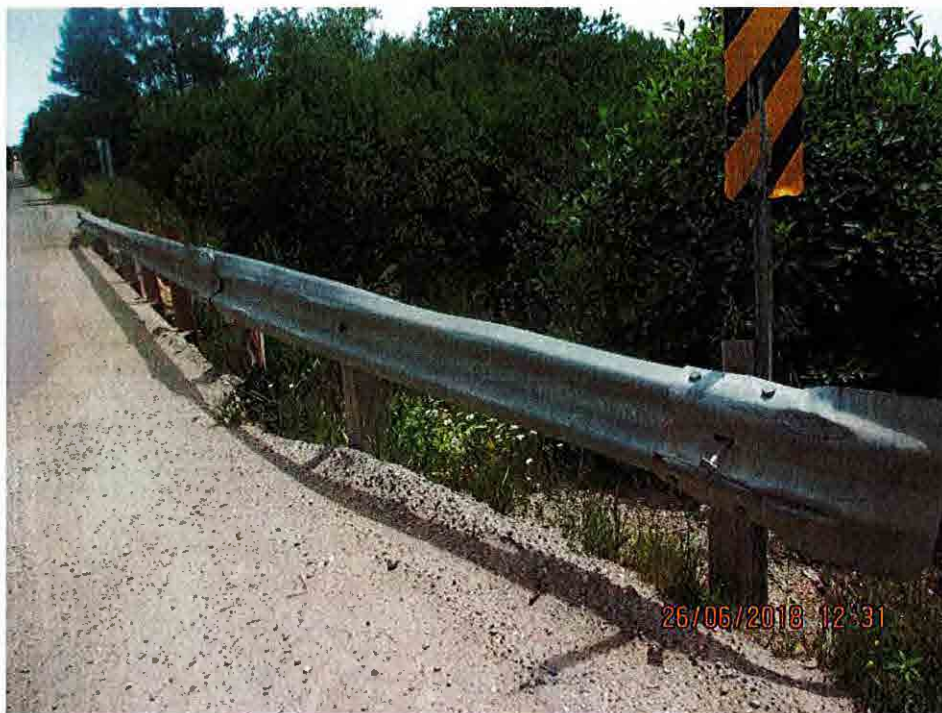
Severely damaged South railing

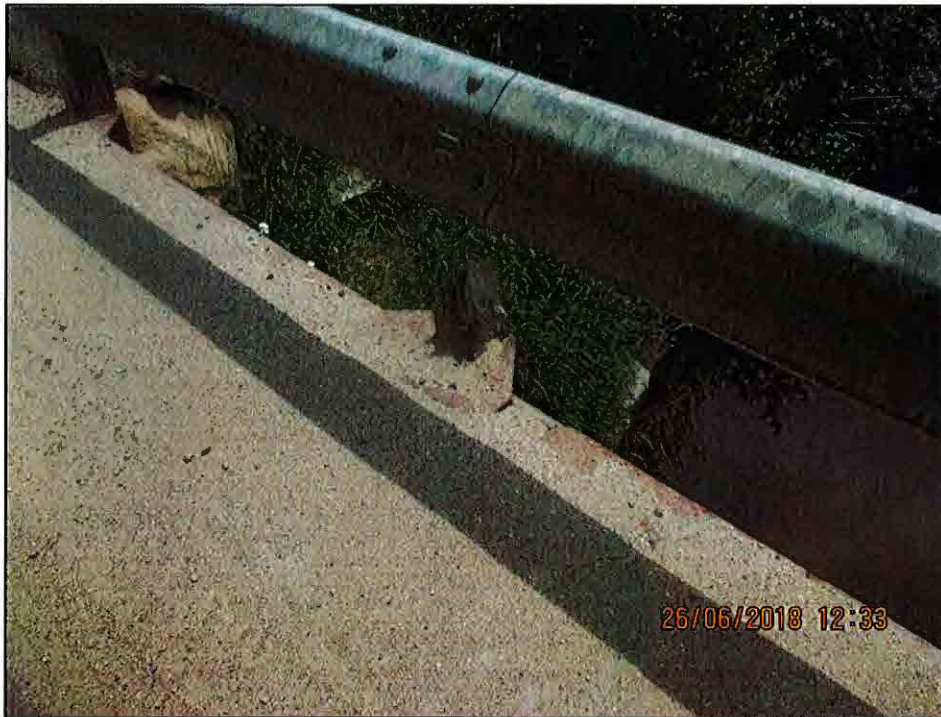
South railing – damaged posts

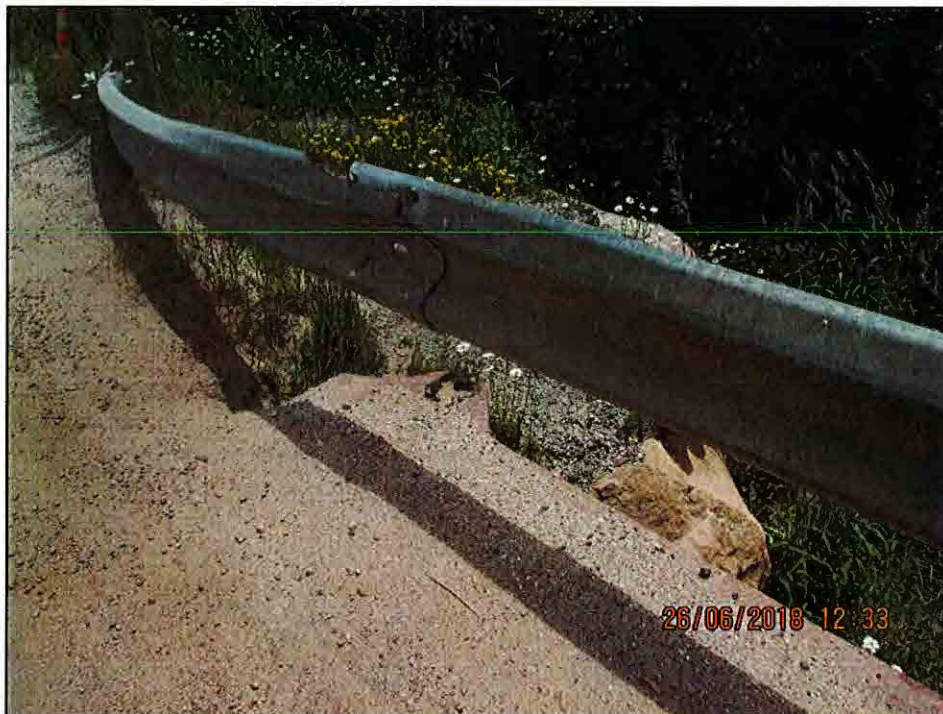
South railing – damaged posts

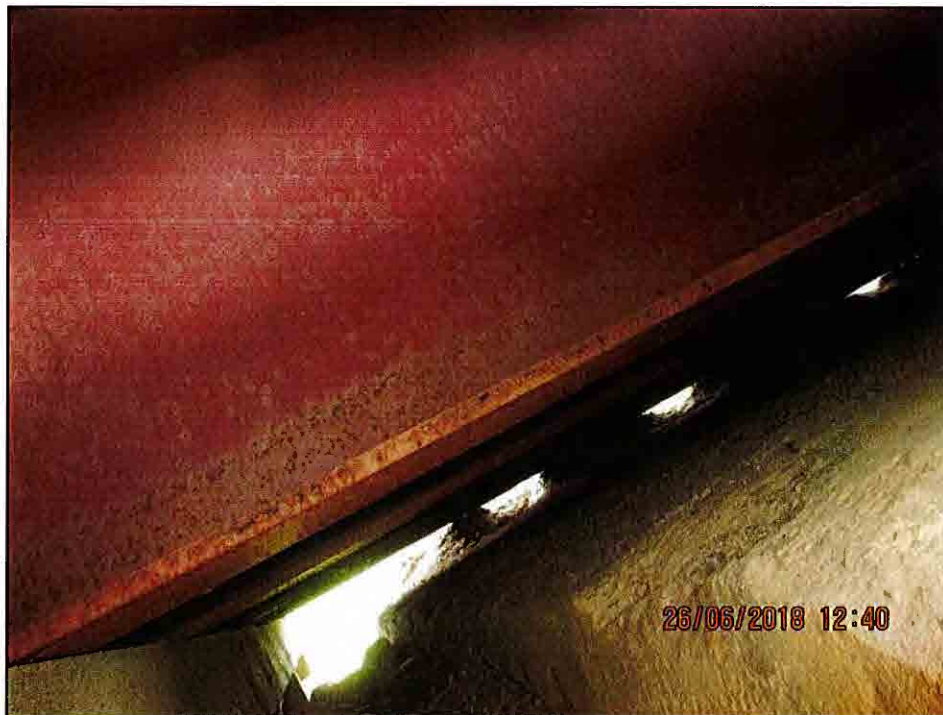
Corrosion of bottom flange

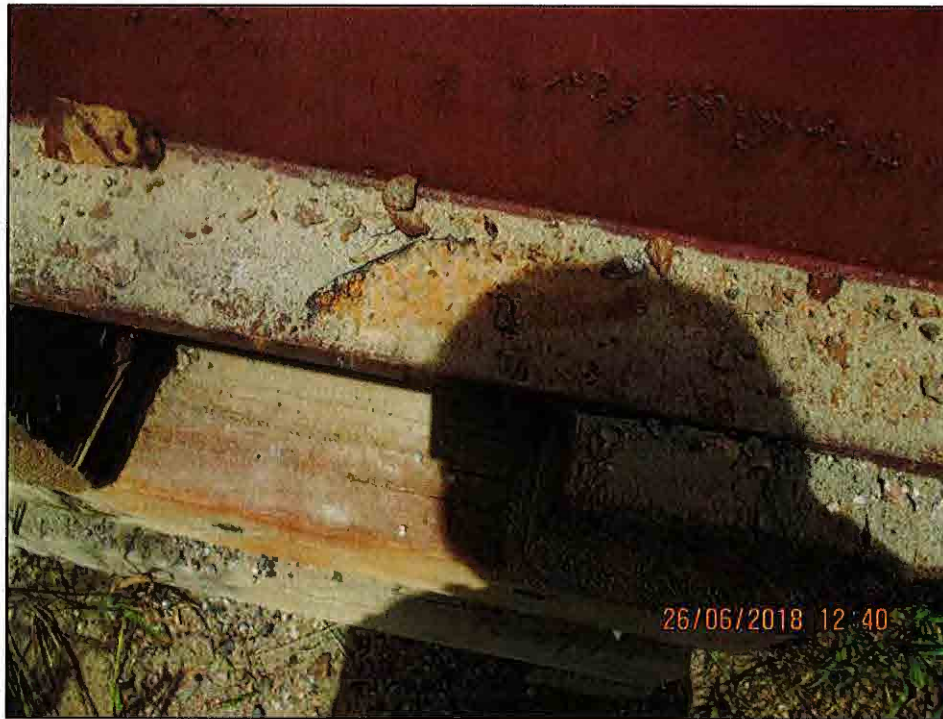
Flaking of exterior girder

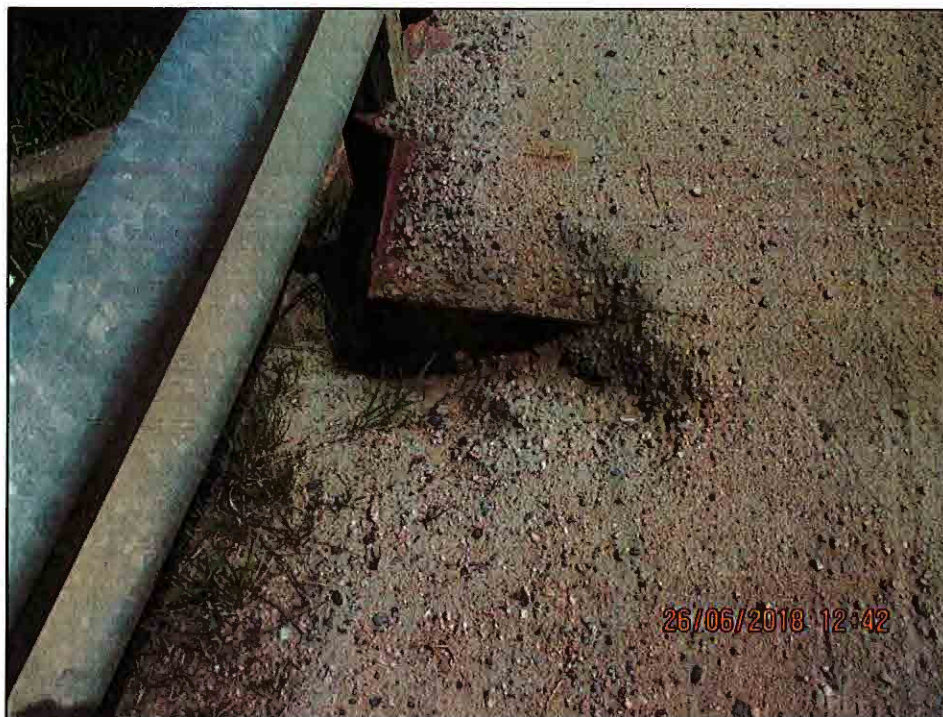
Localized severe erosion of the embankment and loss of material at Northwest

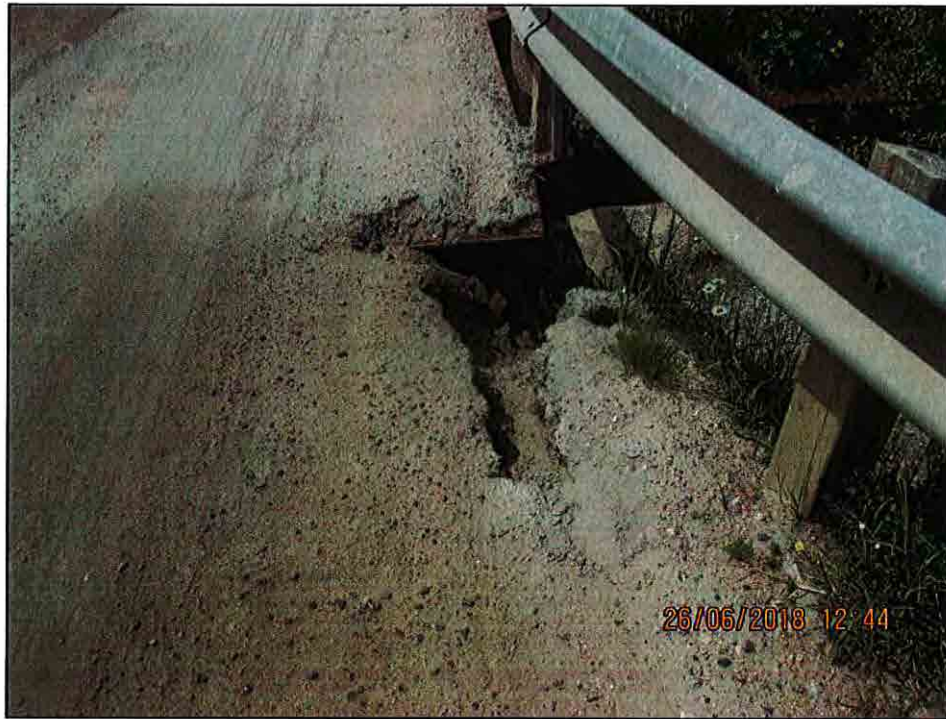
Localized severe erosion of the embankment and loss of material at Northeast

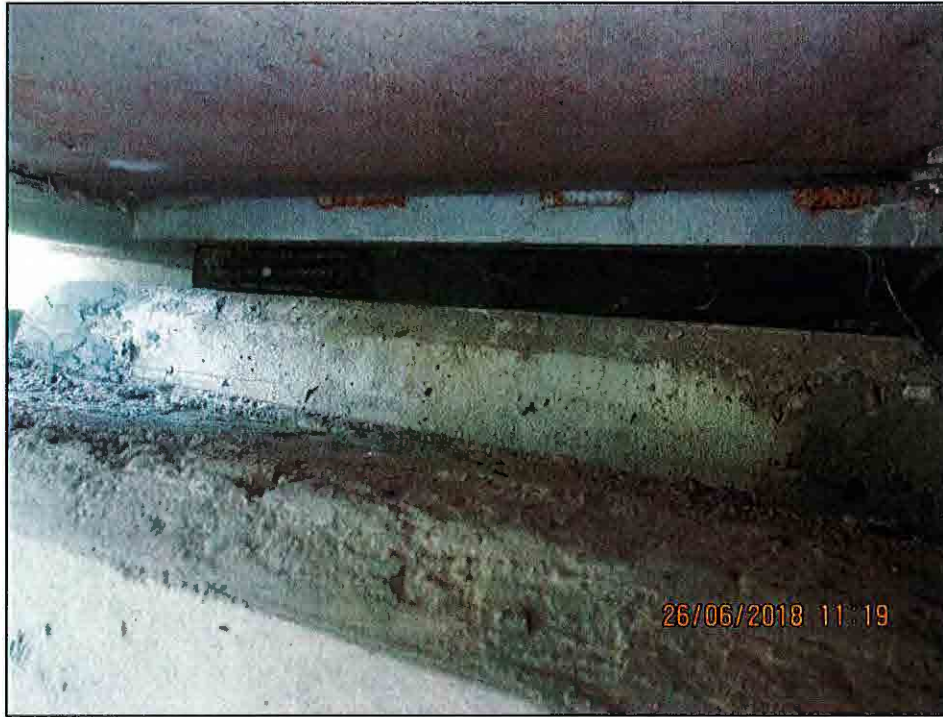
Northeast bearing – minor loss of contact of bearing (Typ. Southeast, Southwest, Northwest)

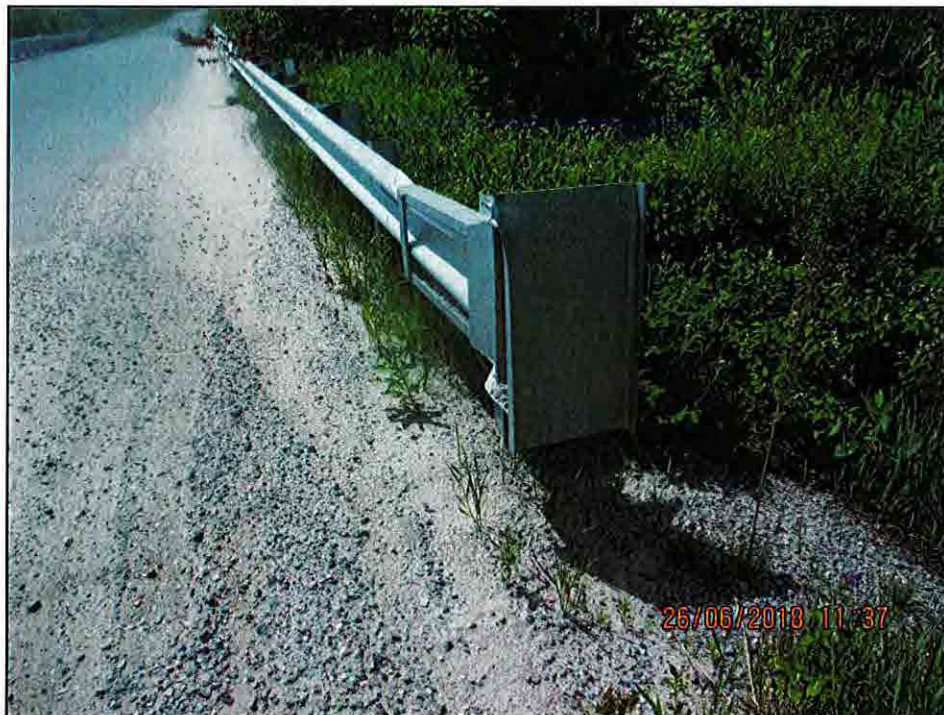
Minor damage at Northeast

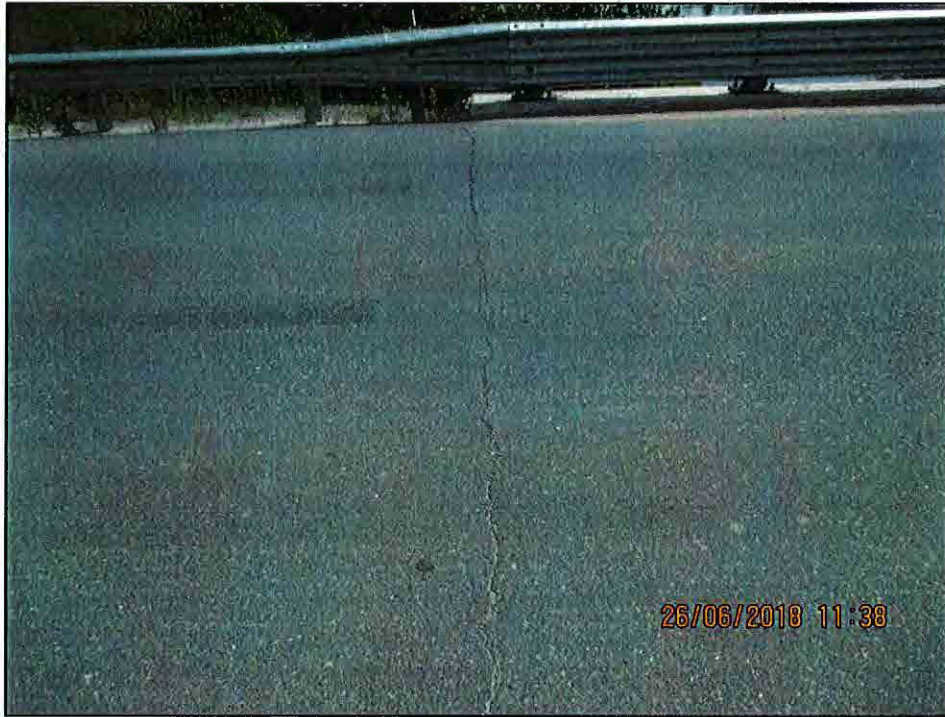
Medium transverse crack on North approach

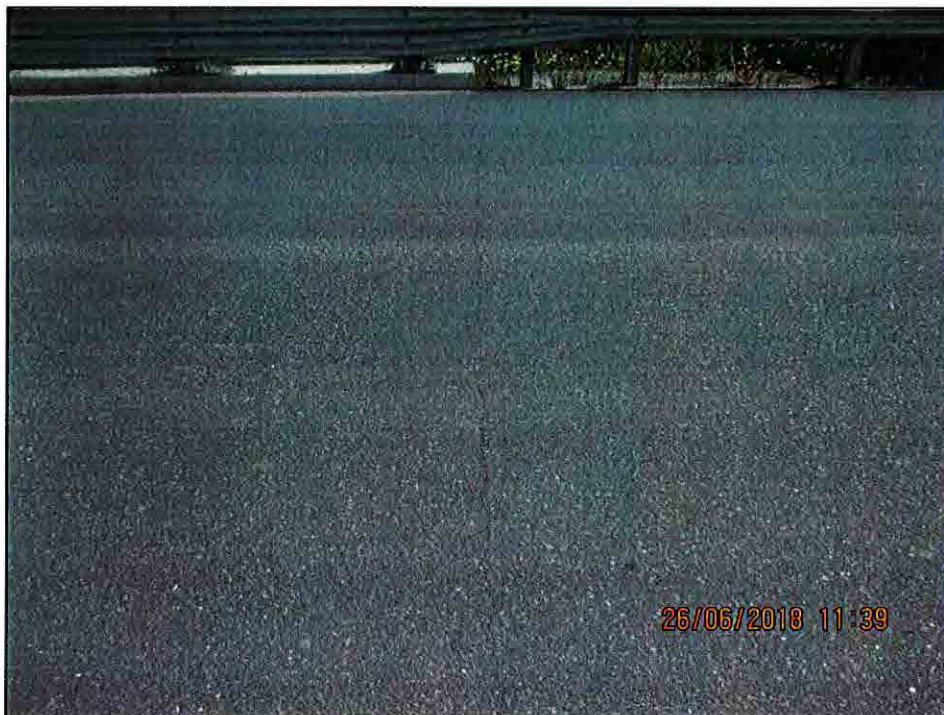
Narrow crack on South approach

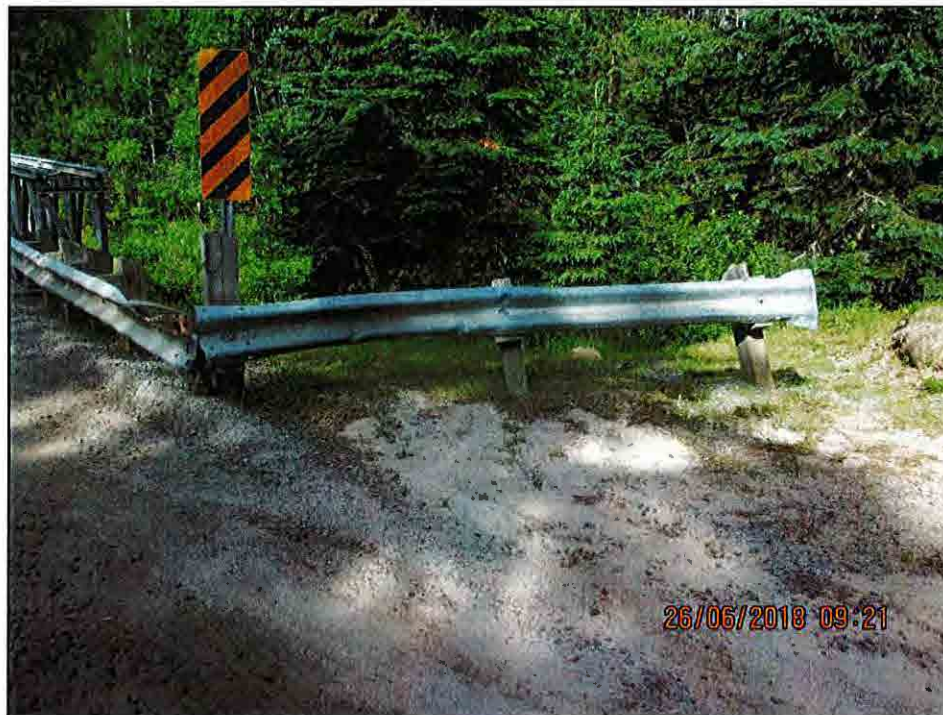
Damaged guide rail at Northeast

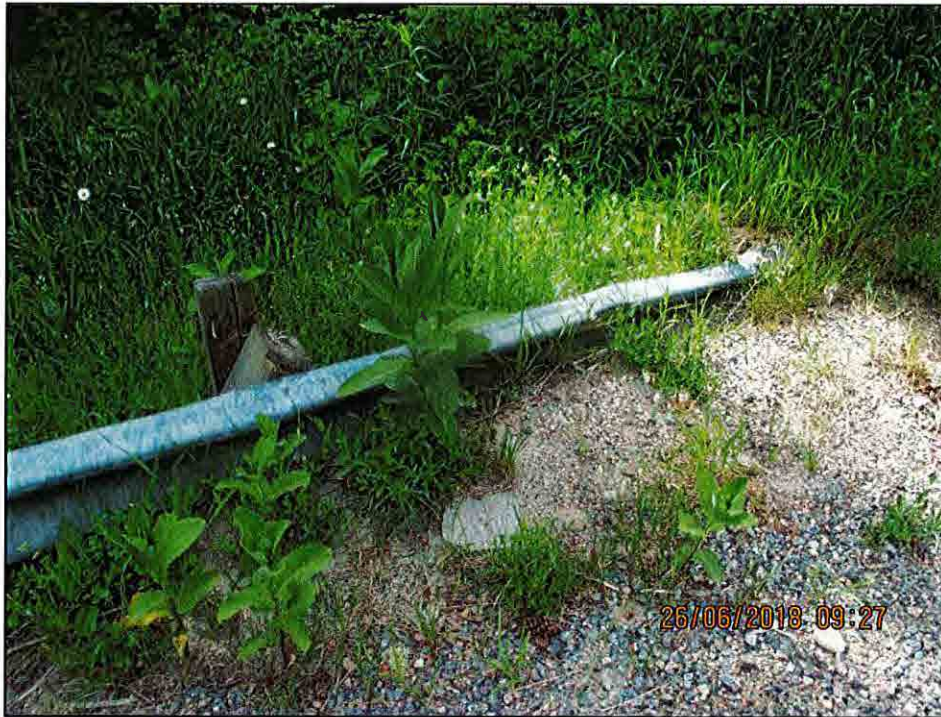
Damaged guide rail at Southwest

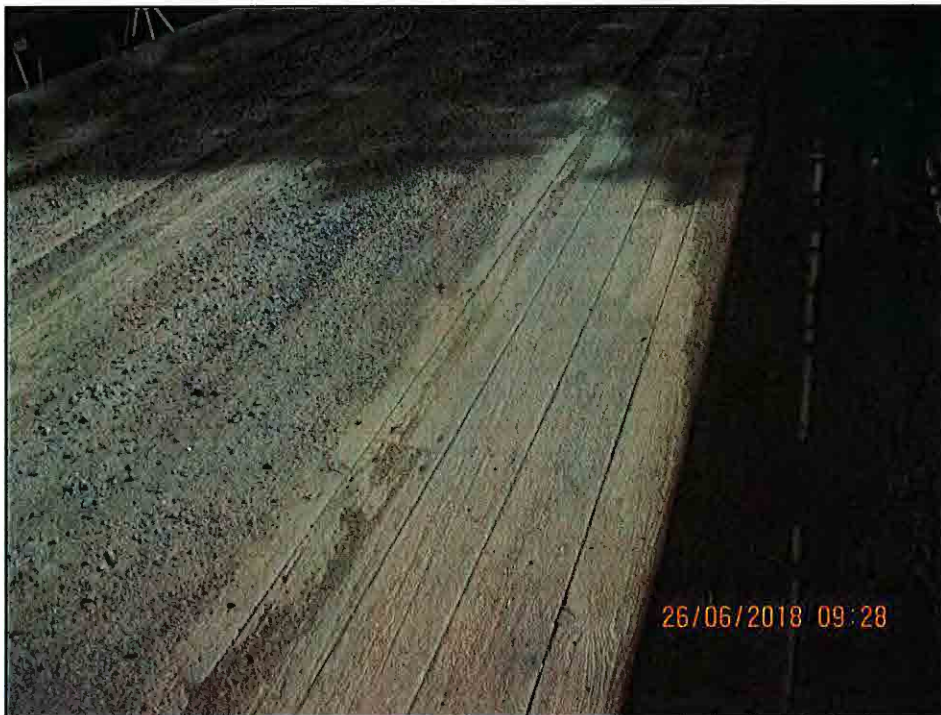
Rotting and splitting of wearing surface

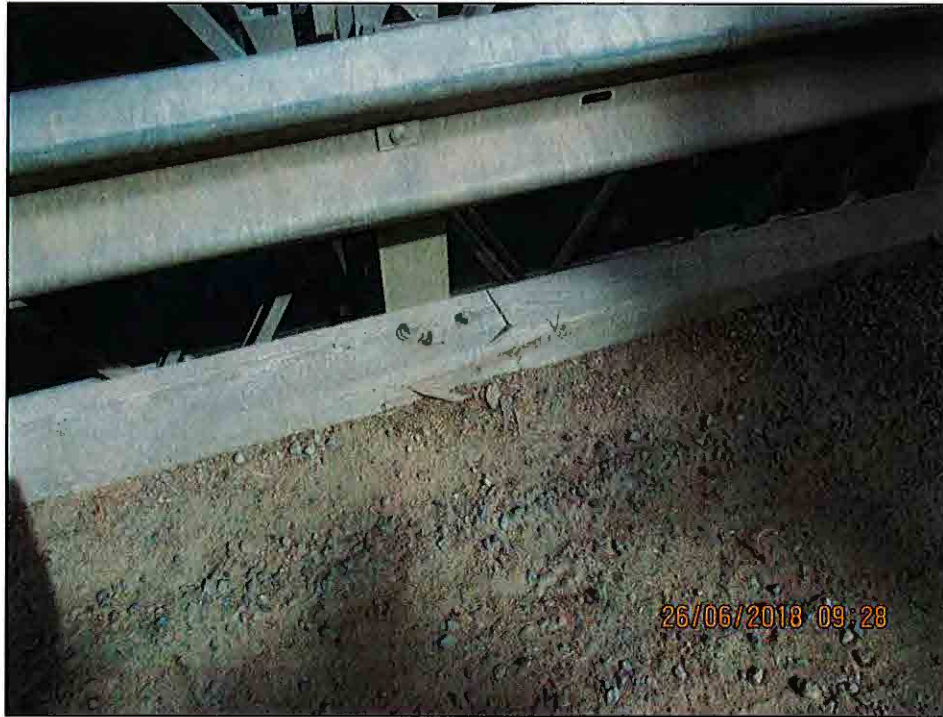
Damaged curb (North side)

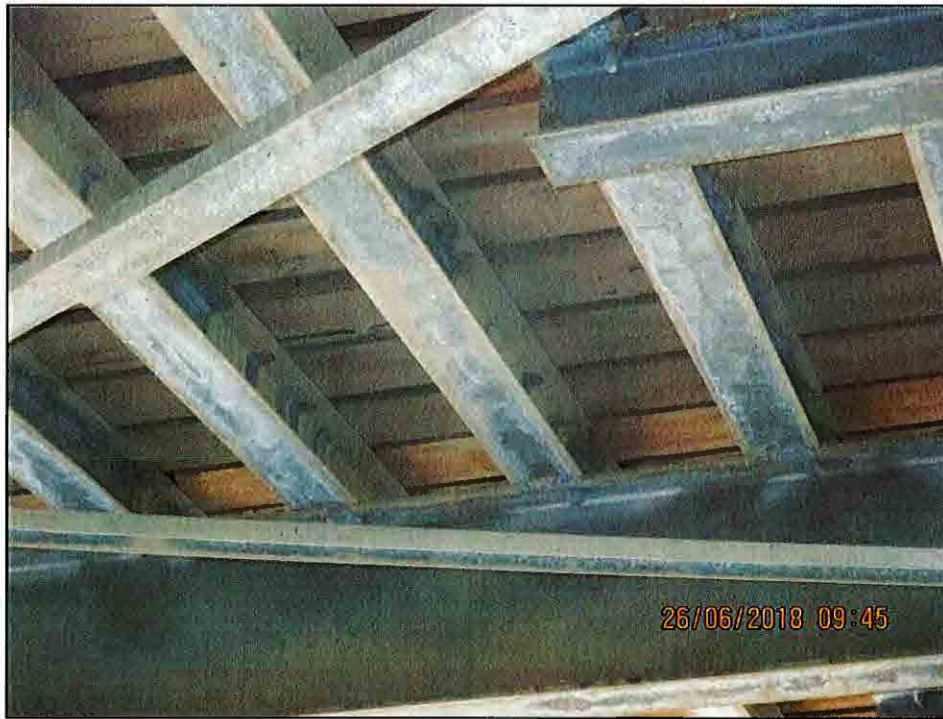
Split soffit timbers

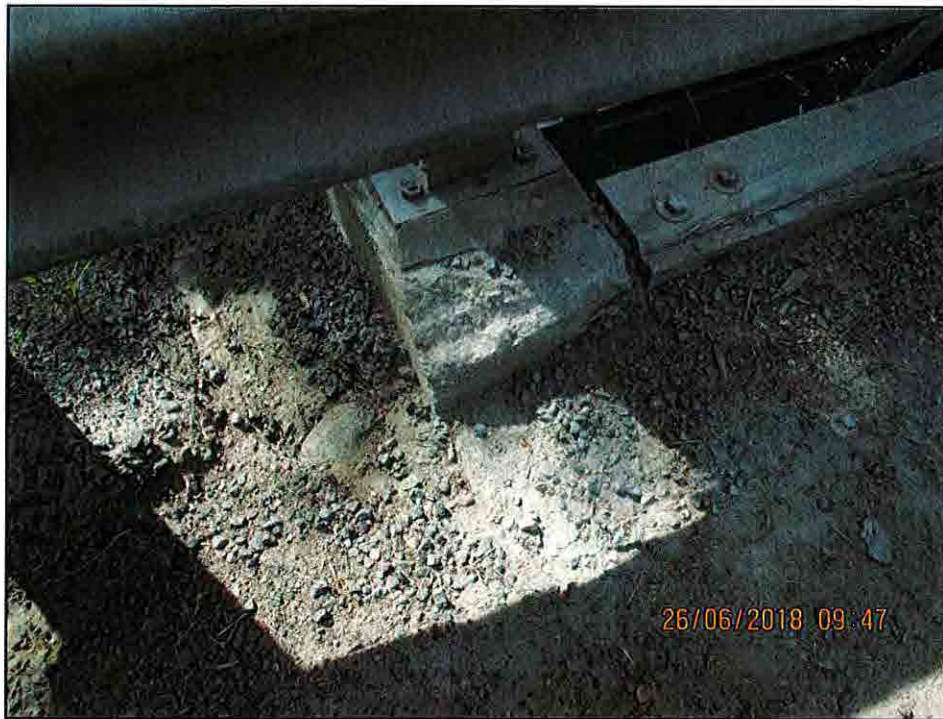
Localized spalls on Southeast ballast wall

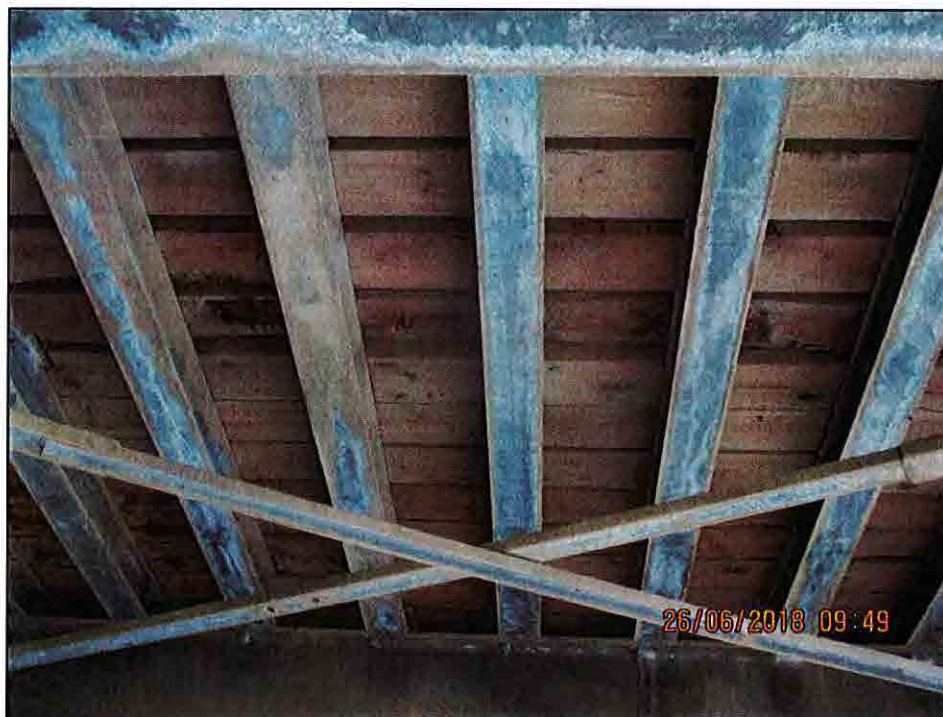
Moisture and rotting of soffit

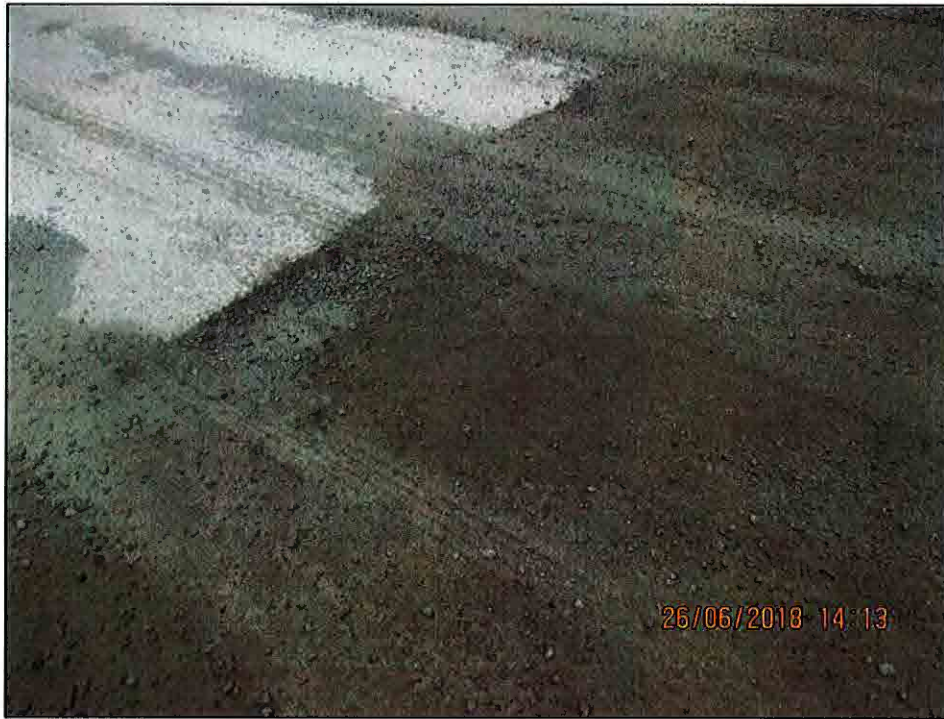
Potholes at South approach

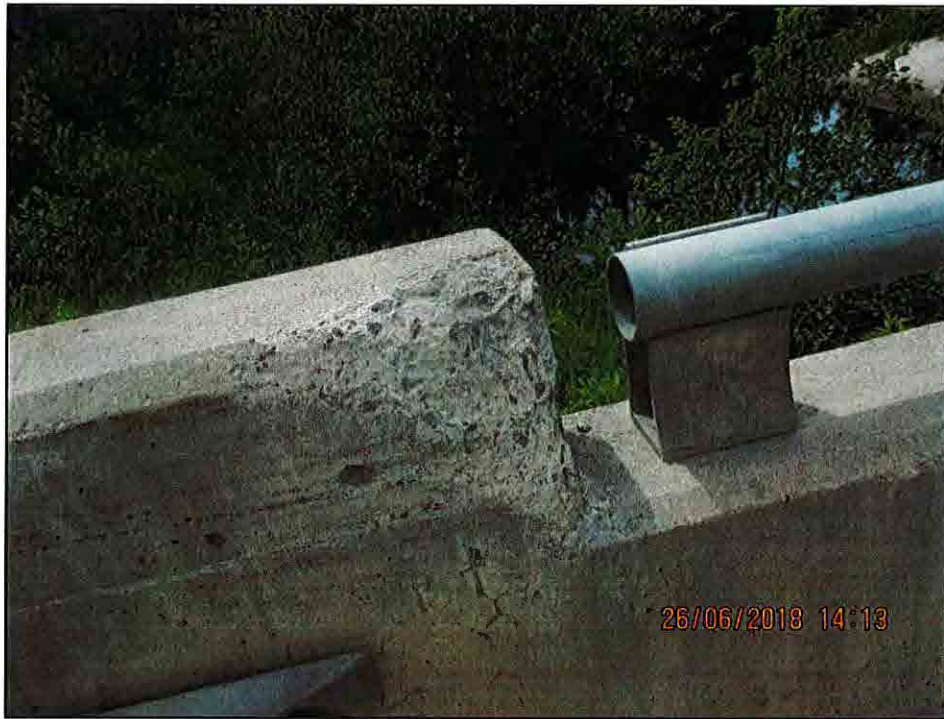
Spall at Southwest

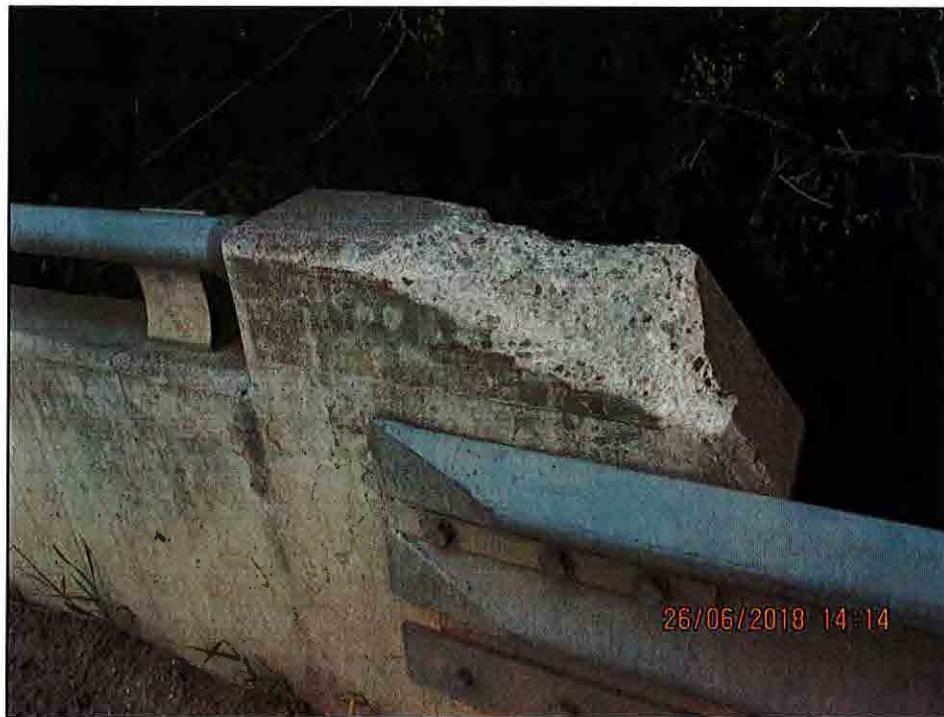
Spall at Northwest

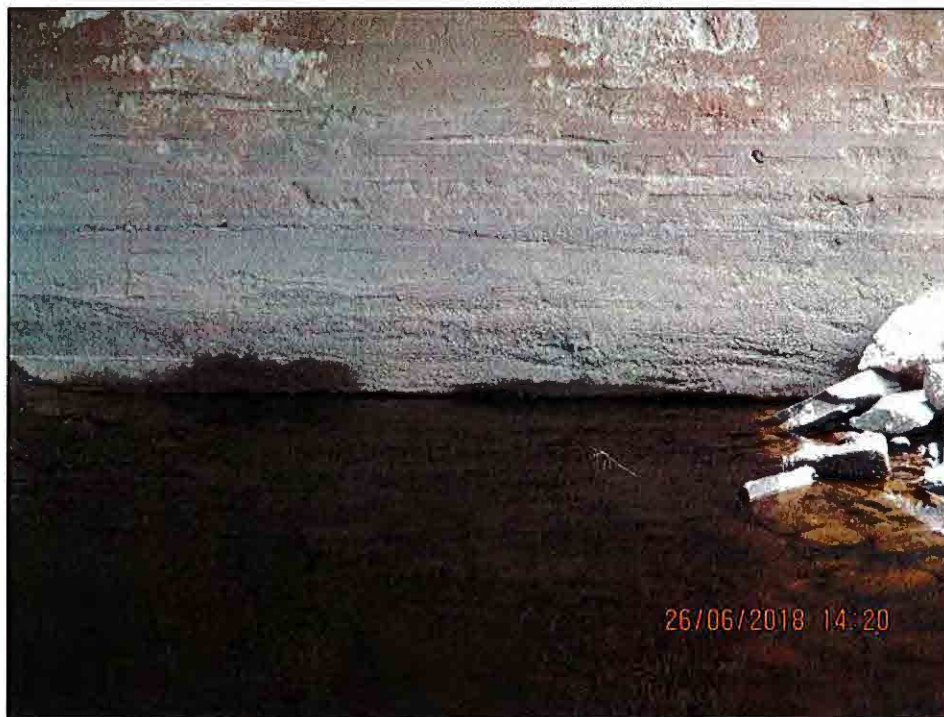
Undermining of South abutment
