**Township of Strong
D.M. Wills Project No. 24-9217**

**2018 Municipal Structure
Inspection Program**

Summary Report

September 2018

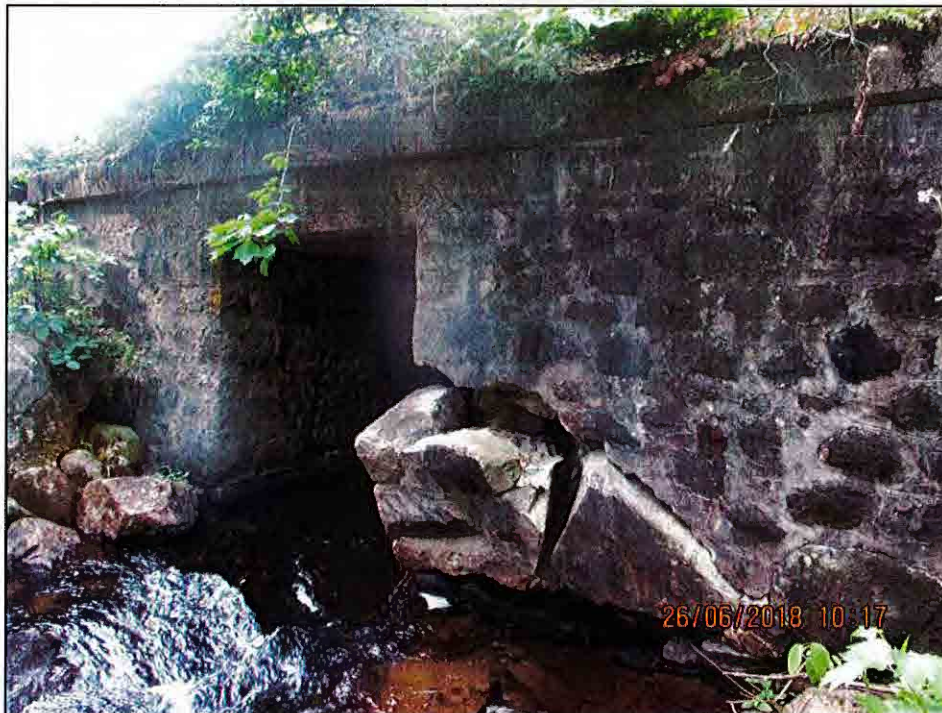
Partial failure at Northeast wing wall

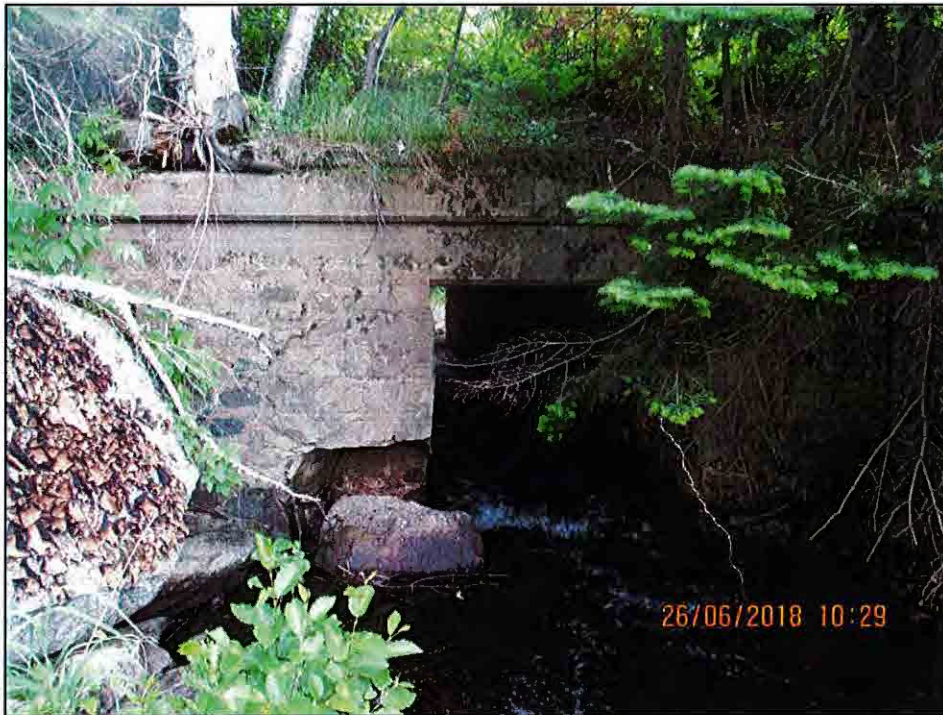
Partial failure of Northeast wing wall

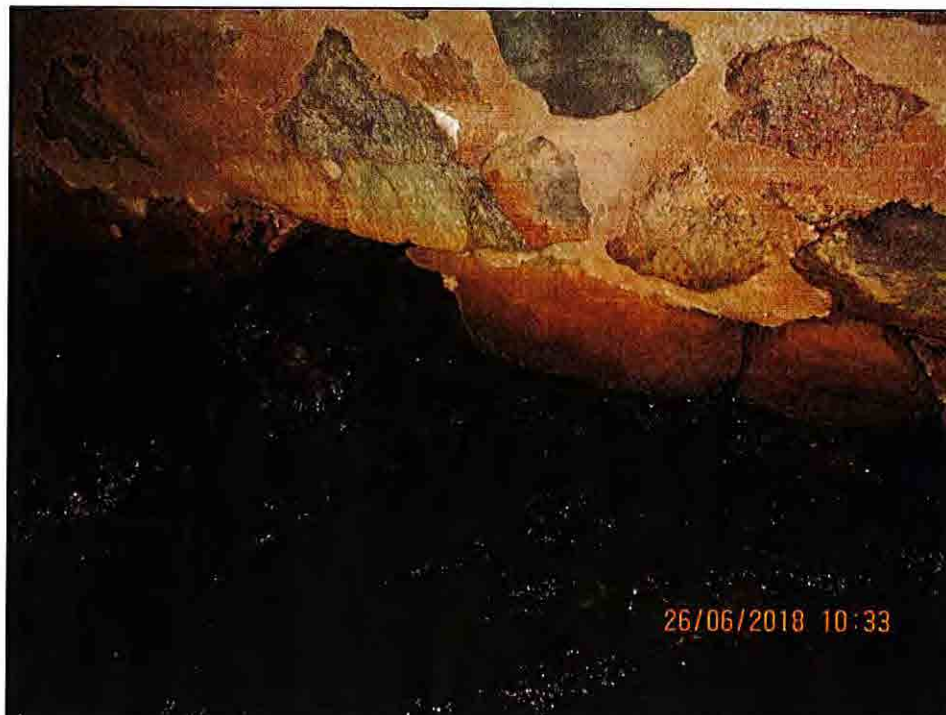
Scouring along the abutment walls

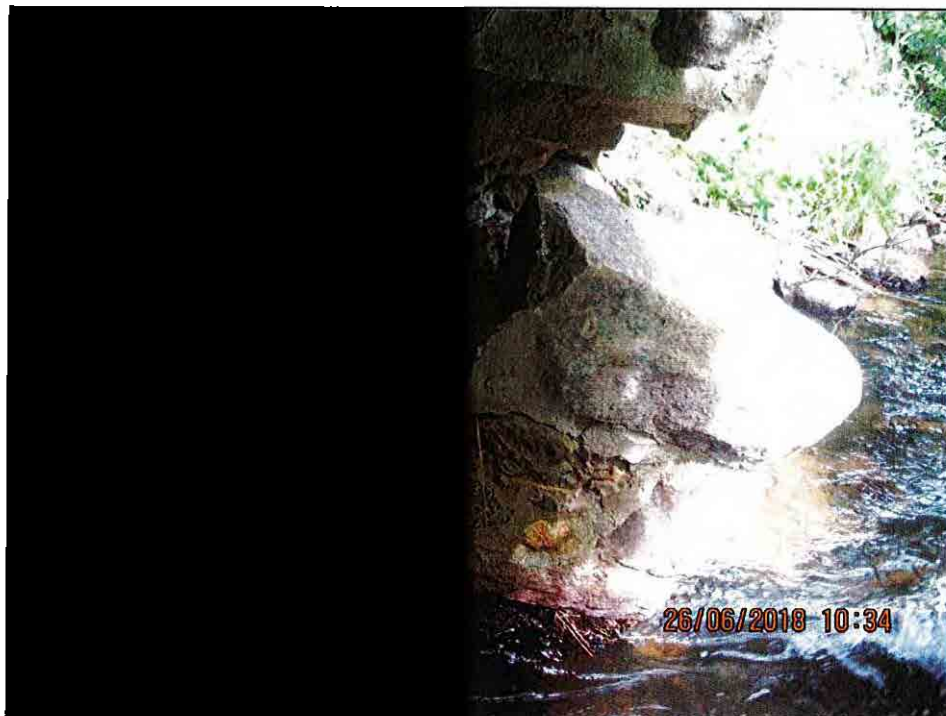
Partial failure at Northeast wing wall
