FACILITY CONDITION ASSESSMENT

TOWNSHIP OF STRONG

Sundridge Strong Joly Arena
14 Albert Street North, Sundridge, ON P0A 1Z0

WalterFedy Project No.: 2021-0270

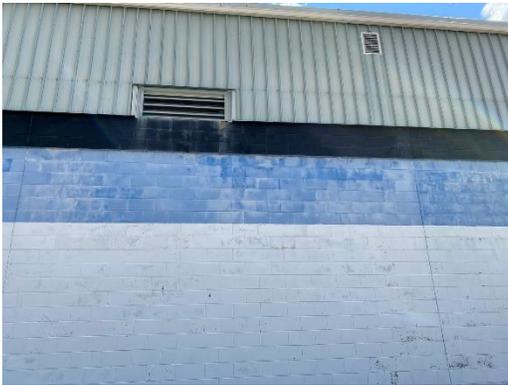
5.4 B - Shell

Element Description: Aluminum Siding (Original)

Estimated Useful Life (EUL)	50	Remaining Service Life	0
Current Replacement Value (CRV)	\$33,000	Action Cost:	\$33,000
Quantity Estimate:	3000 SF	Action Year:	2028
Unit Cost:	\$11	Repeat Cycle:	50
Urgency of Action:	Medium (5-10 Years)	Energy Savings:	N/A
Health and Safety:	No	Accessibility Issue:	No

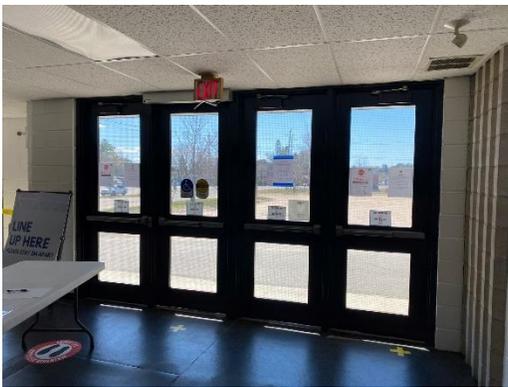
5.9 B - Shell

Estimated Useful Life (EUL)	25	Remaining Service Life	0
Current Replacement Value (CRV)	\$8,000	Action Cost:	\$8,000
Quantity Estimate:	4 Unit(s)	Action Year:	2027
Unit Cost:	\$2,000	Repeat Cycle:	25
Urgency of Action:	Medium (5-10 Years)	Energy Savings:	N/A
Health and Safety:	No	Accessibility Issue:	No

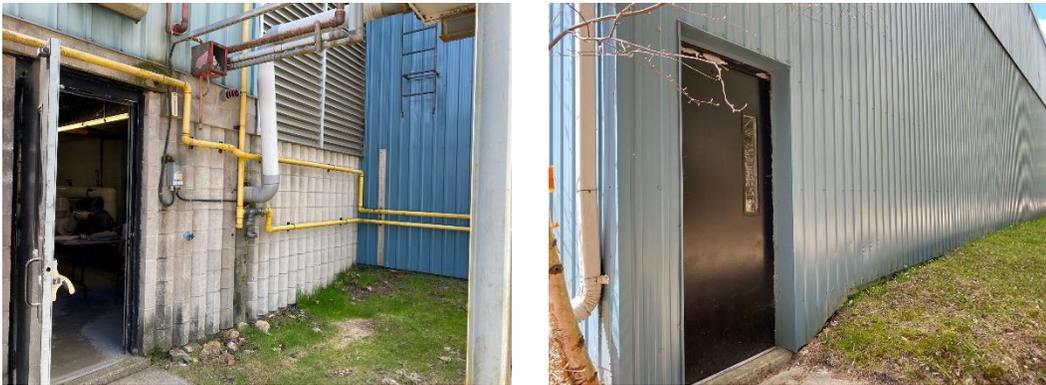
5.10 B - Shell

Element Description: Exterior Doors

Estimated Useful Life (EUL)	25	Remaining Service Life	0
Current Replacement Value (CRV)	\$8,000	Action Cost:	\$8,000
Quantity Estimate:	4 Unit(s)	Action Year:	2027
Unit Cost:	\$2,000	Repeat Cycle:	25
Urgency of Action:	Medium (5-10 Years)	Energy Savings:	N/A
Health and Safety:	No	Accessibility Issue:	No

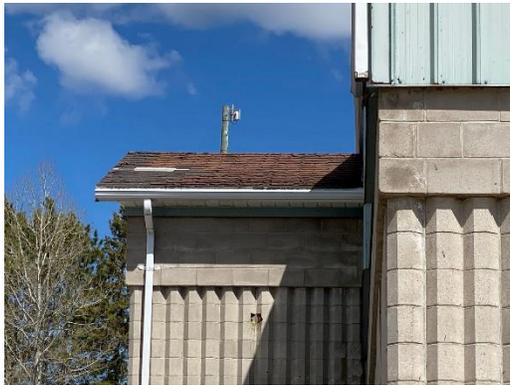
5.12 B - Shell

Element Description: EPDM Roofing

Estimated Useful Life (EUL)	20	Remaining Service Life	0
Current Replacement Value (CRV)	\$500	Action Cost:	\$500
Quantity Estimate:	100 SF	Action Year:	2023
Unit Cost:	\$5	Repeat Cycle:	20
Urgency of Action:	High (1-5 Years)	Energy Savings:	N/A
Health and Safety:	No	Accessibility Issue:	No

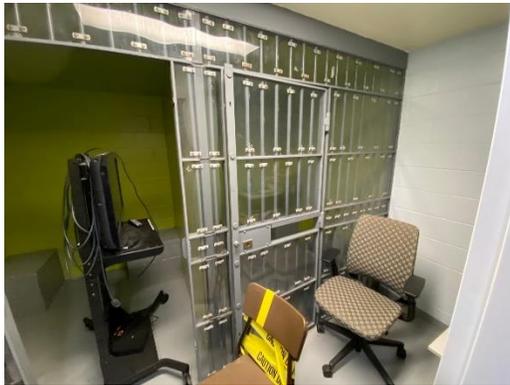
5.16 C - Interiors

Element Description: Storage Cells
Year of Installation: 2005
Location: Storage Area
Condition: Good
Consequence of Failure: Low

Estimated Useful Life (EUL)	30	Remaining Service Life	14
Current Replacement Value (CRV)	\$10,000	Action Cost:	Not Applicable
Quantity Estimate:	Not Applicable	Action Year:	Not Applicable
Unit Cost:	Not Applicable	Repeat Cycle:	Not Applicable
Urgency of Action:	N/A	Energy Savings:	N/A
Health and Safety:	No	Accessibility Issue:	No

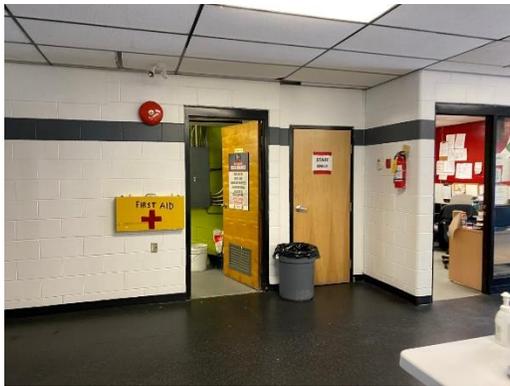
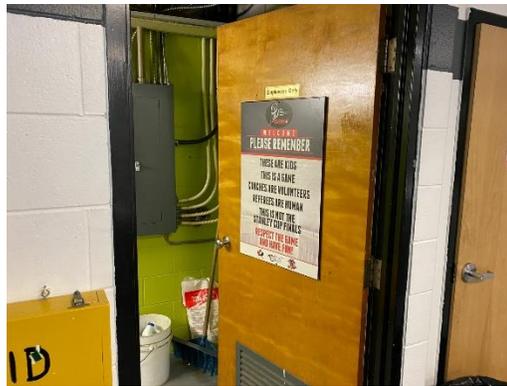
5.17 C - Interiors

Element Description: Metal Interior Doors
Year of Installation: 1970
Location: Throughout Building
Condition: Good
Consequence of Failure: Low

Estimated Useful Life (EUL)	30	Remaining Service Life	0
Current Replacement Value (CRV)	\$15,000	Action Cost:	\$15,000
Quantity Estimate:	10 Unit(s)	Action Year:	2031
Unit Cost:	\$1,500	Repeat Cycle:	30
Urgency of Action:	Low (10+ Years)	Energy Savings:	N/A
Health and Safety:	No	Accessibility Issue:	No

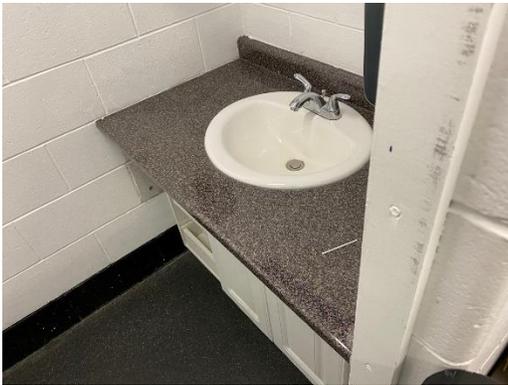
5.27 D - Mechanical Services

Element Description: Plumbing Fixtures
Year of Installation: 2010
Location: Throughout Building
Condition: Good
Consequence of Failure: Low

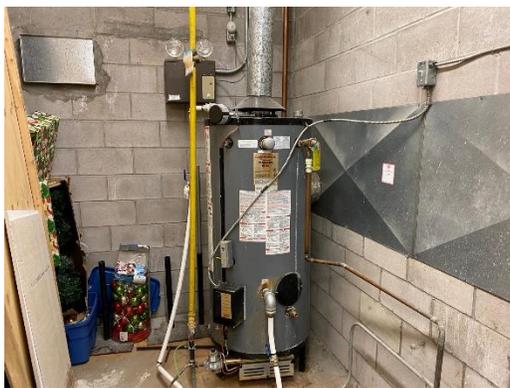
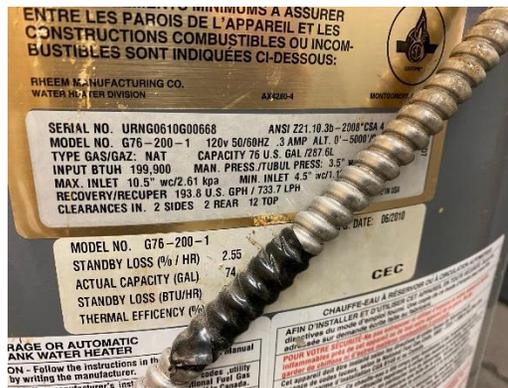
5.33 D - Mechanical Services

Element Description: Domestic Hot Water Heater (2)
Year of Installation: 2010
Location: Second Floor
Condition: Good
Consequence of Failure: Moderate

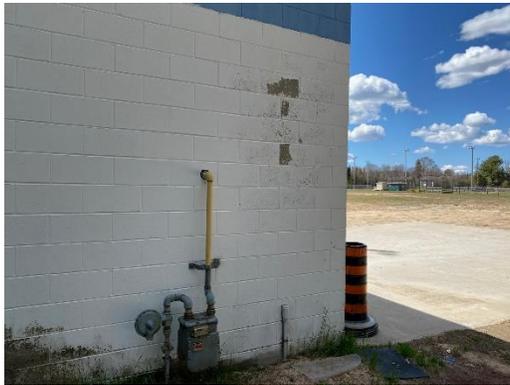
5.34 D - Mechanical Services

Element Description: Natural Gas Line
Year of Installation: 1970
Location: Throughout Building
Condition: Fair
Consequence of Failure: Moderate

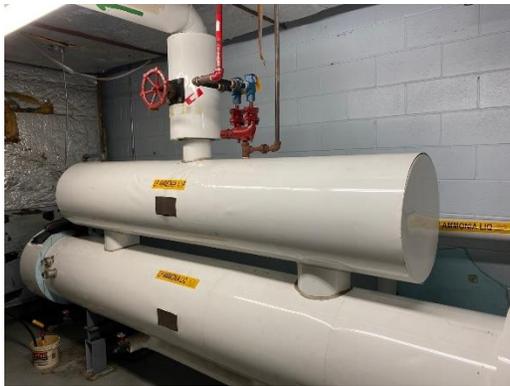
5.35 D - Mechanical Services

Element Description: Chiller
Year of Installation: 2002
Location: Mechanical Room
Condition: Fair
Consequence of Failure: Moderate
Commentary: The is one chiller manufactured by Henry Technologies (M/N: RA-16096-509, S/N: C220370B-1) is located in the mechanical room. The chiller was observed to be in fair condition based on age, with no reports of any issues. An allowance has been included to replace the chiller at the end of its useful life.

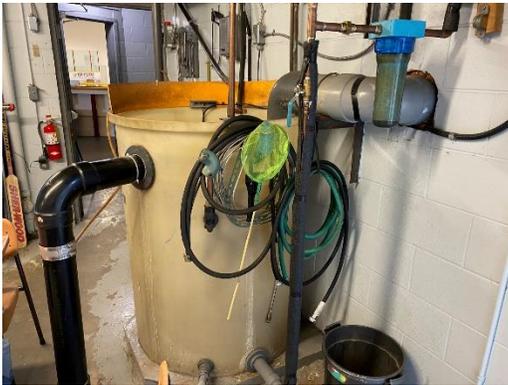
5.36 D - Mechanical Services

Element Description: Water Tank
Year of Installation: 2002
Location: Mechanical Room
Condition: Fair
Consequence of Failure: Moderate
Commentary:

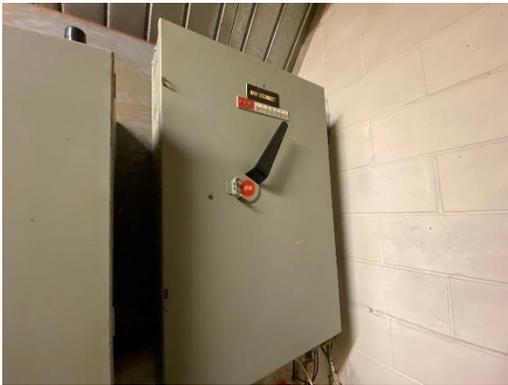
5.48 D - Electrical Services

Element Description: Main Disconnect
Year of Installation: 1970
Location: Electrical Room
Condition: Fair
Consequence of Failure: Moderate

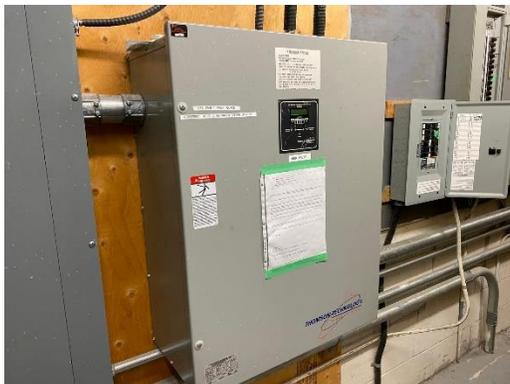
5.50 D - Electrical Services

Element Description: Transfer Switch
Year of Installation: 1970
Location: Electrical Room
Condition: Fair
Consequence of Failure: Moderate

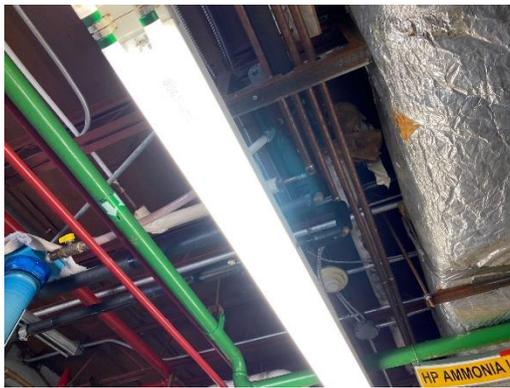
5.53 D - Electrical Services

Element Description: Interior Lighting
Year of Installation: 2010
Location: Throughout Building
Condition: Fair
Consequence of Failure: Low

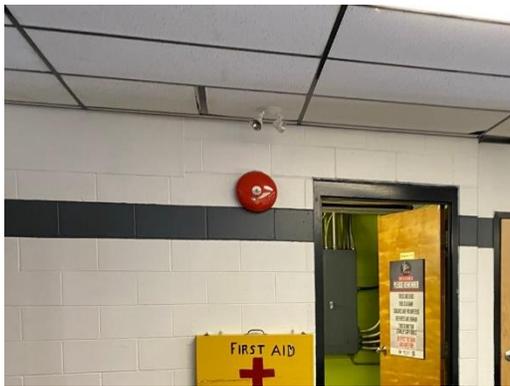
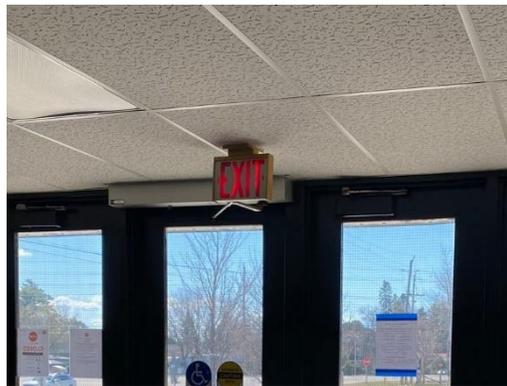
5.60 D - Electrical Services

Element Description: Exit Signage & Emergency Lighting
Year of Installation: 1970
Location: Throughout Building
Condition: Poor
Consequence of Failure: Very High

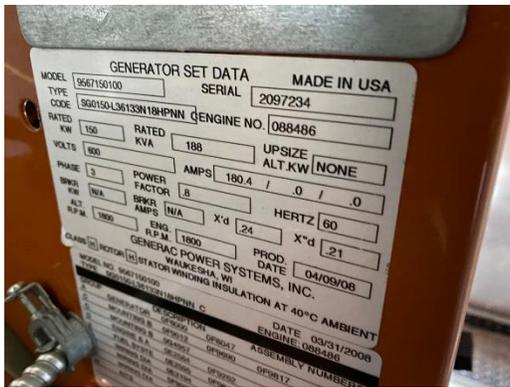
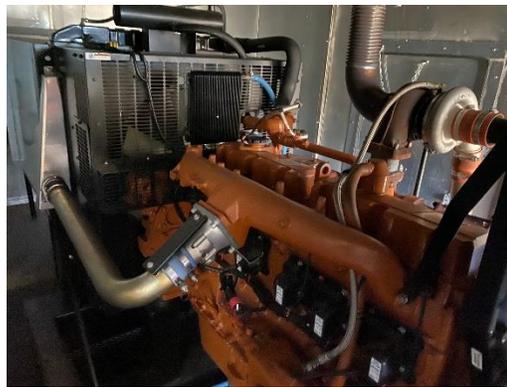
5.61 D - Electrical Services

Element Description: Generator
Year of Installation: 2008
Location: Zamboni Bay
Condition: Good
Consequence of Failure: Very High

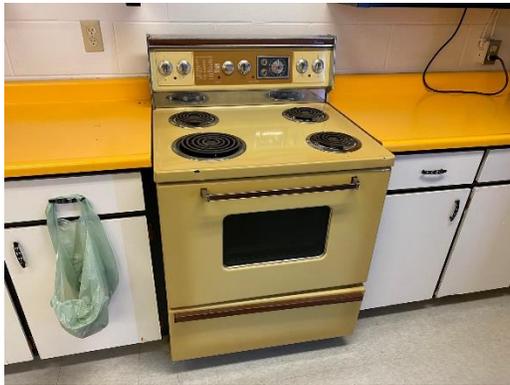
5.62 E - Equipment and Furnishings

Element Description: Stove
Year of Installation: 2007
Location: Kitchen Areas
Condition: Good
Consequence of Failure: Low
