**Township of Strong
D.M. Wills Project No. 24-9217**

**2018 Municipal Structure
Inspection Program**

Summary Report

September 2018

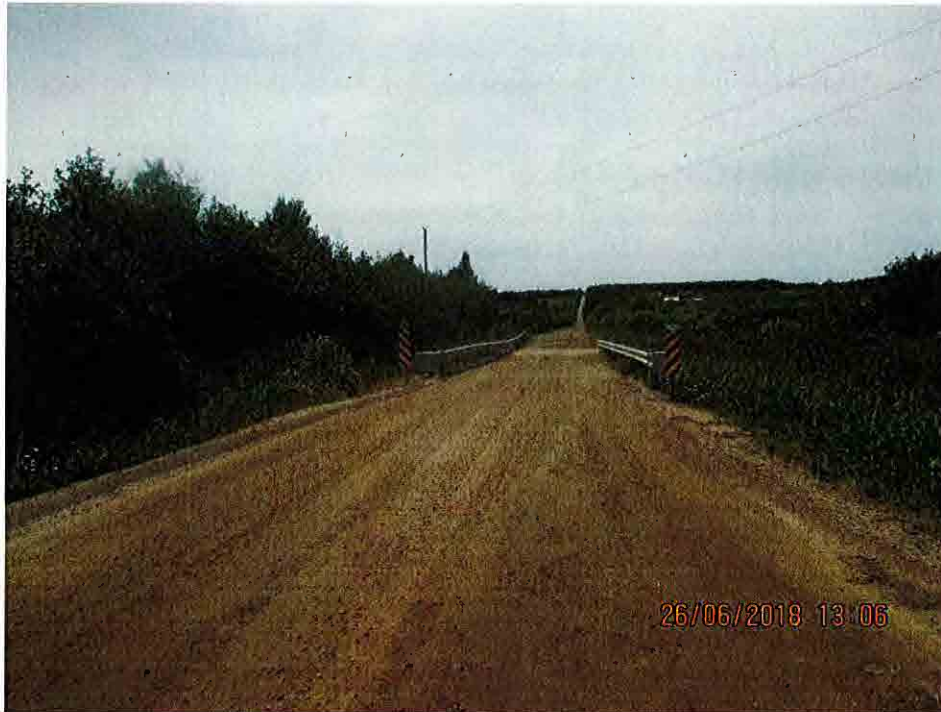
Roadway looking West

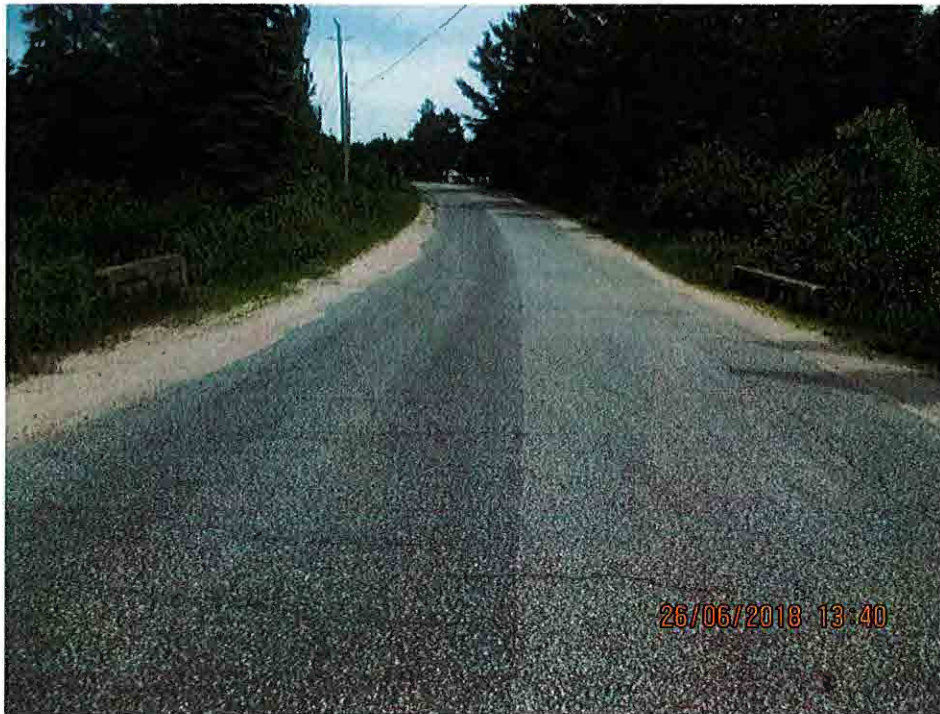
Roadway looking East

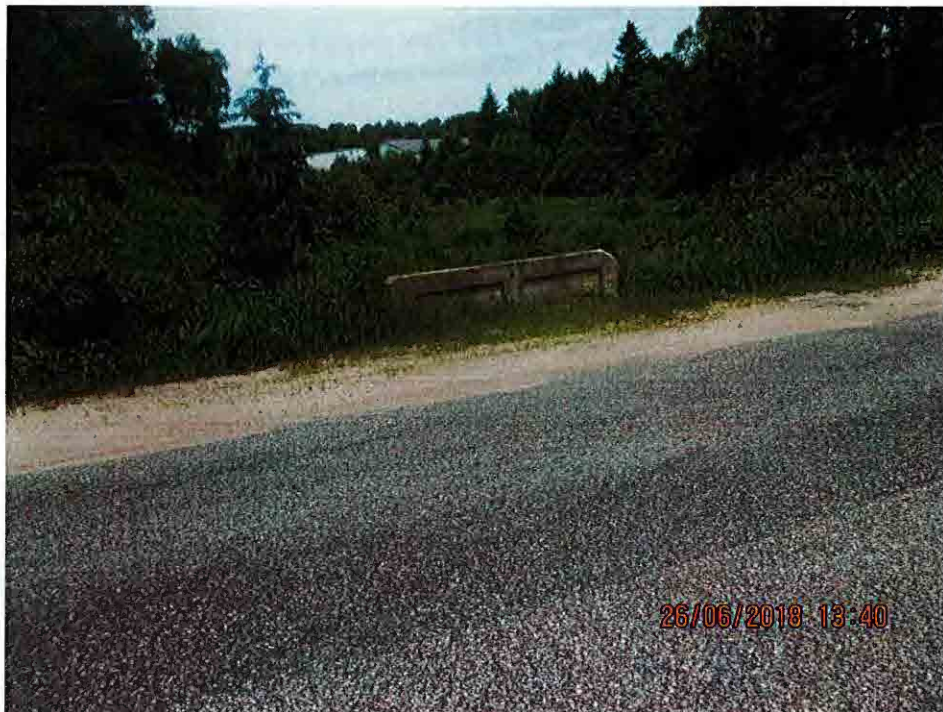
North barrier wall

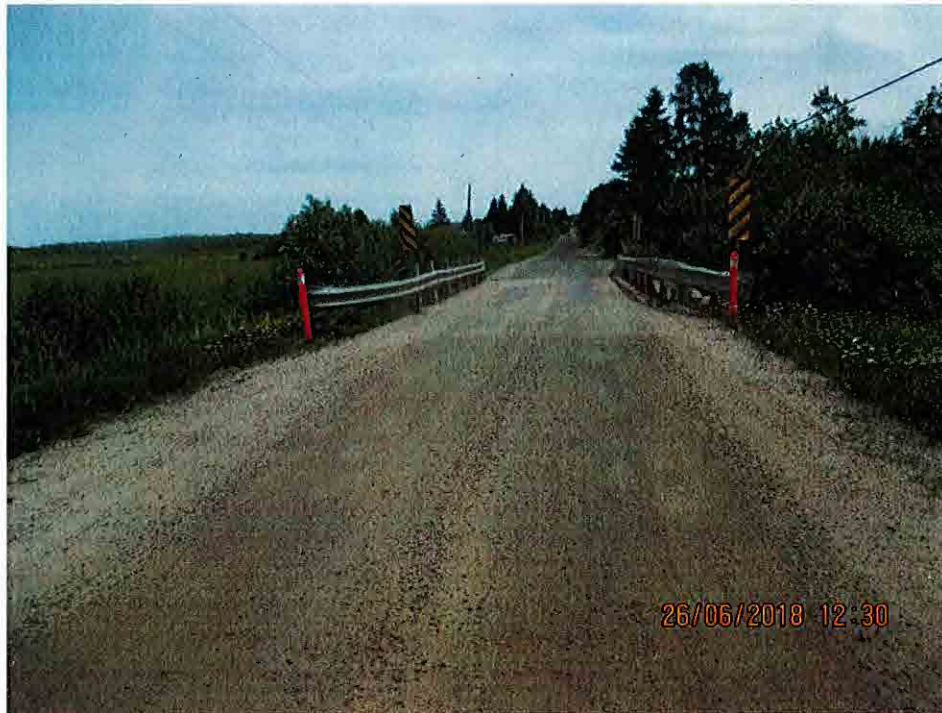
Roadway looking East

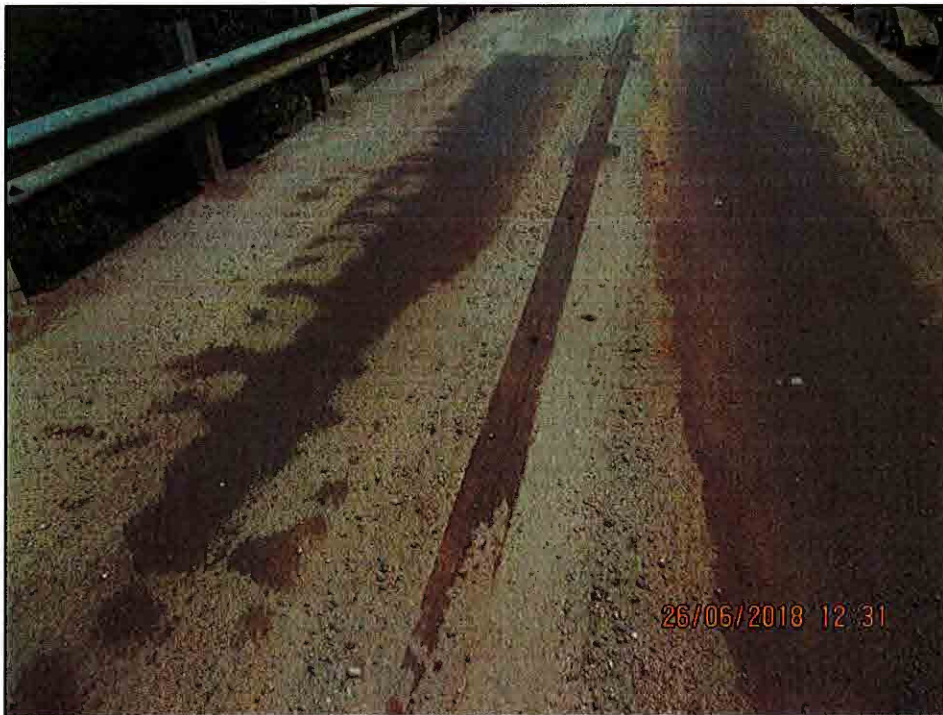
Debris on deck

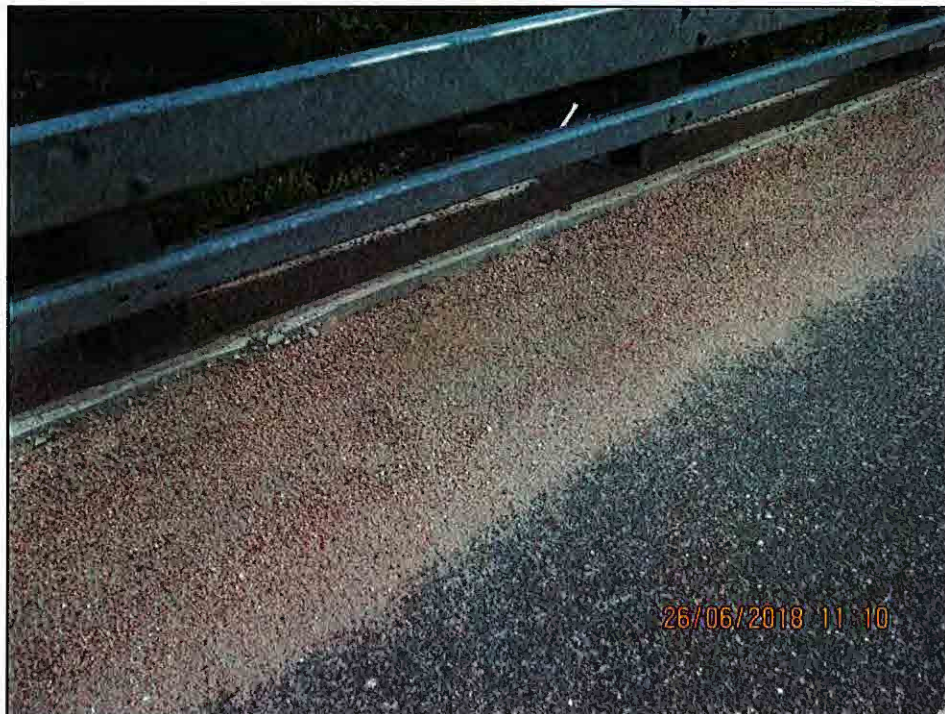
Accumulated sand on road

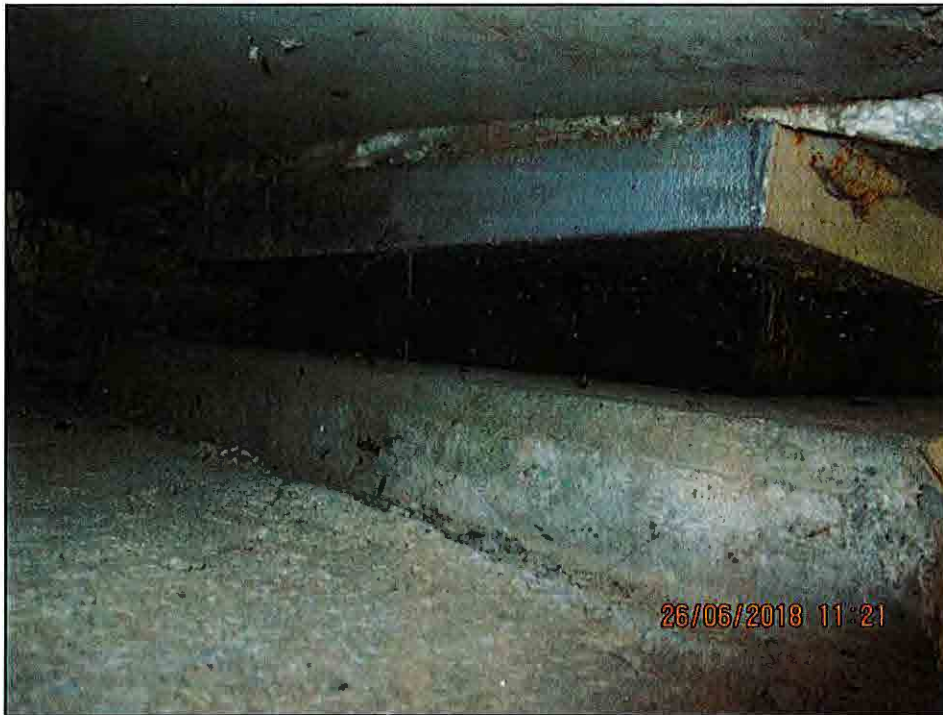
Minor loss of bearing contact

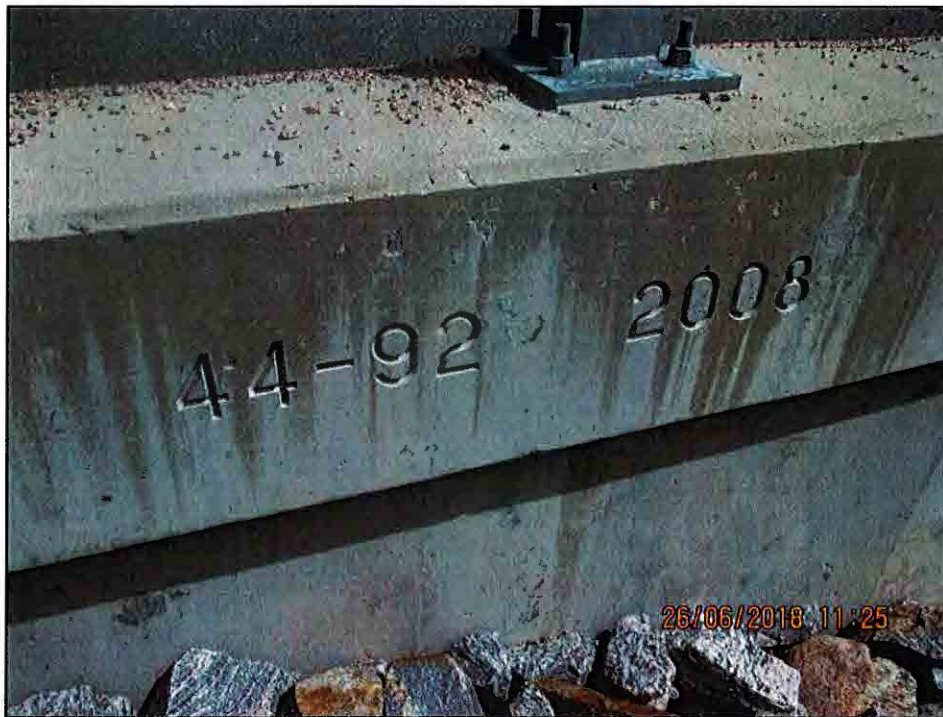
Southwest wing wall

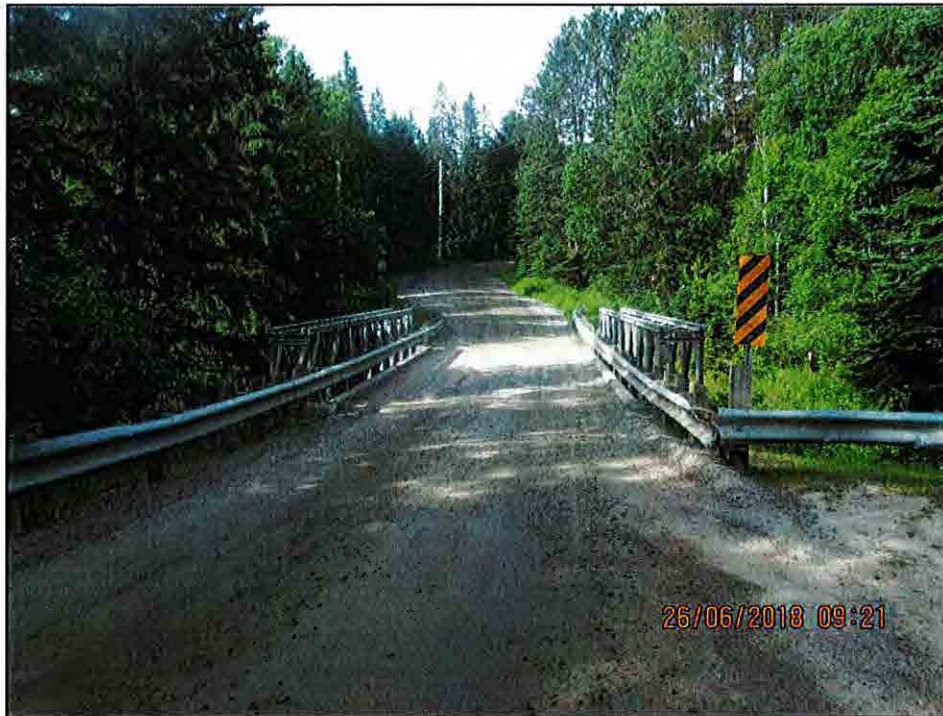
Roadway looking West

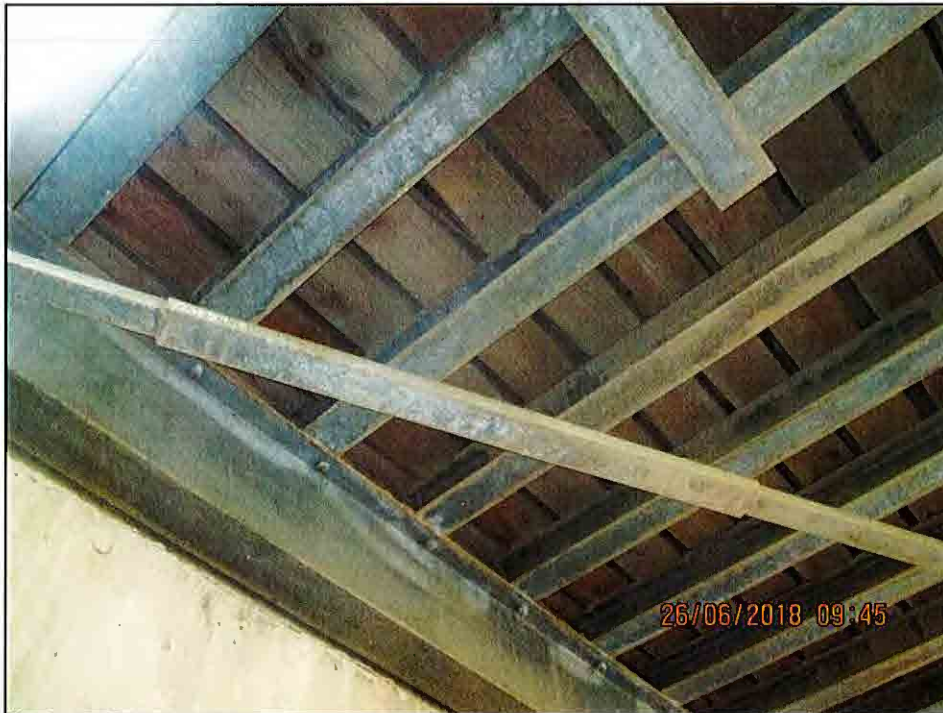
Split soffit timbers

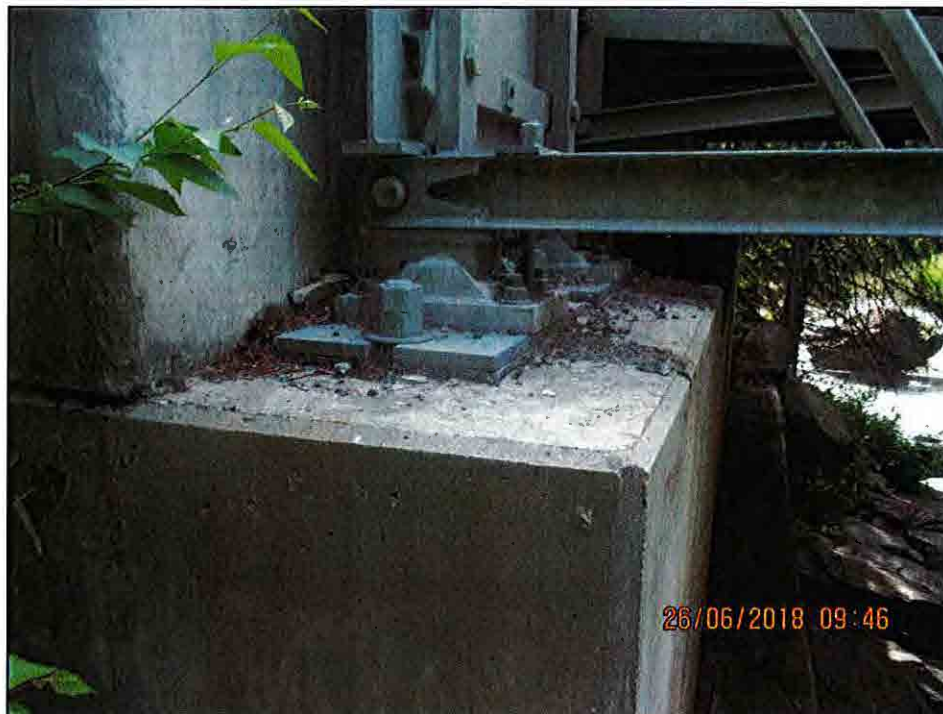
Debris at bearings (Typ.)

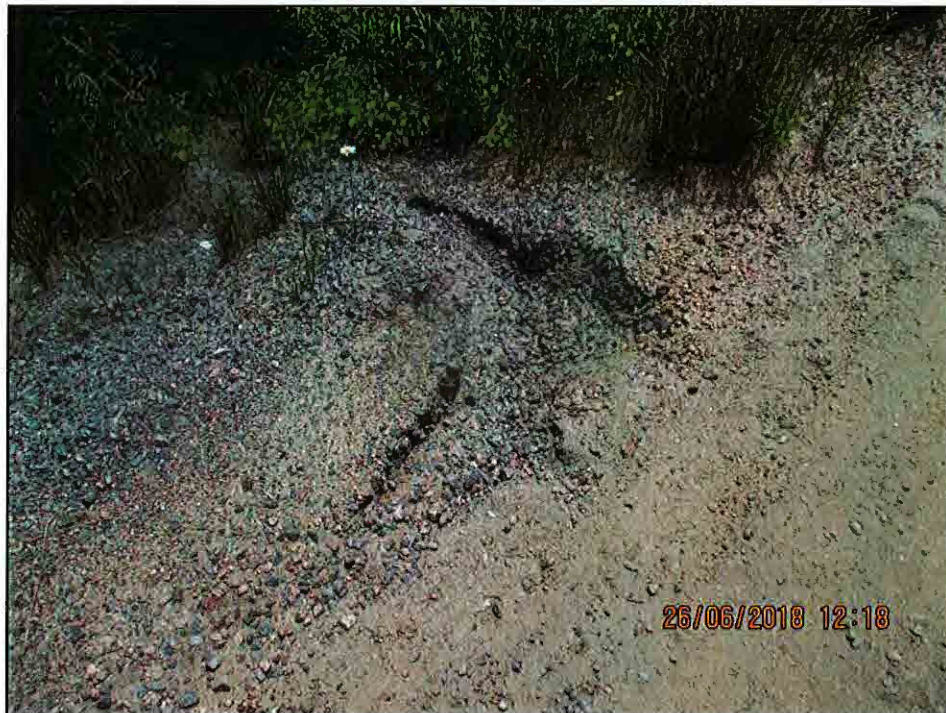
Minor erosion of embankment at Southeast
