FACILITY CONDITION ASSESSMENT

TOWNSHIP OF STRONG

Sundridge Strong Joly Arena
14 Albert Street North, Sundridge, ON P0A 1Z0

WalterFedy Project No.: 2021-0270

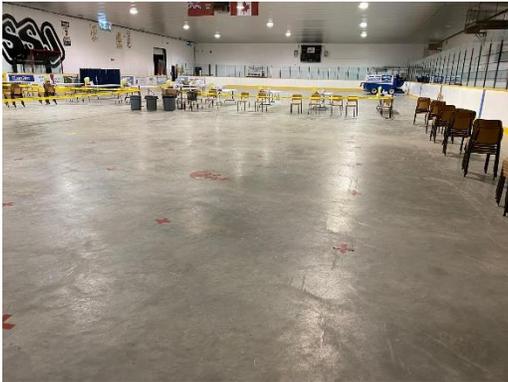
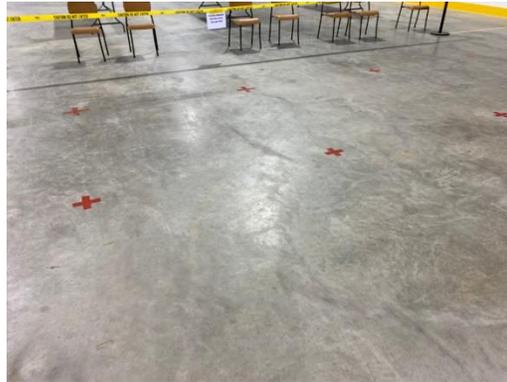
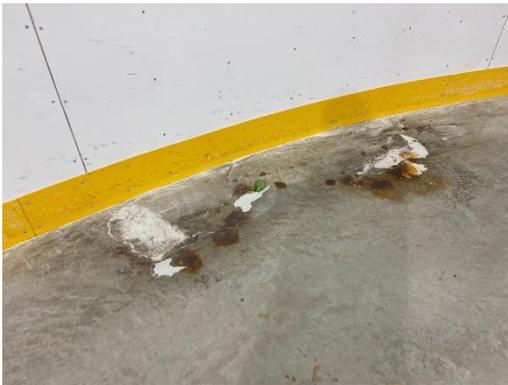
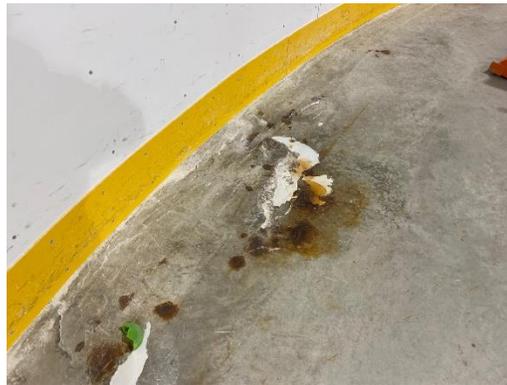
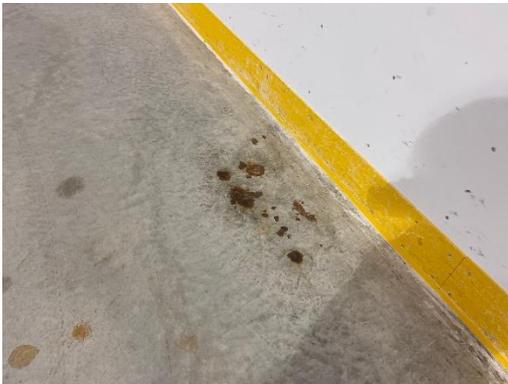
5.2 A - Substructure

Element Description: Ice Rink Floor Slab
Year of Installation: 1970
Location: Slab-on-Grade
Condition: Poor
Consequence of Failure: High

Estimated Useful Life (EUL)	50	Remaining Service Life	0
Current Replacement Value (CRV)	\$250,000	Action Cost:	\$150,000
Quantity Estimate:	1 Unit(s)	Action Year:	2023
Unit Cost:	\$150,000	Repeat Cycle:	50
Urgency of Action:	High (1-5 Years)	Energy Savings:	N/A
Health and Safety:	No	Accessibility Issue:	No

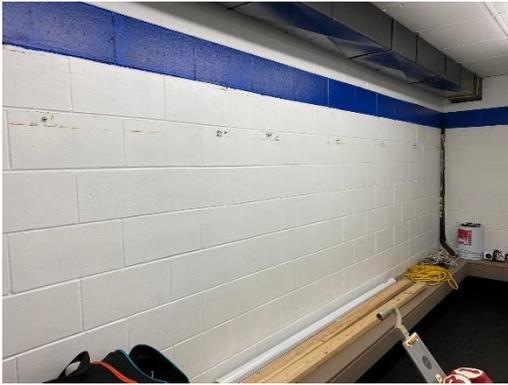
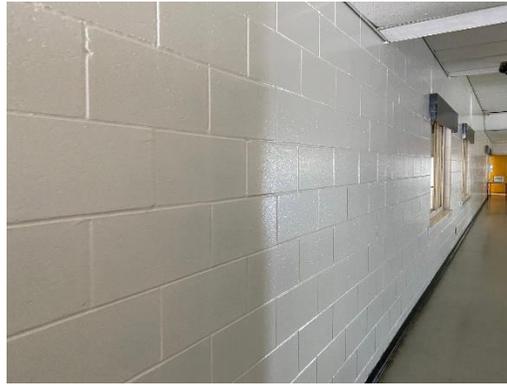
5.3 B - Shell

Element Description: Superstructure
Year of Installation: 1970
Location: General Construction
Condition: Good
Consequence of Failure: High

Estimated Useful Life (EUL)	80	Remaining Service Life	29
Current Replacement Value (CRV)	\$1,872,500	Action Cost:	\$10,000
Quantity Estimate:	1 Unit(s)	Action Year:	2026
Unit Cost:	\$10,000	Repeat Cycle:	5
Urgency of Action:	Medium (5-10 Years)	Energy Savings:	N/A
Health and Safety:	No	Accessibility Issue:	No

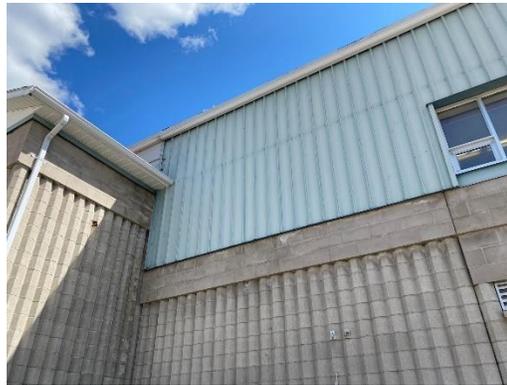
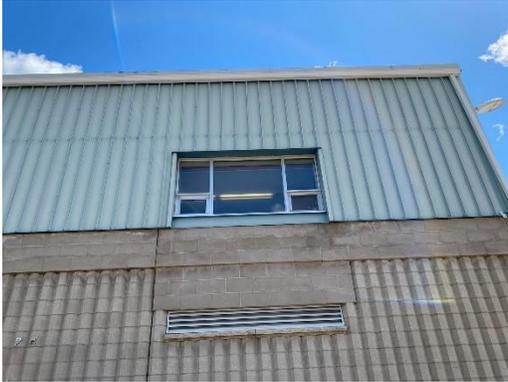
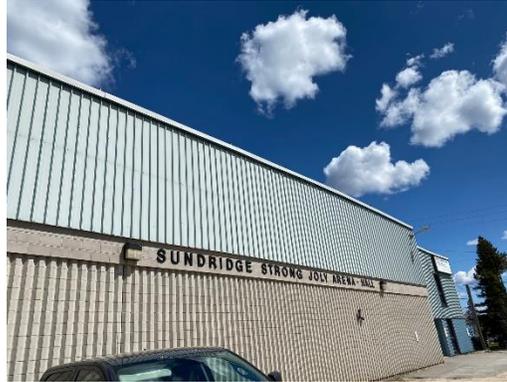
5.4 B - Shell

Element Description: Aluminum Siding (Original)

Estimated Useful Life (EUL)	50	Remaining Service Life	0
Current Replacement Value (CRV)	\$33,000	Action Cost:	\$33,000
Quantity Estimate:	3000 SF	Action Year:	2028
Unit Cost:	\$11	Repeat Cycle:	50
Urgency of Action:	Medium (5-10 Years)	Energy Savings:	N/A
Health and Safety:	No	Accessibility Issue:	No

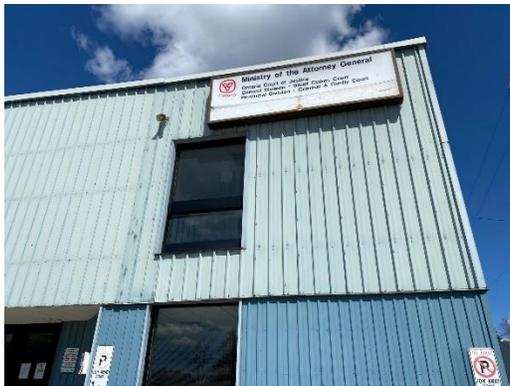
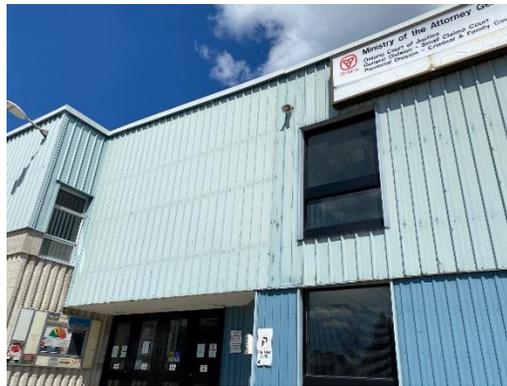
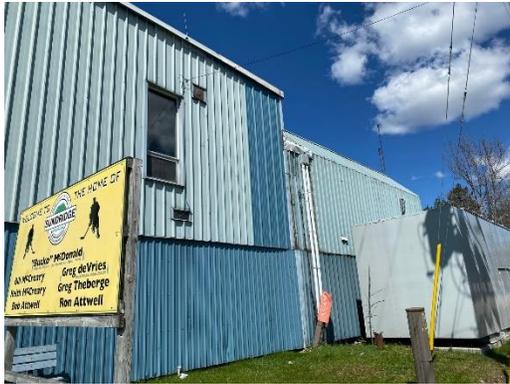
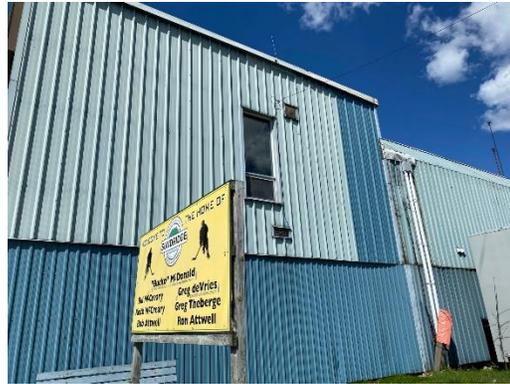
5.5 B - Shell

Element Description: Aluminum Siding (Foyer Addition)

Estimated Useful Life (EUL)	50	Remaining Service Life	7
Current Replacement Value (CRV)	\$33,000	Action Cost:	\$33,000
Quantity Estimate:	3000 SF	Action Year:	2028
Unit Cost:	\$11	Repeat Cycle:	50
Urgency of Action:	Low (10+ Years)	Energy Savings:	N/A
Health and Safety:	No	Accessibility Issue:	No

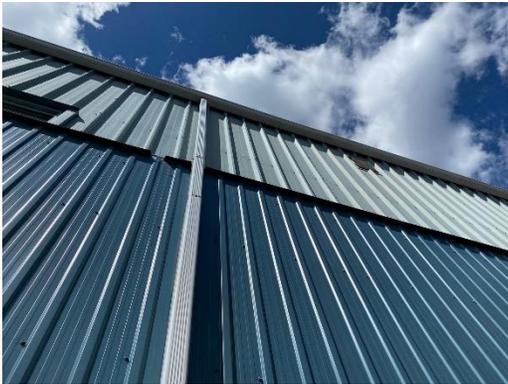
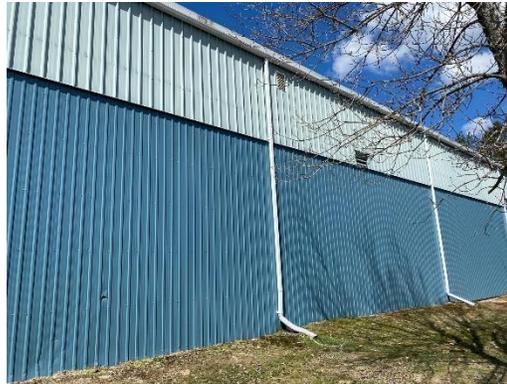
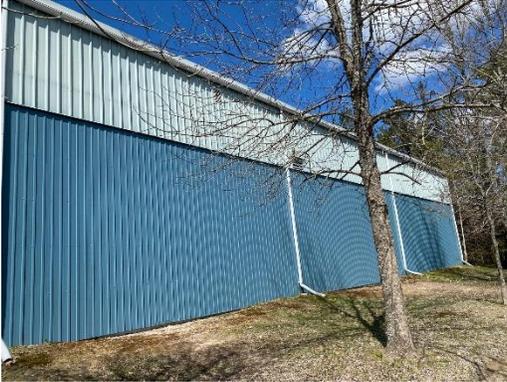
5.6 B - Shell

Element Description: Aluminum Siding (Rear Wall)

Estimated Useful Life (EUL)	50	Remaining Service Life	37
Current Replacement Value (CRV)	\$33,000	Action Cost:	Not Applicable
Quantity Estimate:	Not Applicable	Action Year:	Not Applicable
Unit Cost:	Not Applicable	Repeat Cycle:	Not Applicable
Urgency of Action:	Not Applicable	Energy Savings:	N/A
Health and Safety:	No	Accessibility Issue:	No

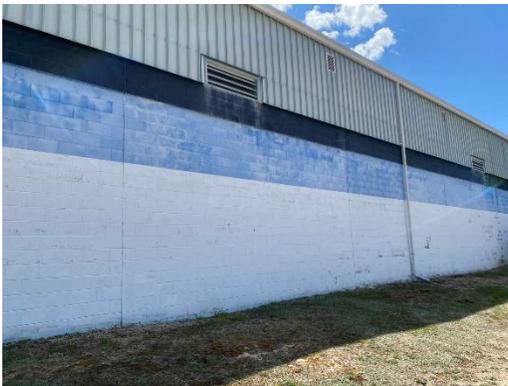
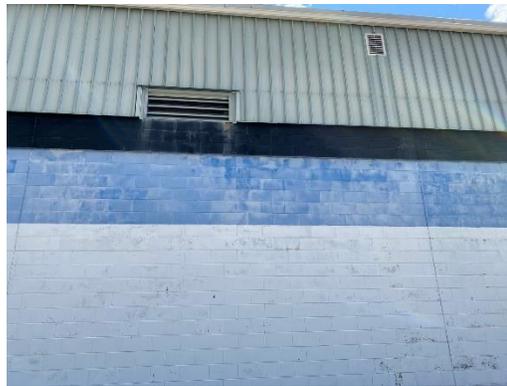
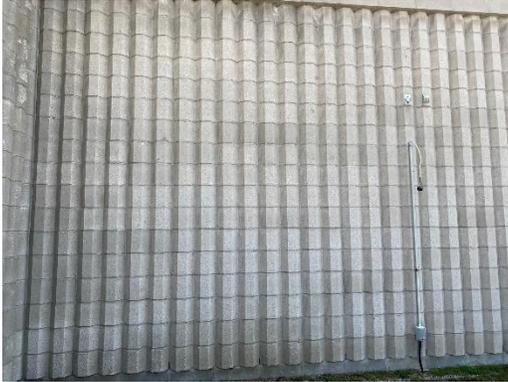
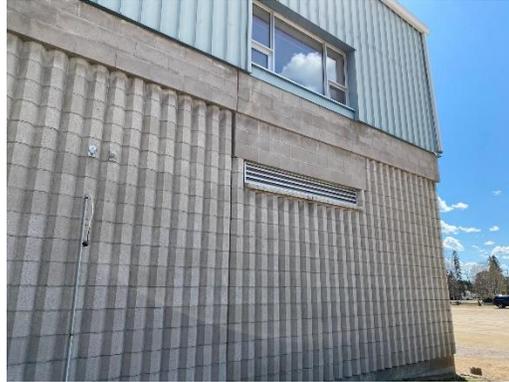
5.7 B - Shell

Element Description: Concrete Masonry
Year of Installation: 1970
Location: Building Exterior
Condition: Fair
Consequence of Failure: Moderate
Commentary: A portion of the exterior walls are finished with concrete block and fluted concrete

Estimated Useful Life (EUL)	80	Remaining Service Life	29
Current Replacement Value (CRV)	\$146,000	Action Cost:	\$5,000
Quantity Estimate:	1 Unit(s)	Action Year:	2026
Unit Cost:	\$5,000	Repeat Cycle:	10
Urgency of Action:	Medium (5-10 Years)	Energy Savings:	N/A
Health and Safety:	No	Accessibility Issue:	No

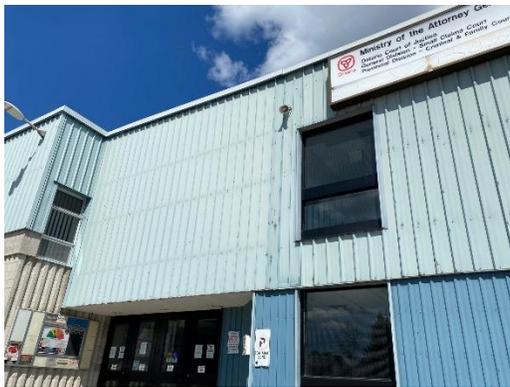
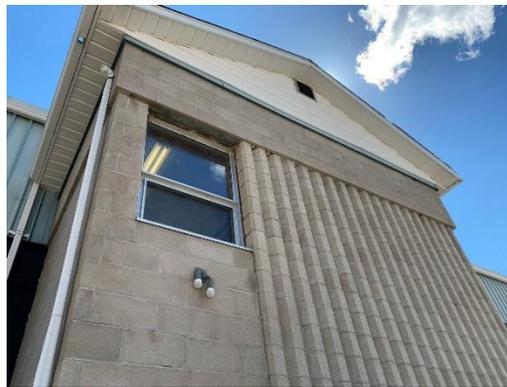
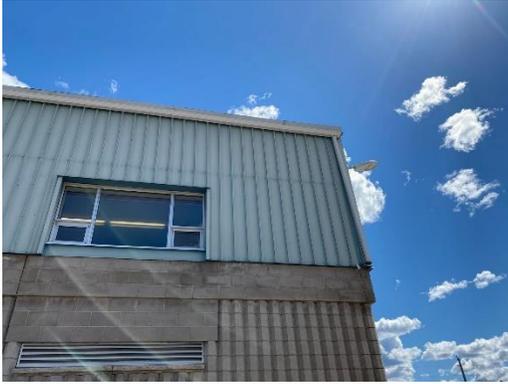
5.8 B - Shell

Element Description: Windows
Year of Installation: 1970
Location: Building Exterior
Condition: Poor
Consequence of Failure: Low

Estimated Useful Life (EUL)	30	Remaining Service Life	0
Current Replacement Value (CRV)	\$12,000	Action Cost:	\$12,000
Quantity Estimate:	6 Unit(s)	Action Year:	2023
Unit Cost:	\$2,000	Repeat Cycle:	30
Urgency of Action:	High (1-5 Years)	Energy Savings:	Low
Health and Safety:	No	Accessibility Issue:	No

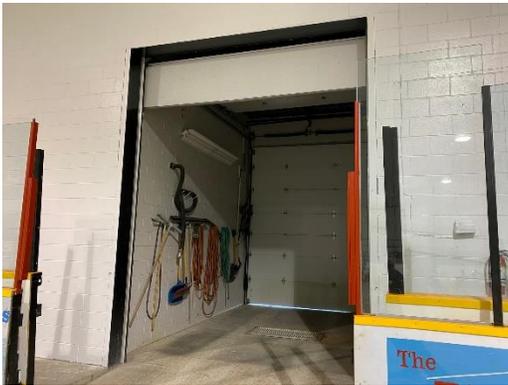
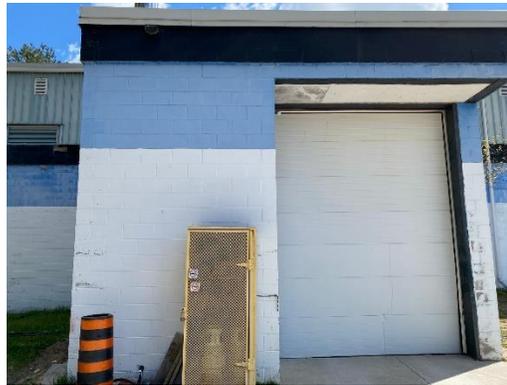
5.11 B - Shell

Element Description: Overhead Doors

Estimated Useful Life (EUL)	25	Remaining Service Life	14
Current Replacement Value (CRV)	\$6,000	Action Cost:	Not Applicable
Quantity Estimate:	Not Applicable	Action Year:	Not Applicable
Unit Cost:	Not Applicable	Repeat Cycle:	Not Applicable
Urgency of Action:	Not Applicable	Energy Savings:	N/A
Health and Safety:	No	Accessibility Issue:	No

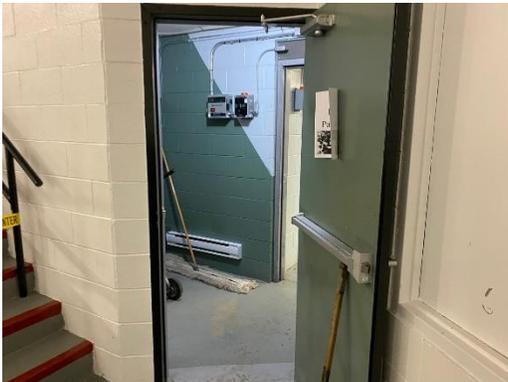
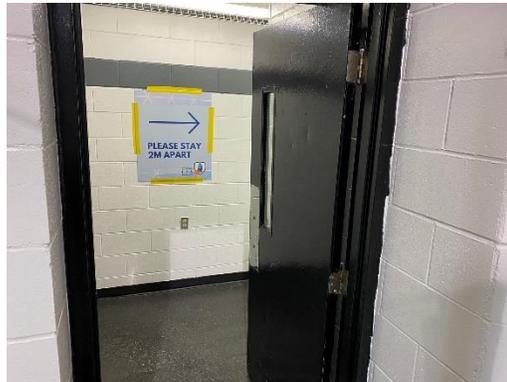
5.17 C - Interiors

Element Description: Metal Interior Doors
Year of Installation: 1970
Location: Throughout Building
Condition: Good
Consequence of Failure: Low

Estimated Useful Life (EUL)	30	Remaining Service Life	0
Current Replacement Value (CRV)	\$12,000	Action Cost:	\$12,000
Quantity Estimate:	6 Unit(s)	Action Year:	2031
Unit Cost:	\$2,000	Repeat Cycle:	30
Urgency of Action:	Low (10+ Years)	Energy Savings:	N/A
Health and Safety:	No	Accessibility Issue:	No

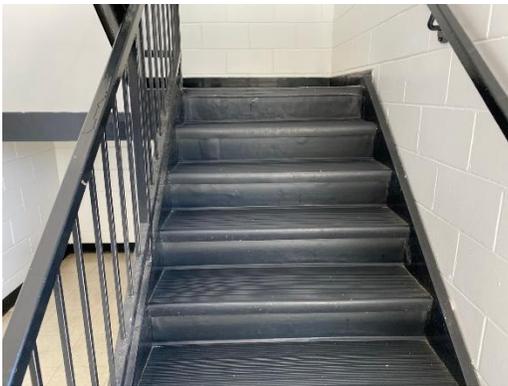
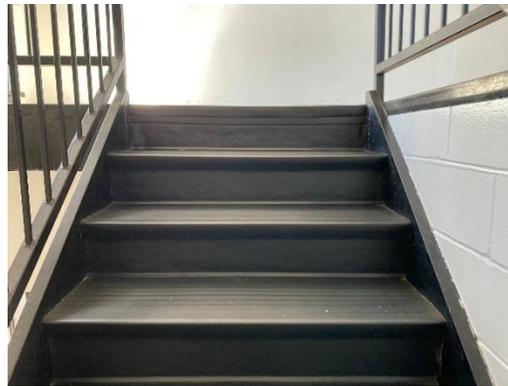
5.19 C - Interiors

Element Description: Metal Staircase
Year of Installation: 1970
Location: Throughout Building
Condition: Good
Consequence of Failure: Medium

Estimated Useful Life (EUL)	85	Remaining Service Life	34
Current Replacement Value (CRV)	\$80,000	Action Cost:	Not Applicable
Quantity Estimate:	Not Applicable	Action Year:	Not Applicable
Unit Cost:	Not Applicable	Repeat Cycle:	Not Applicable
Urgency of Action:	Not Applicable	Energy Savings:	N/A
Health and Safety:	Yes	Accessibility Issue:	No

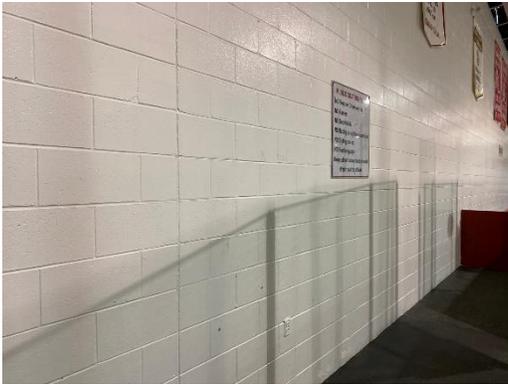
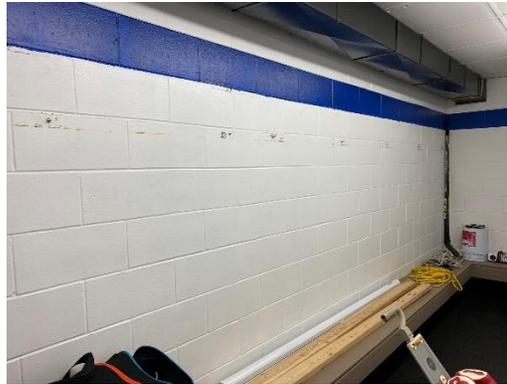
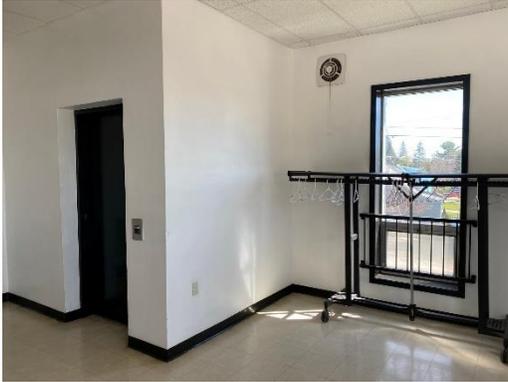
Estimated Useful Life (EUL)	15	Remaining Service Life	0
Current Replacement Value (CRV)	\$70,000	Action Cost:	\$5,000
Quantity Estimate:	1 Unit(s)	Action Year:	2021
Unit Cost:	\$5,000	Repeat Cycle:	1
Urgency of Action:	High (1-5 Years)	Energy Savings:	N/A
Health and Safety:	No	Accessibility Issue:	No

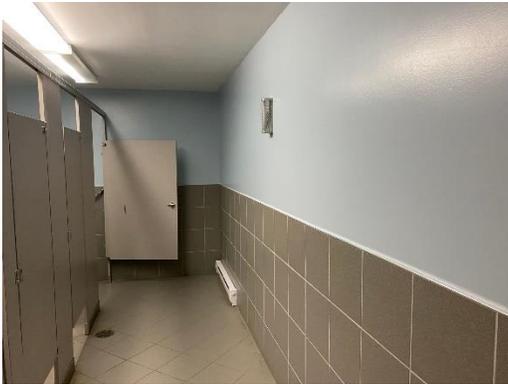
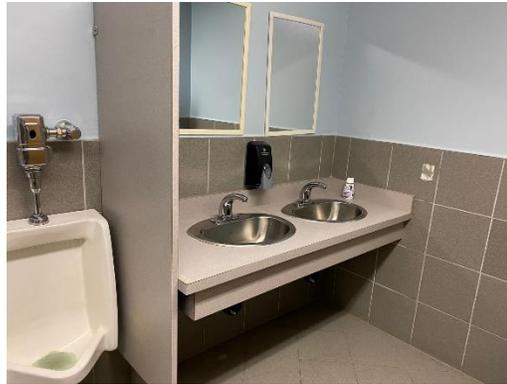
Element Description: Ceramic Tile Walls
Year of Installation: 2000
Location: Washrooms
Condition: Good
Consequence of Failure: Very Low

Commentary: The lower portions of the washroom walls are finished with ceramic tile. The actual age of the tile is unknown; therefore, the last major action year has been estimated. Upon inspection, the ceramic tiles appeared to be in good condition. No capital expenditures are anticipated within the term of the study.

Recommended Action: No Action is Required.

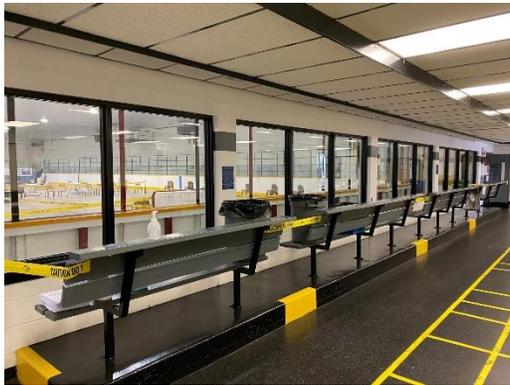
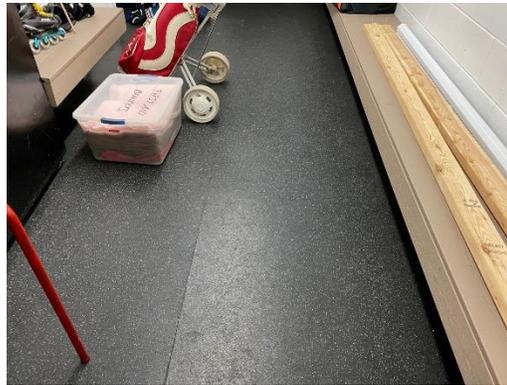
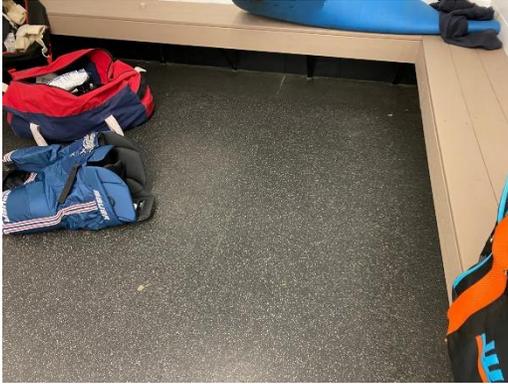
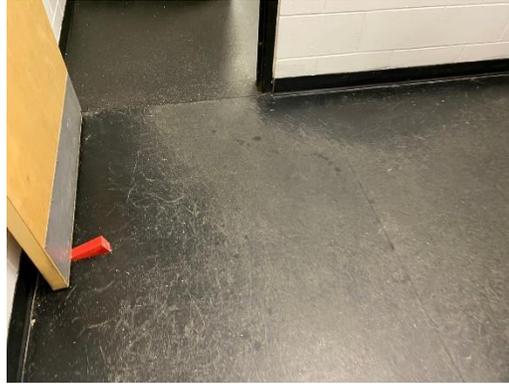
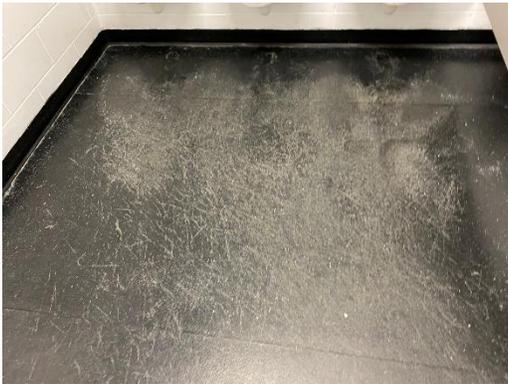
Element Description: Rubber Flooring
Year of Installation: 2011
Location: Throughout Building
Condition: Good
Consequence of Failure: Low

Commentary: There is rubber flooring located throughout the building including the lobby, changing rooms, some of the washrooms and around the ice surface. It is our understanding that the flooring was replaced ten years ago. Upon inspection, the flooring appeared to be in overall good condition. An allowance has been included to replace the flooring at the end of its useful life.

Recommended Action: Replacement

Action Summary:	Action Description:
Allowance for lifecycle replacement	Replace rubber flooring

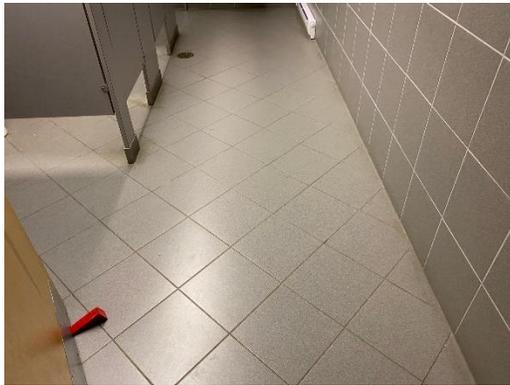
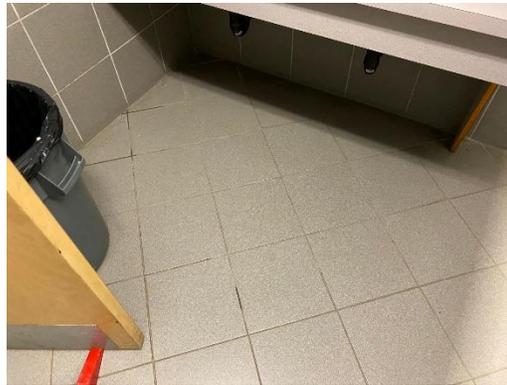
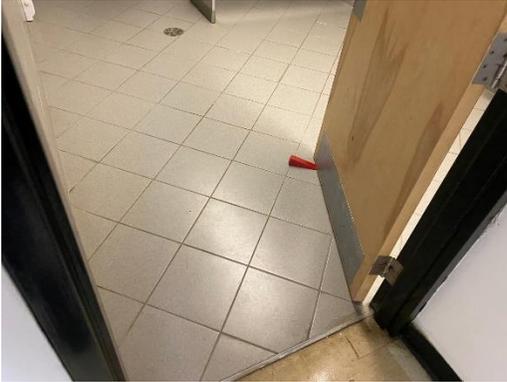
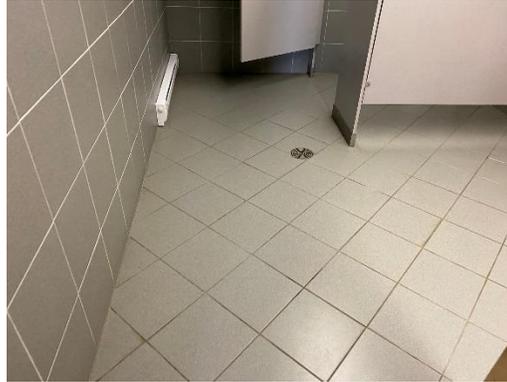
Element Description: Ceramic Floor Tile
Year of Installation: 2001
Location: Washrooms
Condition: Good
Consequence of Failure: Low

Commentary: There is ceramic tile flooring located in some of the washrooms. The tile appears to have been replaced, but the actual age is unknown; therefore, the last major action year has been estimated. Upon inspection, the tile flooring in the appeared to be in good condition. An allowance has been included to replace the ceramic tile at the end of its useful life.

Recommended Action: Replacement

Action Summary:	Action Description:
Allowance for lifecycle replacement	Replace ceramic tile flooring

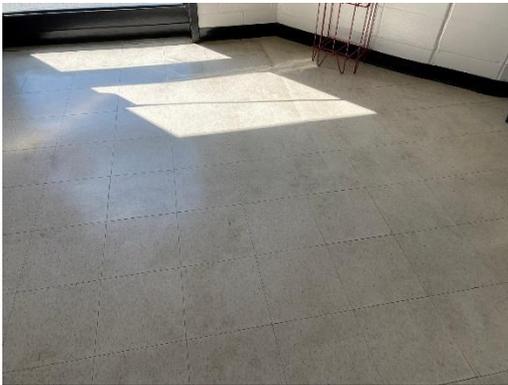
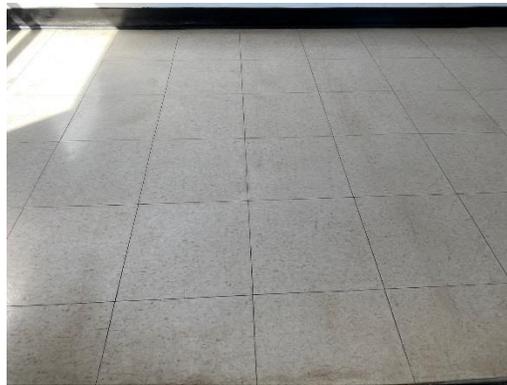
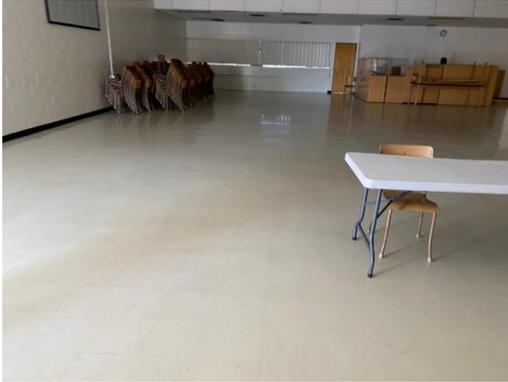
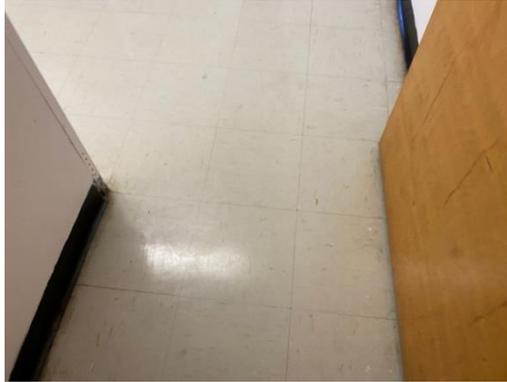
Element Description: VCT Flooring
Year of Installation: 2011
Location: Throughout Building
Condition: Good
Consequence of Failure: Low

Commentary: There is VCT (Vinyl Composite Tile) flooring located in the second floor and storage areas. The actual age of the tile is unknown; therefore, the last major action year has been estimated. Upon inspection, the tile appeared to be in good condition. An allowance has been included to replace the VCT flooring at the end of its useful life.

Recommended Action: Replacement

Action Summary:	Action Description:
Allowance for lifecycle replacement	Replace VCT flooring

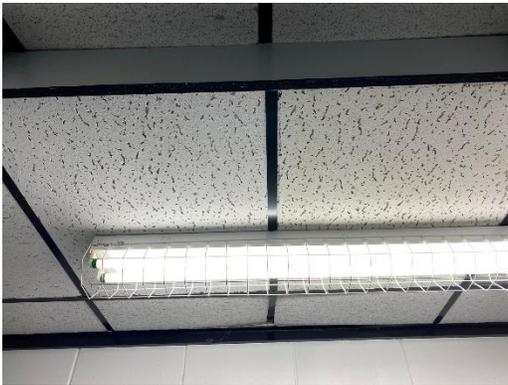
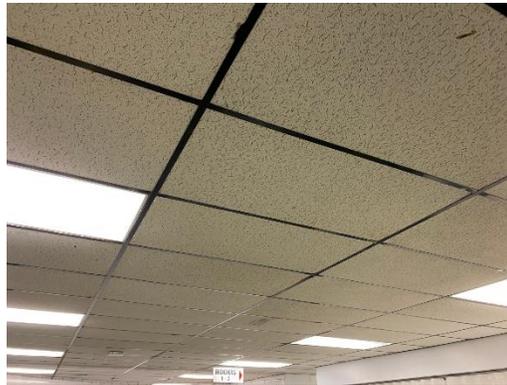
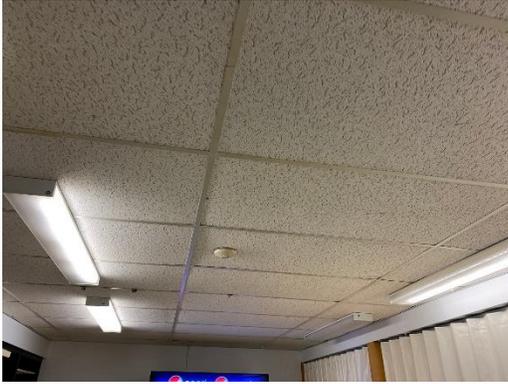
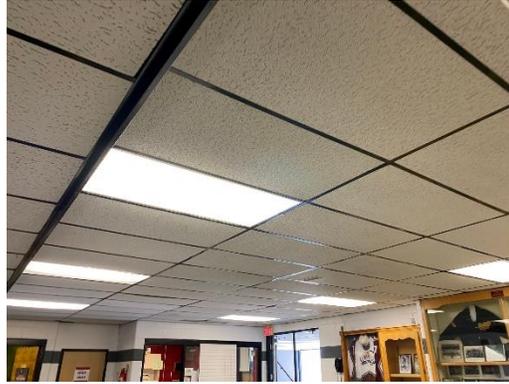
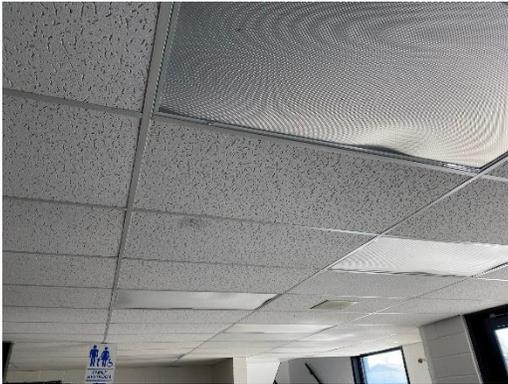
Element Description: Acoustic Ceiling Tiles

Condition: Fair

Commentary: The ceilings throughout the building are finished with acoustic ceiling tiles. The actual age of the tiles is unknown; therefore, the last major action year has been estimated. Upon inspection, the tiles appeared to be in fair condition with signs of aging and deterioration. An allowance has been included to replace the acoustic ceiling tiles at the end of their useful life.

Recommended Action: Replacement

Action Summary:	Action Description:
Allowance for lifecycle replacement	Replace acoustic ceiling tiles

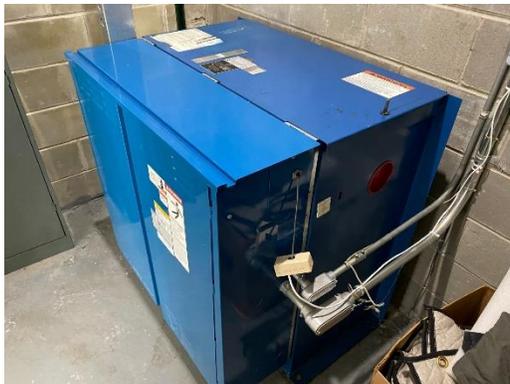
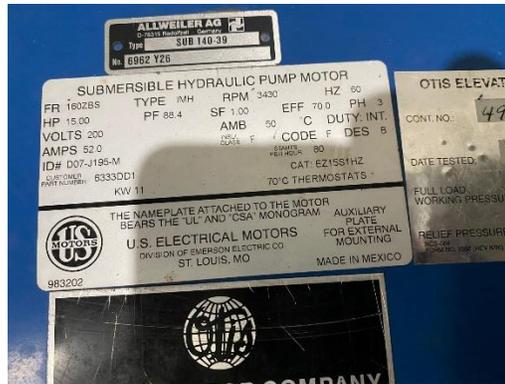
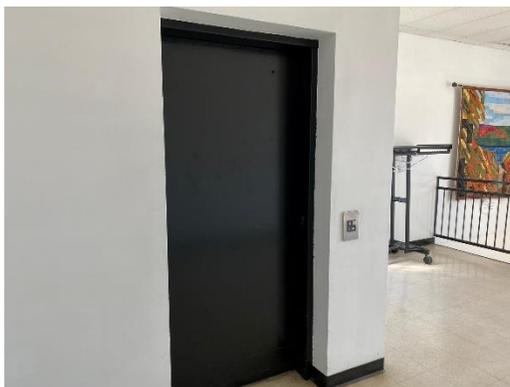
Element Description: Hydraulic Elevator
Year of Installation: 2000
Location: Lobby
Condition: Poor
Consequence of Failure: High

Commentary: There is one hydraulic elevator manufactured by Otis Elevator providing access to the second floor from the lobby of the building. Upon inspection, the elevator appeared to be in poor condition as it is approaching its expected service life in the next four years. Allowances have been included for modernization, cab and fixture upgrades, and replacement of the door operators in 2025.

5.26.1 Recommended Action: Replacement

5.26.2 Recommended Action: Repair

Action Summary:	Action Description:
Allowance for repairs	Cab and fixture upgrade

5.26.3 Recommended Action: Replacement

Action Summary:	Action Description:
Allowance for lifecycle replacement	Replace door operators

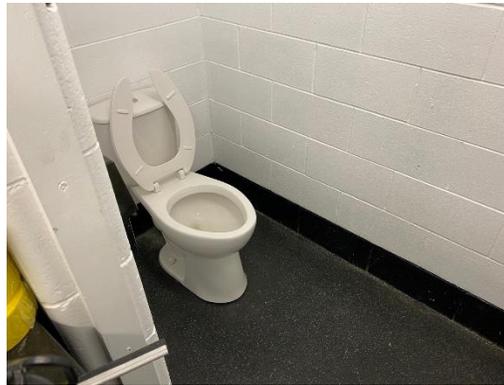
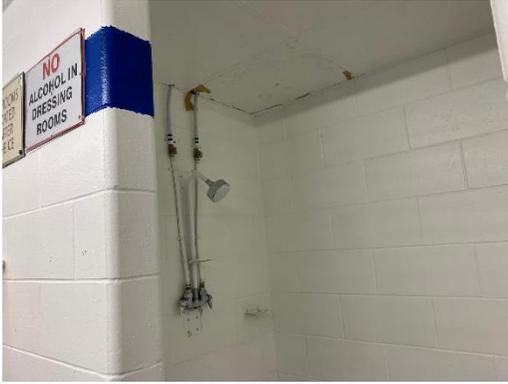
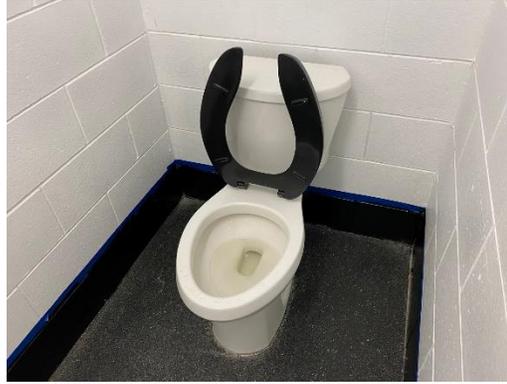
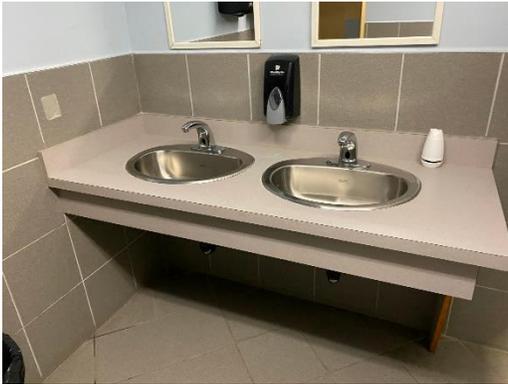
Element Description: Plumbing Fixtures
Year of Installation: 2010
Location: Throughout Building
Condition: Good
Consequence of Failure: Low

Commentary: Plumbing fixtures within the building include 11 toilets, six urinals, four showers, and 13 sinks. The actual age of the fixtures is unknown; therefore, the last major action year has been estimated. Upon inspection, the fixtures appeared to be in good condition. No capital expenditures are anticipated within the term of the study.

Recommended Action: No Action is Required.

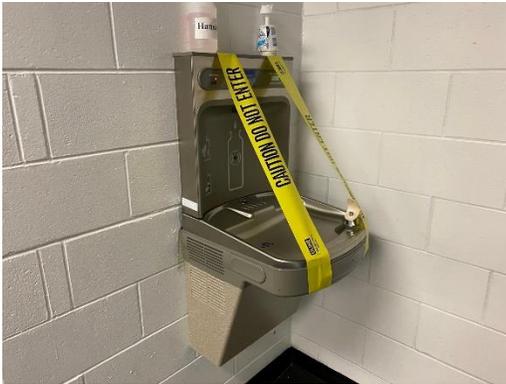
Element Description: Drinking Fountain

Commentary: There is a drinking fountain located in the lobby of the building. It is our understanding that the fountain was replaced in 2019 and has only been used for one year (2019). Upon inspection, the fountain appeared to be in good condition. No capital expenditures are anticipated within the term of the study.

Recommended Action: No Action is Required.

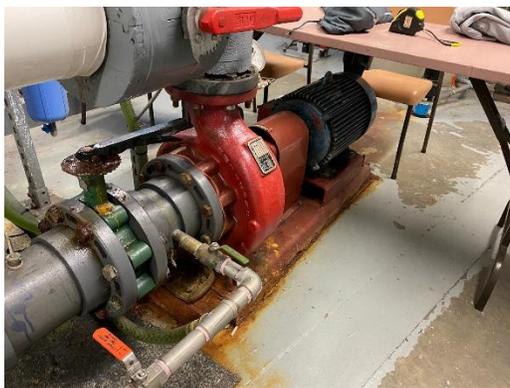
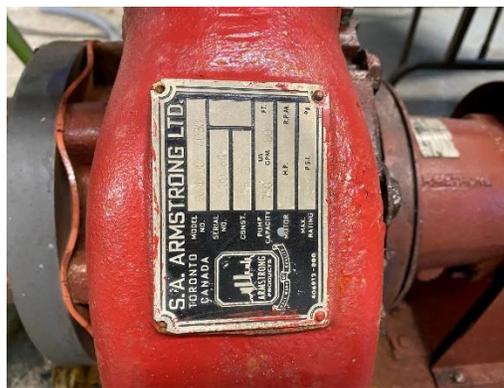
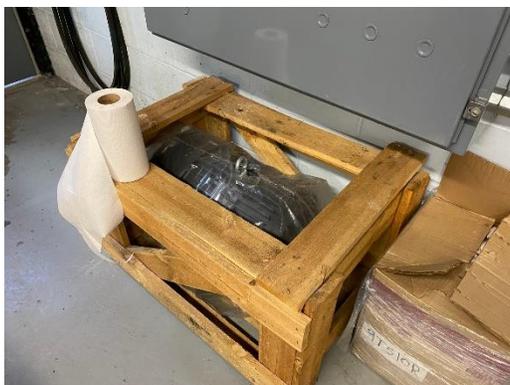
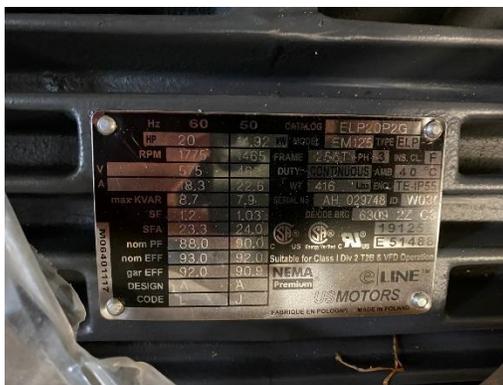
Element Description: Circulation Pump
Year of Installation: 1970
Location: Mechanical Room
Condition: Poor
Consequence of Failure: High

Commentary: There is a circulation pump manufactured by Armstrong (M/N: 6X4X10 4030, S/N: 109384) located in the mechanical room. The pump was rated for 750 USGAL/M. The pump appeared to be original to building construction. It is our understanding that a replacement pump has been purchased and will be installed when the original pump fails. Upon inspection, the pump appeared to be in good condition based on age and signs of deterioration. No major capital expenditures are anticipated within the term of the study.

Recommended Action: No Action is Required.

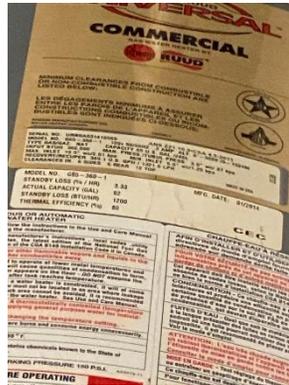
Element Description: Domestic Hot Water Heater (1)
Year of Installation: 2014
Location: Rink Area
Condition: Good
Consequence of Failure: Moderate

Commentary: There is a domestic water heater manufactured by Ruud (M/N: G65-360-1, S/N: URNGA031416569) located in the rink area of the building which services the Zamboni bay. The capacity of the heater is 62 USGAL and 380,000 BTUH. Upon inspection, the water heater appeared to be in good condition. An allowance has been included to replace the water heater at the end of its useful life.

Recommended Action: Replacement

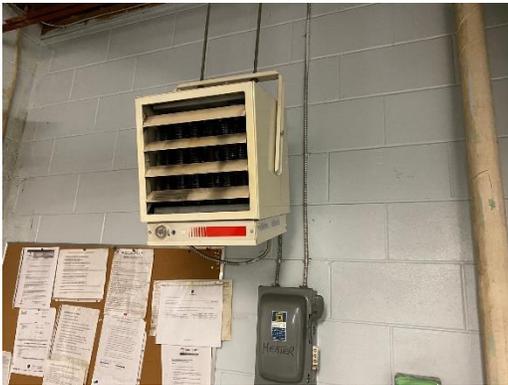
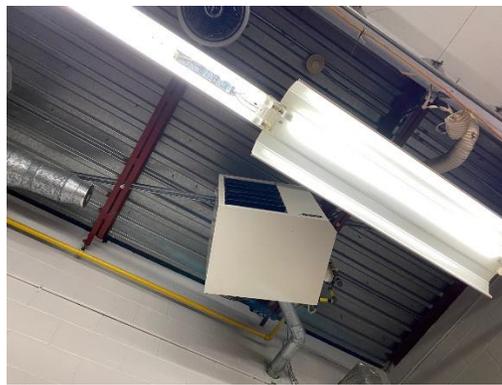
5.40 D - Mechanical Services

Element Description: Unit Heaters
Year of Installation: 2000
Location: Throughout Building
Condition: Good
Consequence of Failure: Moderate

Commentary: There are two unit heaters providing heat to the mechanical room and near the Zamboni bay in the rink area. Identification tags could not be viewed during the site visit. The actual age of the heaters is unknown; therefore, the last major action year has been estimated. Upon inspection, the heaters appeared to be in good condition. No major capital expenditures are anticipated within the term of the study.

Recommended Action: No Action is Required.

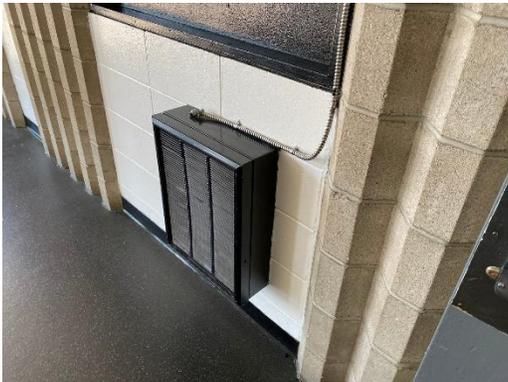
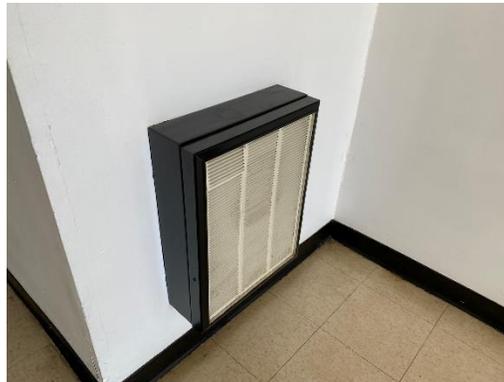
5.41 D - Mechanical Services

Element Description: Wall-Mounted Electric Fan Forced Unit Heaters

Condition: Good

Commentary: There are Wall-mounted electric fan forced unit heaters located at the entrances into the building and in the lobby/second floor areas of the building. The actual age of the units is unknown; therefore, the last major action year has been estimated. Upon inspection, the units appeared to be in good condition. No major capital expenditures are anticipated within the term of the study period.

Recommended Action: No Action is Required.

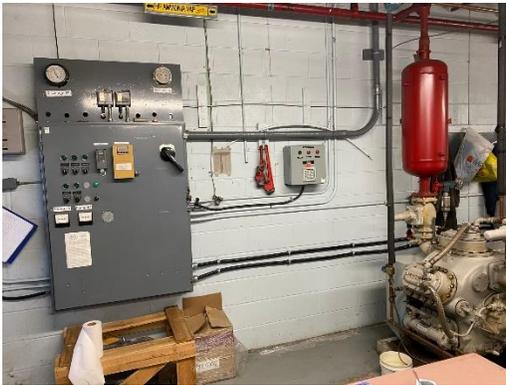
5.42 D - Mechanical Services

Element Description: Control Board
Year of Installation: 2012
Location: Mechanical Room
Condition: Good
Consequence of Failure: Moderate

Commentary: There is a control board located in the mechanical room that controls the chiller and compressors. The actual age of the board is unknown; therefore, the last major action year has been estimated. Upon inspection, the board appeared to be in good condition. No major allowances are anticipated within the term of the study.

Recommended Action: No Action is Required.

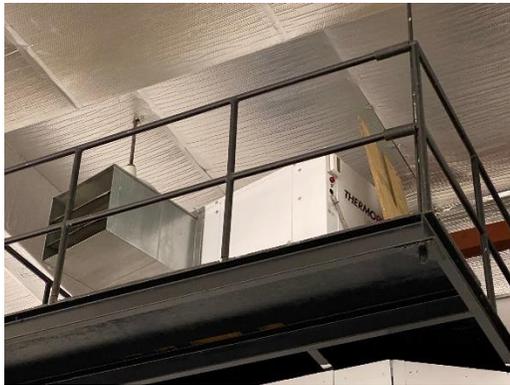
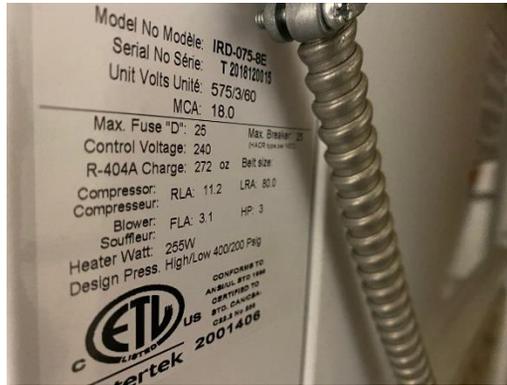
5.43 D - Mechanical Services

Element Description: Dehumidifier
Year of Installation: 2019
Location: Rink Area
Condition: Good
Consequence of Failure: Low

Commentary: There is a dehumidifier manufactured by Thermoplus (M/N: IRD-075-8E, S/N: T2018120015) located in the rink area of the building. It is our understanding that the unit is two (2) years old. Upon inspection, the unit appeared to be in good condition. No major capital expenditures within the term of the study.

Recommended Action: No Action is Required.

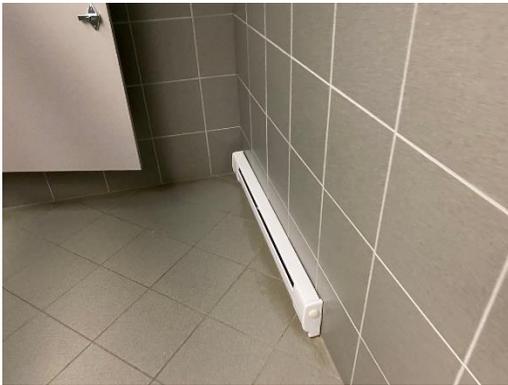
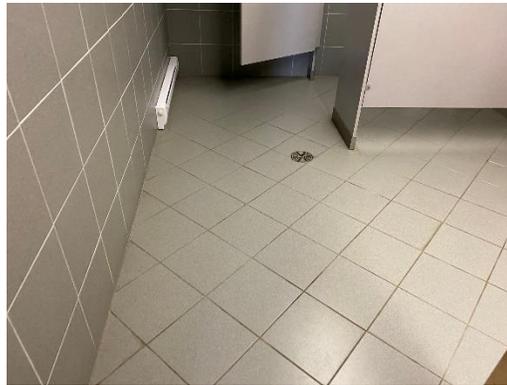
5.44 D - Mechanical Services

Element Description: Electric Baseboard Heating

Condition: Good

Commentary: There are electric baseboard heaters located throughout the building. The actual age of the heaters is unknown; therefore, the last major action year has been estimated. Upon inspection, the heaters appeared to be in good condition. No major capital expenditures are anticipated within the term of the study period.

Recommended Action: No Action is Required.

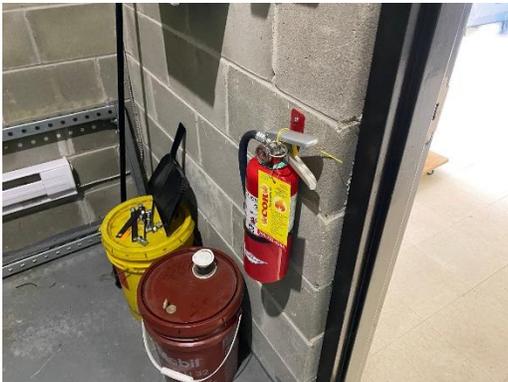
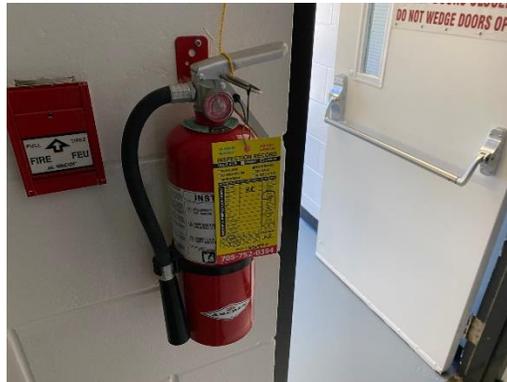
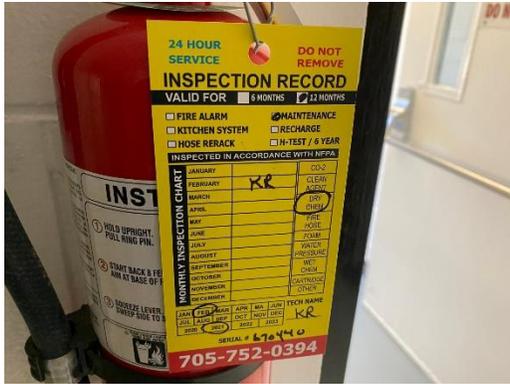
Element Description: Fire Extinguishers
Year of Installation: 2018
Location: Throughout Building
Condition: Fair

Commentary: There are five 5-lb fire extinguishers located throughout the building. The actual age of the extinguishers is unknown; therefore, the last major action year has been estimated. Upon inspection, the extinguishers appeared to be in fair condition. An allowance has been included to replace the extinguishers at the end of their useful life.

Recommended Action: Replacement

Action Summary:	Action Description:
Allowance for lifecycle replacement	Replace fire extinguishers

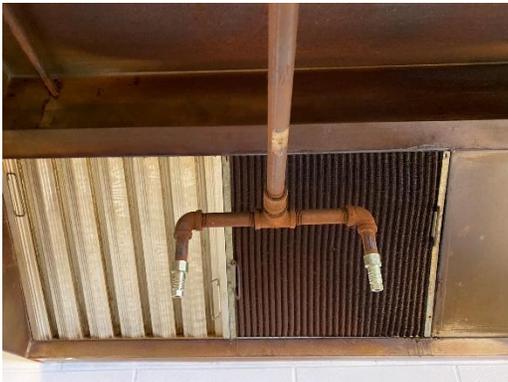
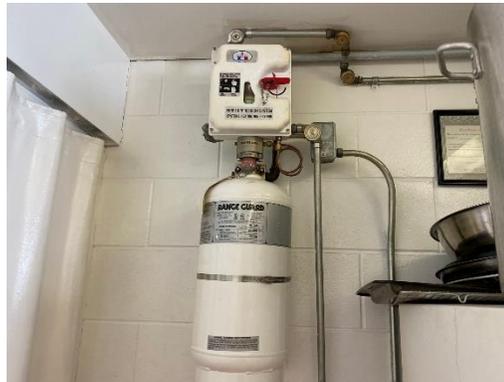
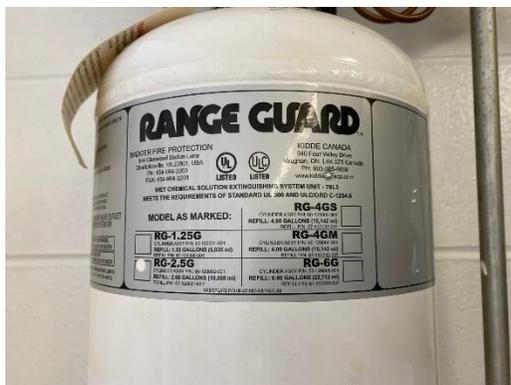
5.47 D - Mechanical Services

Element Description: Range Hood Suppression

Condition: Good

Commentary: There is a range hood suppression system providing fire protection to the open gas equipment in the second floor kitchen area. The actual age of the system is unknown; therefore, the last major action year has been estimated. Upon inspection, the system appeared to be in good condition. No major capital expenditures are anticipated within the term of the study.

Recommended Action: No Action is Required.

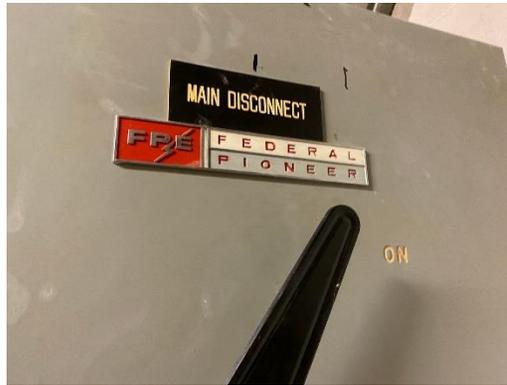
5.48 D - Electrical Services

Element Description: Main Disconnect
Year of Installation: 1970
Location: Electrical Room
Condition: Fair
Consequence of Failure: Moderate

Commentary: There is a main disconnect switch manufactured by FPE (400A) which controls the main line coming into the building. It is our understanding that the disconnect is original to building construction. Upon inspection, the switch appeared to be in fair condition with signs of aging. An allowance has been included to replace the main disconnect switch in the next six years.

Recommended Action: Replacement

Action Summary:	Action Description:
Allowance for lifecycle replacement	Replace main disconnect

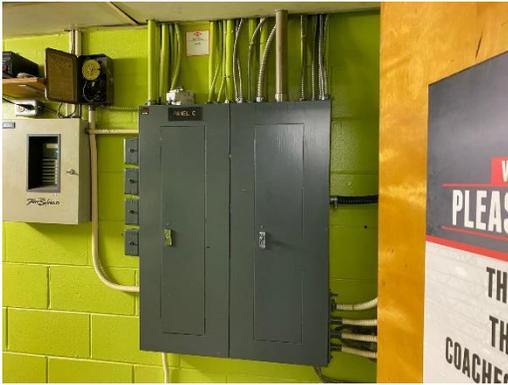
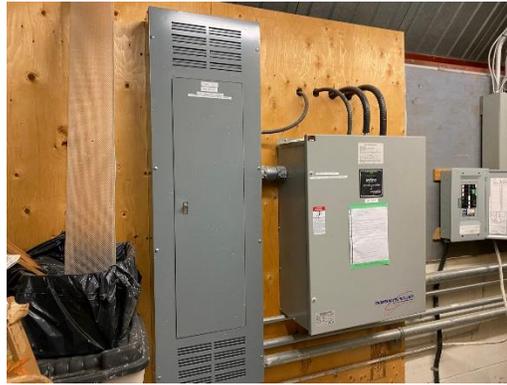
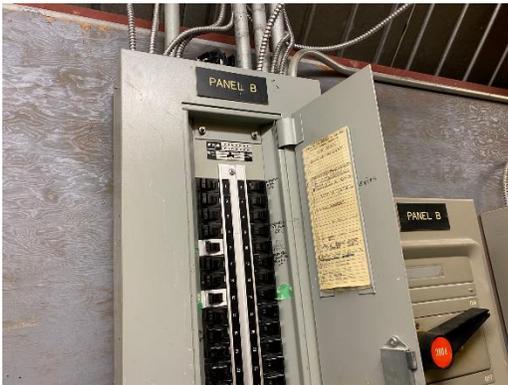
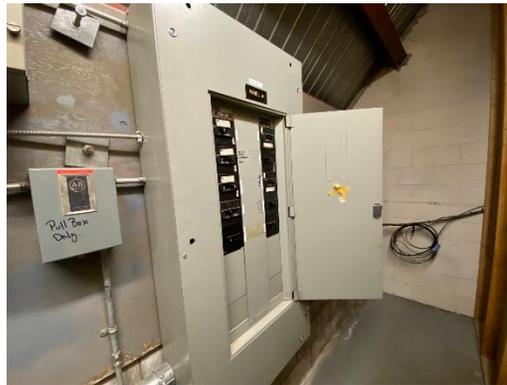
5.49 D - Electrical Services

Element Description: Intermediate Electrical Distribution

Condition: Fair

Commentary: There are five panel boards manufactured by FPE (225 to 400A, 347V, 3-phase, 4-wire) located throughout the building. It is our understanding that the panels are original to the building. Upon inspection, the panels appeared to be in fair condition with signs of aging. It is recommended that a thermal scanning study be done of the electrical equipment to assess the condition of the electrical equipment. Allowances have been included to replace the intermediate panel boards in the next six years as well as thermal scanning every three years.

5.49.1 Recommended Action: Replacement

Action Summary:	Action Description:
Allowance for lifecycle replacement	Replace intermediate panel boards

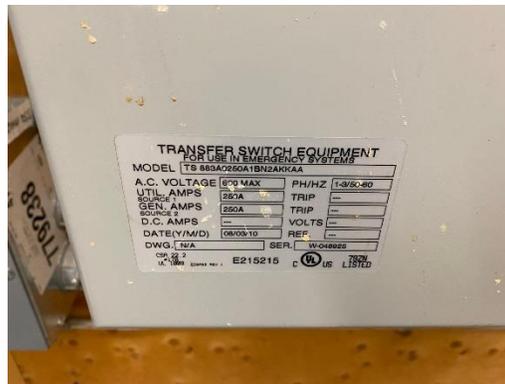
5.50 D - Electrical Services

Element Description: Transfer Switch
Year of Installation: 1970
Location: Electrical Room
Condition: Fair
Consequence of Failure: Moderate

Commentary: There is a transfer switch manufactured by Thomson Technology (M/N: TS 883A0250A1BN2AKKAA, S/N: W-048925) located in the electrical room. It is our understanding that the switch is original to the building. Upon inspection, the unit appears to be in fair condition with signs of aging. An allowance has been included to replace the transfer switch in six years.

Recommended Action: Replacement

Action Summary:	Action Description:
Allowance for lifecycle replacement	Replace transfer switch

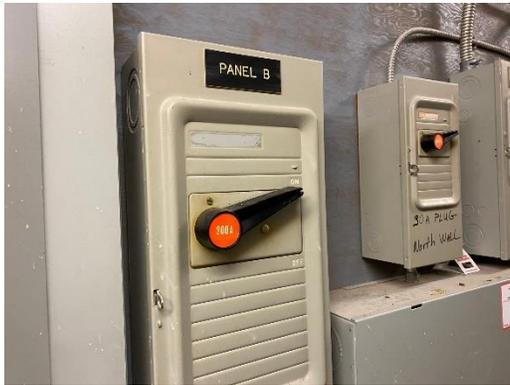
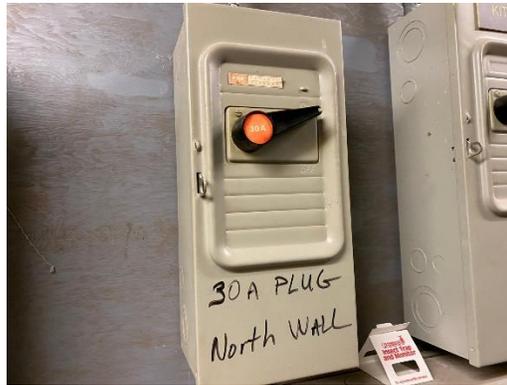
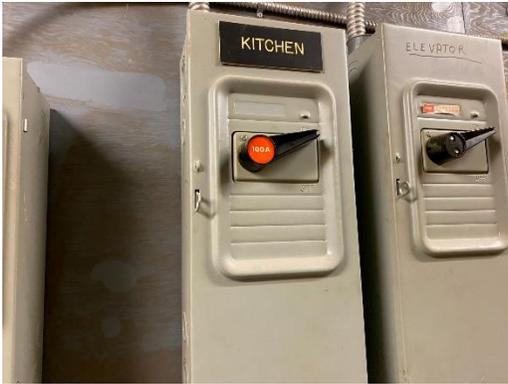
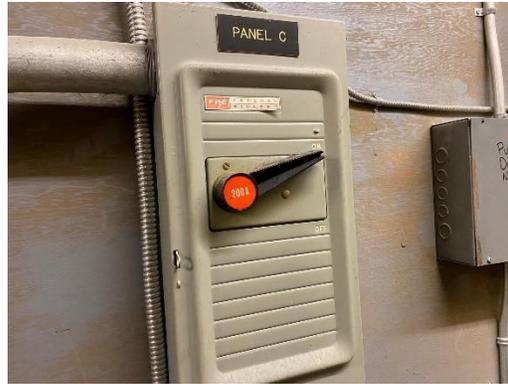
5.51 D - Electrical Services

Element Description: Intermediate Disconnects

Condition: Fair

Commentary: There are five intermediate disconnects manufactured by FPE located in the electrical room. It is our understanding that the disconnects are original to the building. Upon inspection, the units appeared to be in fair condition with signs of aging. An allowance has been included to replace the intermediate disconnects in the next six years.

Recommended Action: Replacement

Action Summary:	Action Description:
Allowance for lifecycle replacement	Replace intermediate disconnect switches
