FACILITY CONDITION ASSESSMENT

TOWNSHIP OF STRONG

Sundridge Strong Joly Arena
14 Albert Street North, Sundridge, ON P0A 1Z0

WalterFedy Project No.: 2021-0270

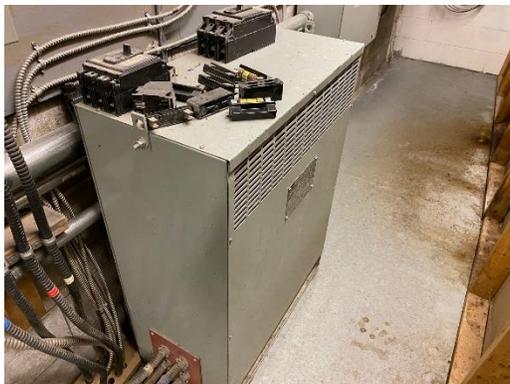
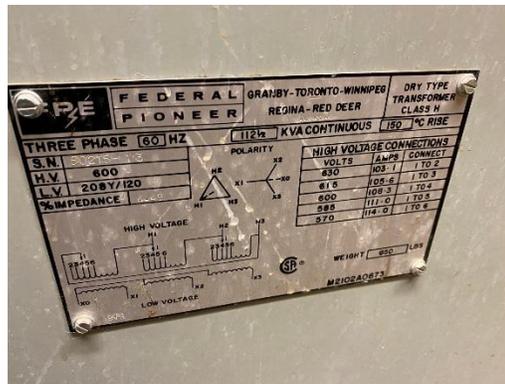
5.52 D - Electrical Services

Element Description: Transformer
Year of Installation: 1970
Location: Electrical Room
Condition: Fair
Consequence of Failure: Moderate
Commentary:

There is a transformer manufactured by FPE (S/N: 50215-13) located in the electrical room. The transformer was found to be rated for 112.5 kVA. It is our understanding that the transformer is original to the building. Upon inspection, the transformer appeared to be in fair condition with signs of aging. An allowance has been included to replace the transformer in the next six years.

Recommended Action: Replacement

Action Summary:	Action Description:
Allowance for lifecycle replacement	Replace transformer

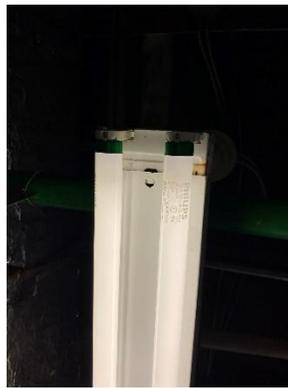
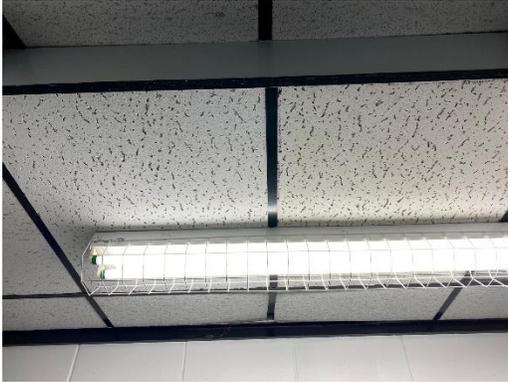
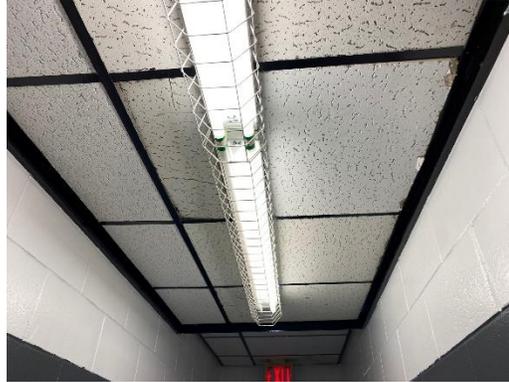
5.53 D - Electrical Services

Element Description: Interior Lighting
Year of Installation: 2010
Location: Throughout Building
Condition: Fair
Consequence of Failure: Low

Commentary: Interior lighting for the building is provided by T8 fluorescent lighting fixtures. It is our understanding that the lights were replaced in 2010. Upon inspection, the fixtures appeared to be in fair condition as the fixtures are approaching the end of their useful life. It is recommended that the fixtures be replaced with LEDs for energy conservation and longer running hours. An allowance has been included to replace the fixtures with LEDs in the next five years.

Recommended Action: Replacement

Action Summary:	Action Description:
Allowance for lifecycle replacement	Upgrade lighting fixtures to LEDs

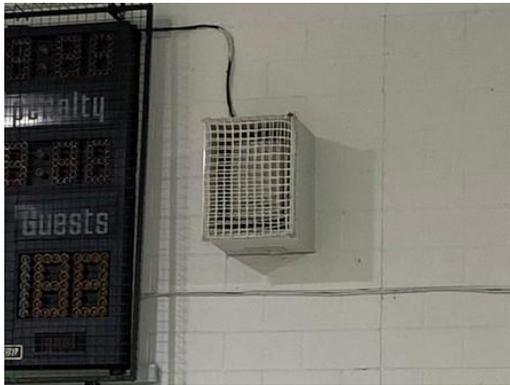
5.54 D - Electrical Services

Element Description: PA System
Year of Installation: 1970
Location: Throughout Building
Condition: Fair
Consequence of Failure: Low

Commentary: There is a PA system installed in the rink area of the building. Upon inspection, the system appeared to be in fair condition with the system being well past its expected service life. The expected service life has been extended as no issues with the system were reported during the site inspection. An allowance has been included to replace the system in the next six years.

Recommended Action: Replacement

Action Summary:	Action Description:
Allowance for lifecycle replacement	Replace PA system

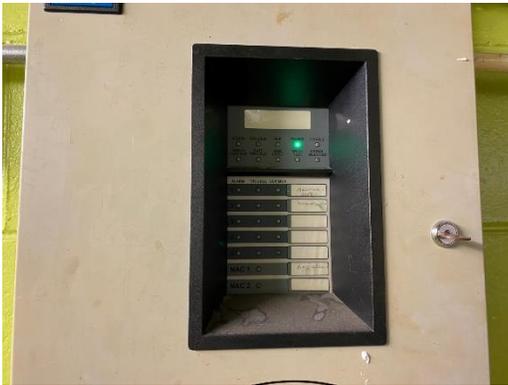
5.55 D - Electrical Services

Element Description: Fire Alarm Panel

Condition: Fair

Commentary: There is a Fireshield alarm panel manufactured by EST located in the electrical room of the building. It is our understanding that the panel is 20 years old but is operating properly. Upon inspection, the panel appeared to be in good condition, therefore, the expected service life has been extended. An allowance has been included to replace the fire alarm panel in the next five years.

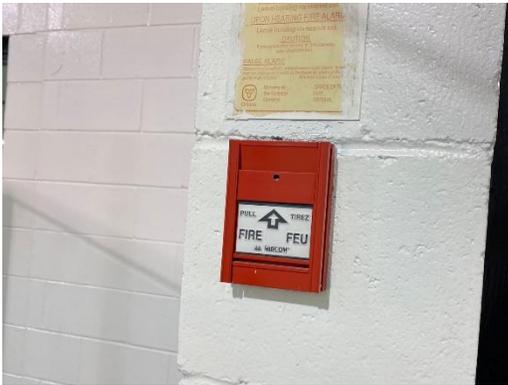
5.56 D - Electrical Services

Element Description: Fire Alarm System - Pull Stations

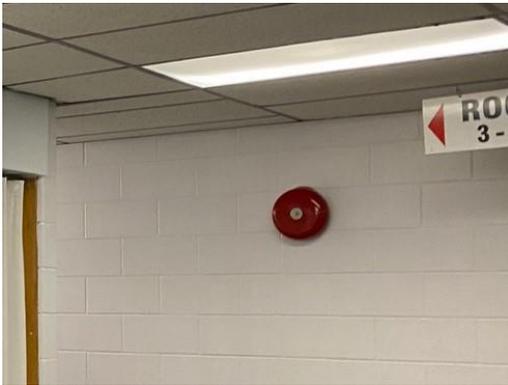
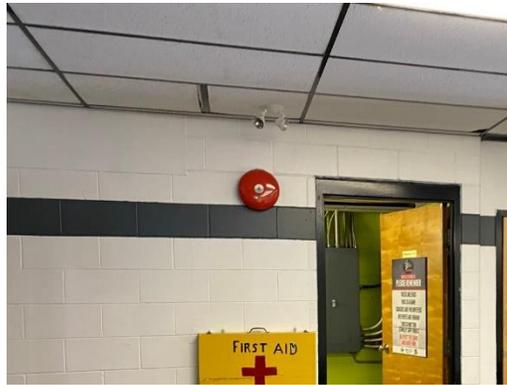
5.57 D - Electrical Services

Element Description: Fire Alarm System - Warning Bells

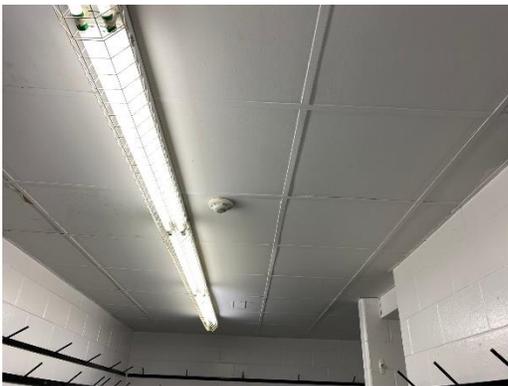
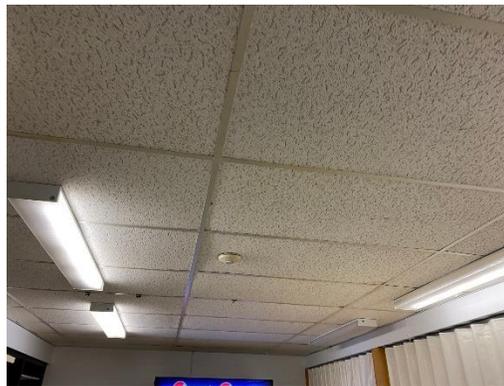
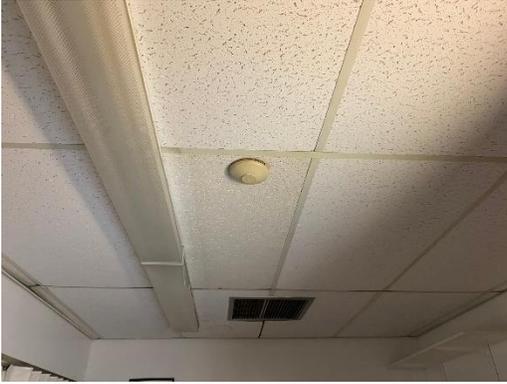
5.58 D - Electrical Services

Element Description: Fire Alarm System - Heat Detectors

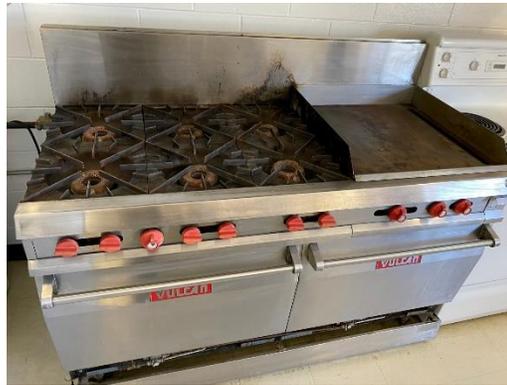
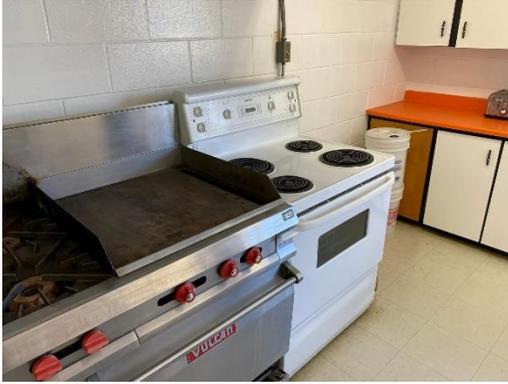
Element Description: Stove
Year of Installation: 2007
Location: Kitchen Areas
Condition: Good
Consequence of Failure: Low

Commentary: There are three gas-fired stoves located in the second and first floor kitchen areas. The actual age of the stoves is unknown; therefore, the last major action year has been estimated. Upon inspection, the stoves appeared to be in good condition. No major capital expenditures are anticipated within the term of the study.

Recommended Action: No Action is Required.

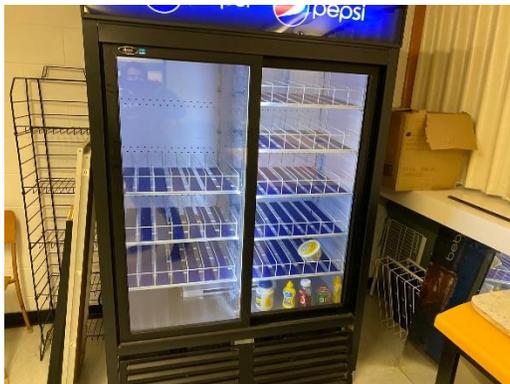
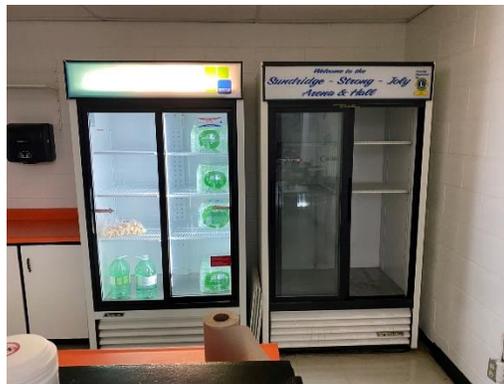
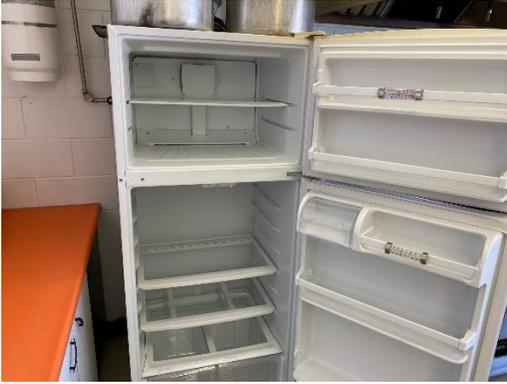
Element Description: Refrigerators
Year of Installation: 2007
Location: Kitchen Areas
Condition: Good
Consequence of Failure: Low

Commentary: There are four refrigerators located in the first and second floor kitchen areas. The actual age of the refrigerators is unknown; therefore, the last major action year has been estimated. Upon inspection, the refrigerators appeared to be in good condition. No major capital expenditures are anticipated within the term of the study.

Recommended Action: No Action is Required.

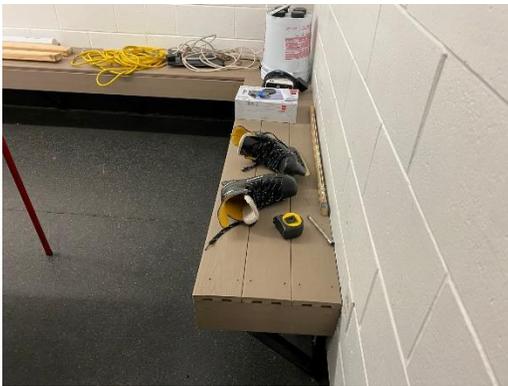
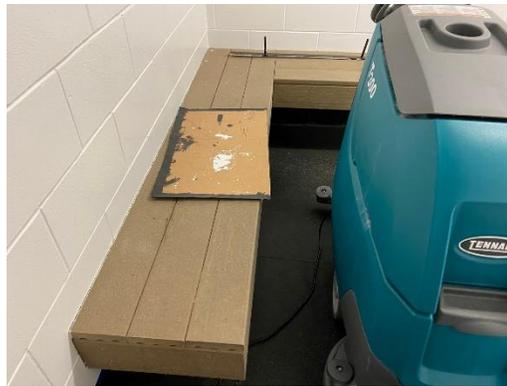
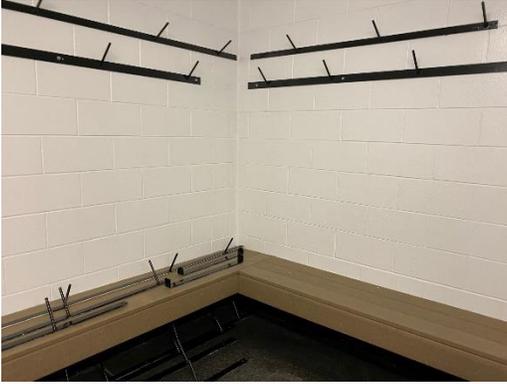
Element Description: Wooden Benches

Commentary: There are wooden benches located in the locker rooms of the building. Upon inspection, the benches appeared to be in fair condition as they have exceeded their expected service life. An allowance has been included to replace the wooden benches in the next seven years.

Recommended Action: Replacement

Action Summary:	Action Description:
Allowance for lifecycle replacement	Replace wooden benches

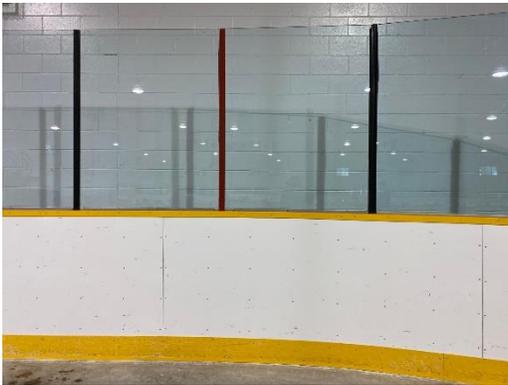
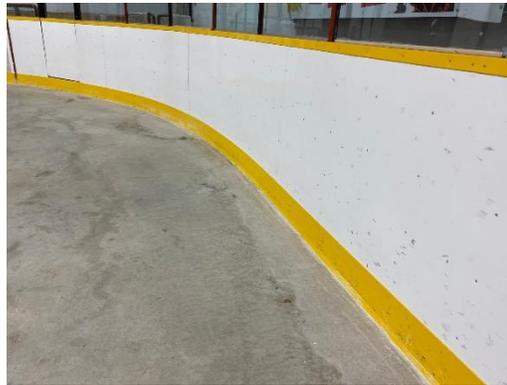
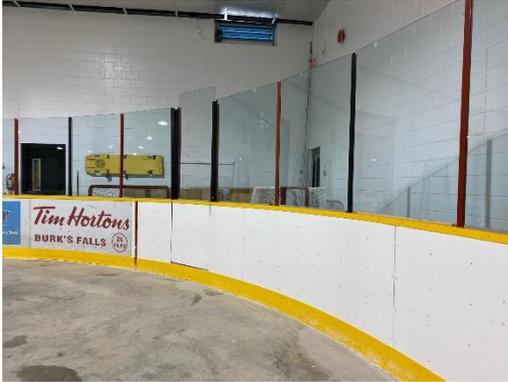
Element Description: Dasher Boards

Commentary: The ice rink is surrounded by plastic dasher boards. It is our understanding that the plastic was replaced last year, but the overall structural components are original to the building. Upon inspection, the boards appeared to be in fair condition, and the expected service life has been extended. An allowance has been included to replace the dasher boards in the next eight years.

Recommended Action: Replacement

Action Summary:	Action Description:
Allowance for lifecycle replacement	Replace dasher boards

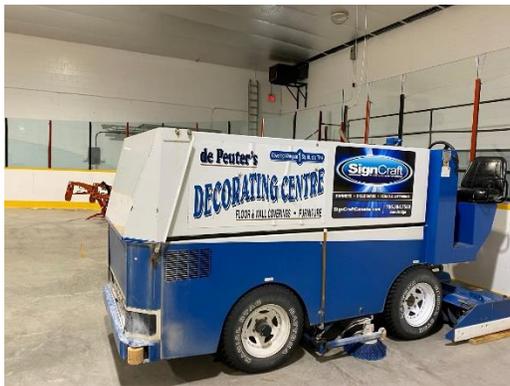
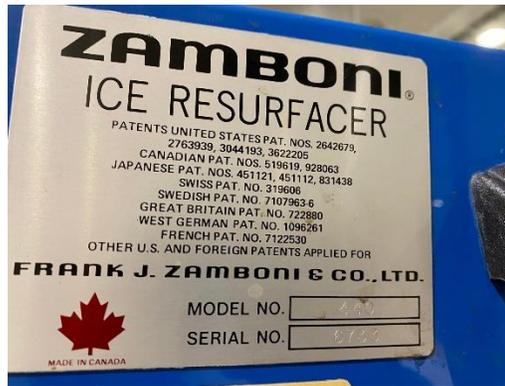
Element Description: Ice Resurfacer
Year of Installation: 2005
Location: Zamboni Bay
Condition: Good
Consequence of Failure: Moderate

Commentary: There is an ice rink resurfacer manufactured by Frank J. Zamboni & CO. (M/N: 440, S/N: 6733) located in the Zamboni Bay of the building. The actual age of the Zamboni is unknown; therefore, the last major action year has been estimated. Upon inspection, the resurfacer appeared to be in good condition with no reported issues, and the expected service life has been extended. No major capital expenditures are anticipated within the term of the study.

Recommended Action: No Action is Required.

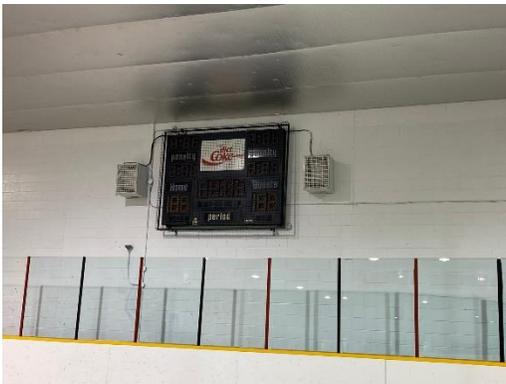
Element Description: Scoreboard

Commentary: There is a scoreboard located in the rink area of the building. It is our understanding that the scoreboard is being replaced this year. No major capital expenditures are anticipated within the term of the study.

Recommended Action: No Action is Required.

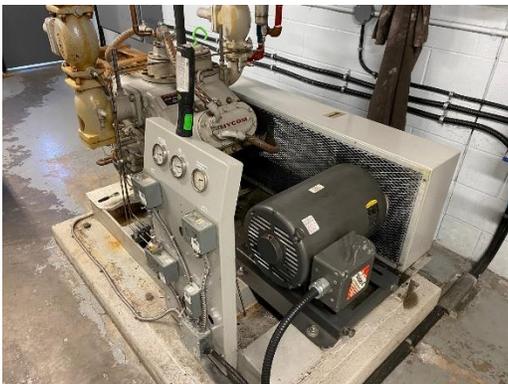
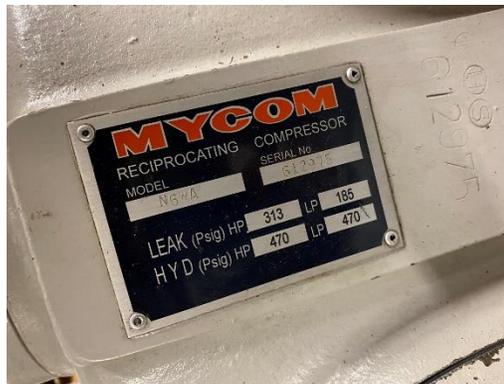
Element Description: Compressors
Year of Installation: 2011
Location: Mechanical Room
Condition: Good
Consequence of Failure: Moderate

Commentary: There are two reciprocating compressors manufactured by Mycom (M/N: N6WA) located in the mechanical room. The compressors are being fed with ammonia as the refrigerant of their system. It is our understanding that the compressors were installed in 2011. Upon inspection, the units appeared to be in good condition. No major capital expenditures are anticipated within the term of the study.

Recommended Action: No Action is Required.

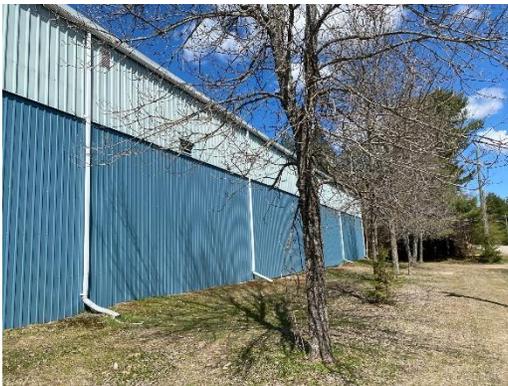
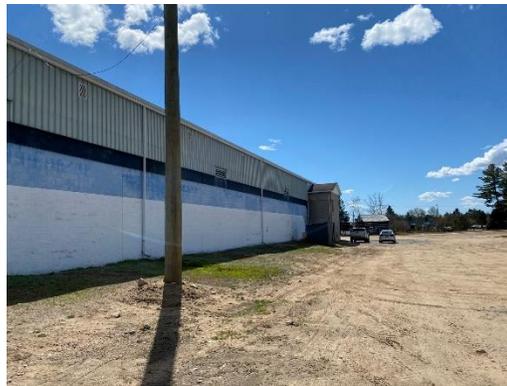
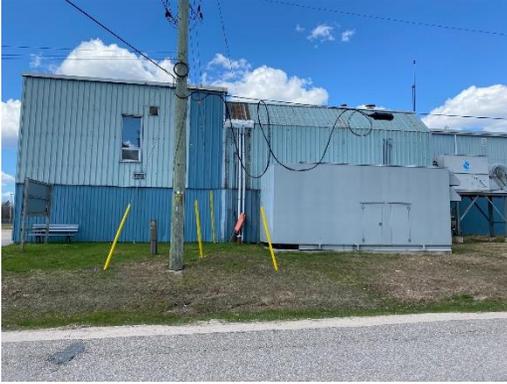
Element Description: Landscaping
Year of Installation: 1970
Location: Site
Condition: Good
Consequence of Failure: Low

Commentary: Landscaping for the site consists of manicured grass, trees, and a gravel parking area. Upon inspection, the landscaping appeared to be in good condition. An allowance has been included to periodically maintain the site landscaping.

Recommended Action: Repair

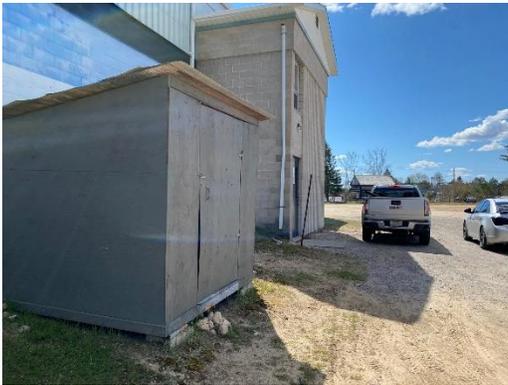
Element Description: Shed
Year of Installation: 2006
Location: Site
Condition: Fair
Consequence of Failure: Low
Commentary:

There is a wooden shed located at the western elevation of the building. The actual age of the shed is unknown; therefore, the last major action year has been estimated. Upon inspection, the shed appeared to be in fair condition with signs of wear and aging. An allowance has been included to replace the shed at the end of its useful life.

Recommended Action: Replacement

Action Summary:	Action Description:
Allowance for lifecycle replacement	Replace wooden shed

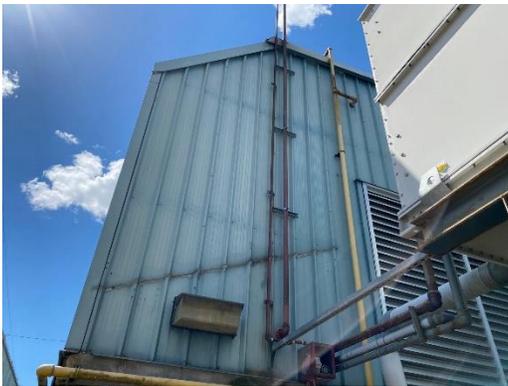
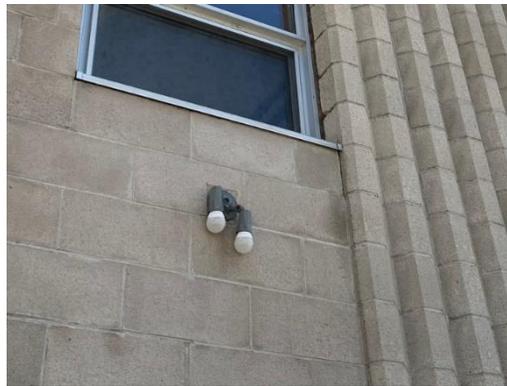
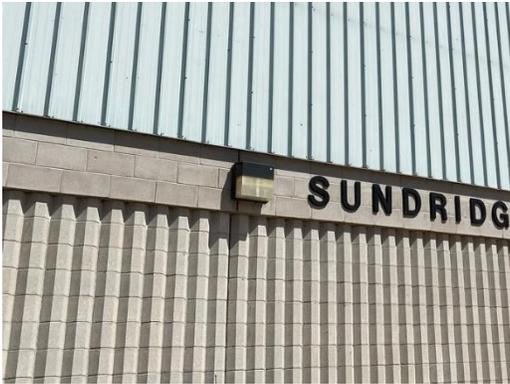
Element Description: Site Lighting

Commentary: Site lighting is provided by four wall packs and two pole fixtures. It is our understanding that the fixtures were replaced roughly nine years ago. Upon inspection, the fixtures appeared to be in good condition. No major capital expenditures are anticipated within the term of the study.

Recommended Action: No Action is Required.
