**Township of Strong
D.M. Wills Project No. 24-9217**

**2018 Municipal Structure
Inspection Program**

Summary Report

September 2018

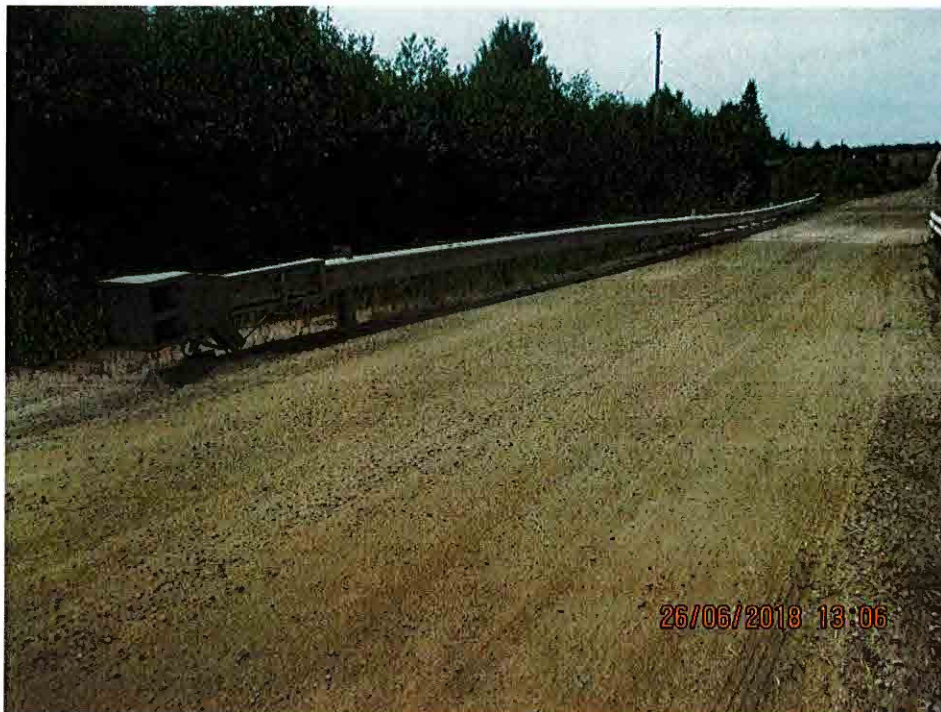
South railing

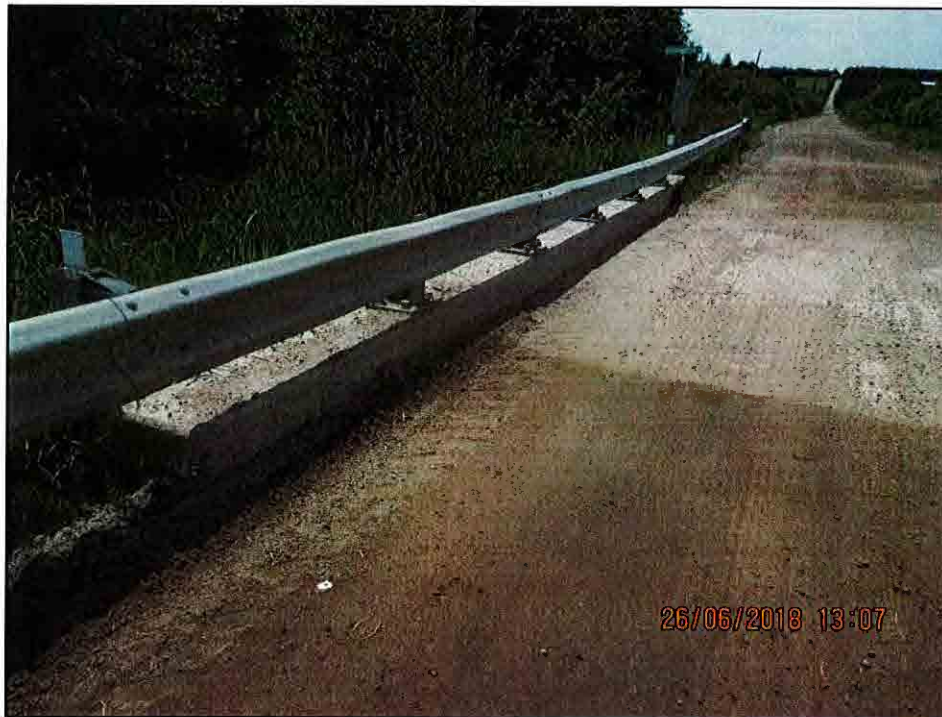
South railing

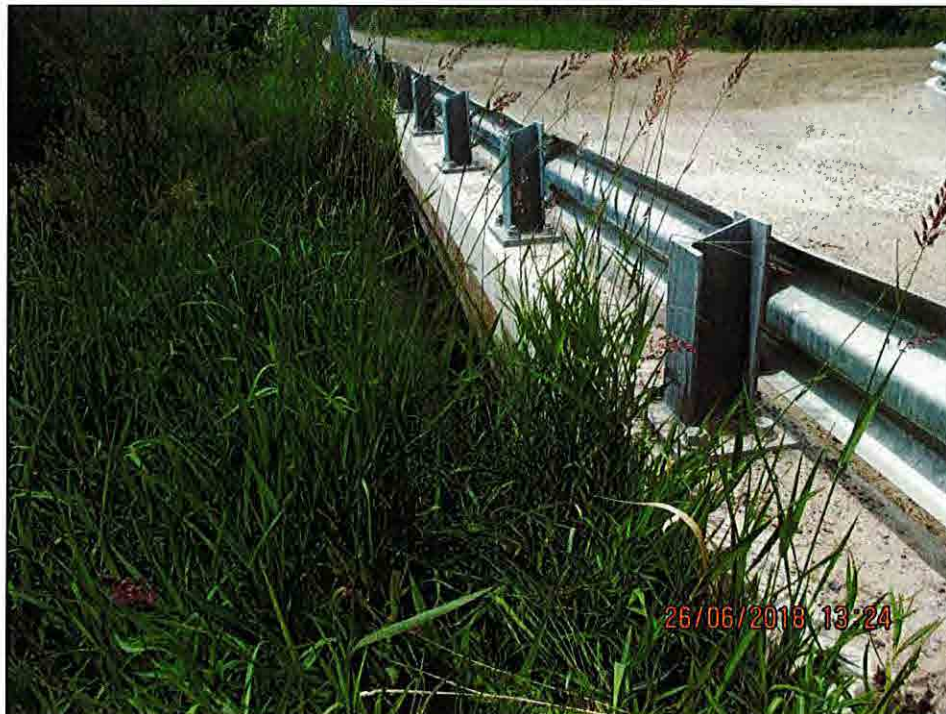
South elevation

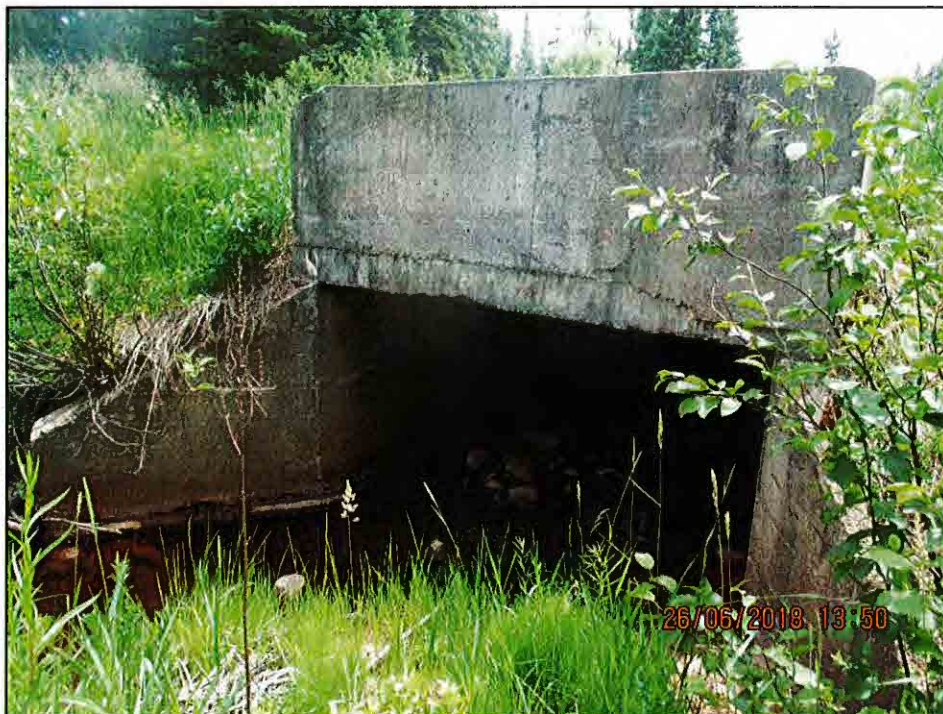
Inlet

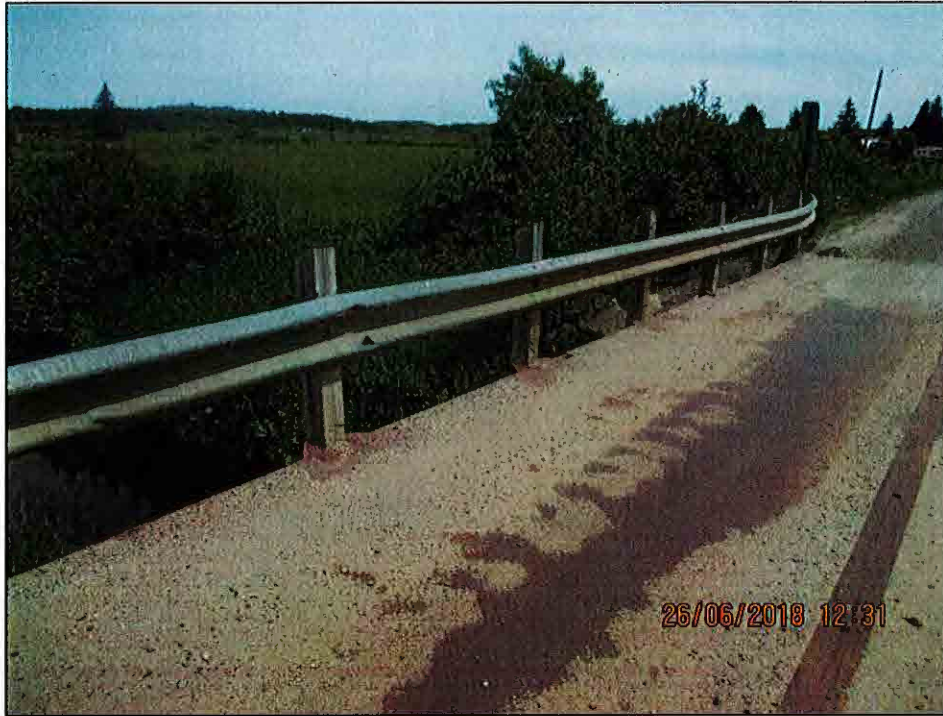
North railing

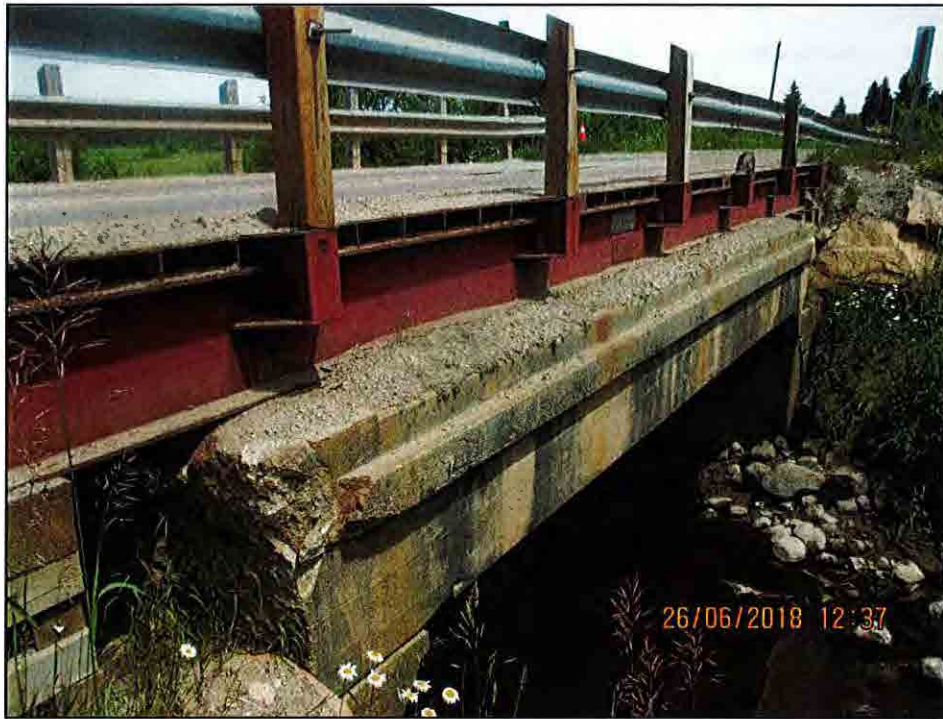
South elevation

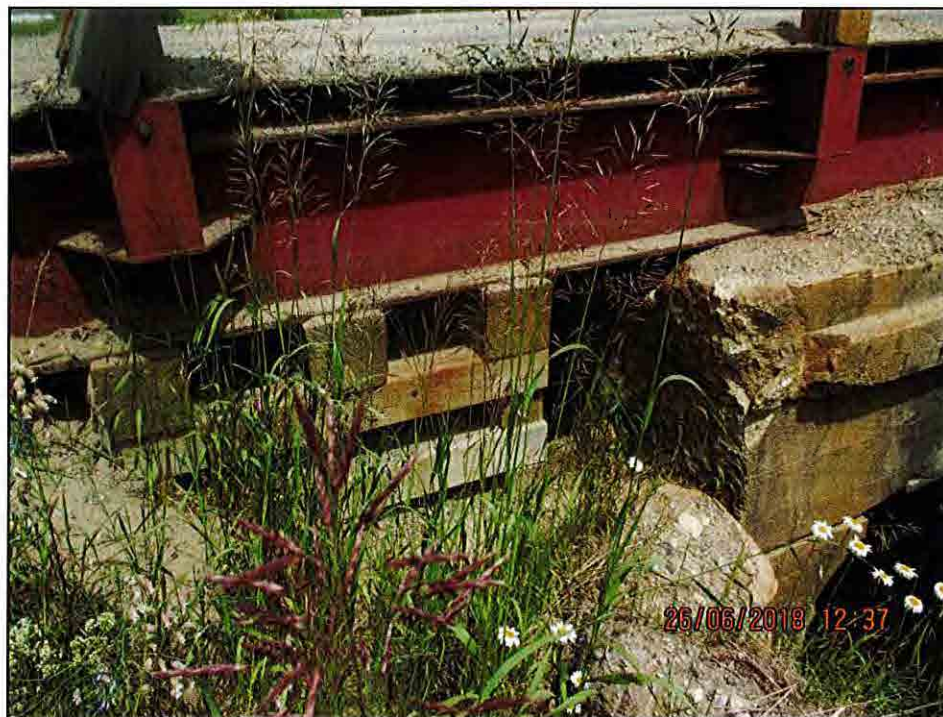
West abutment

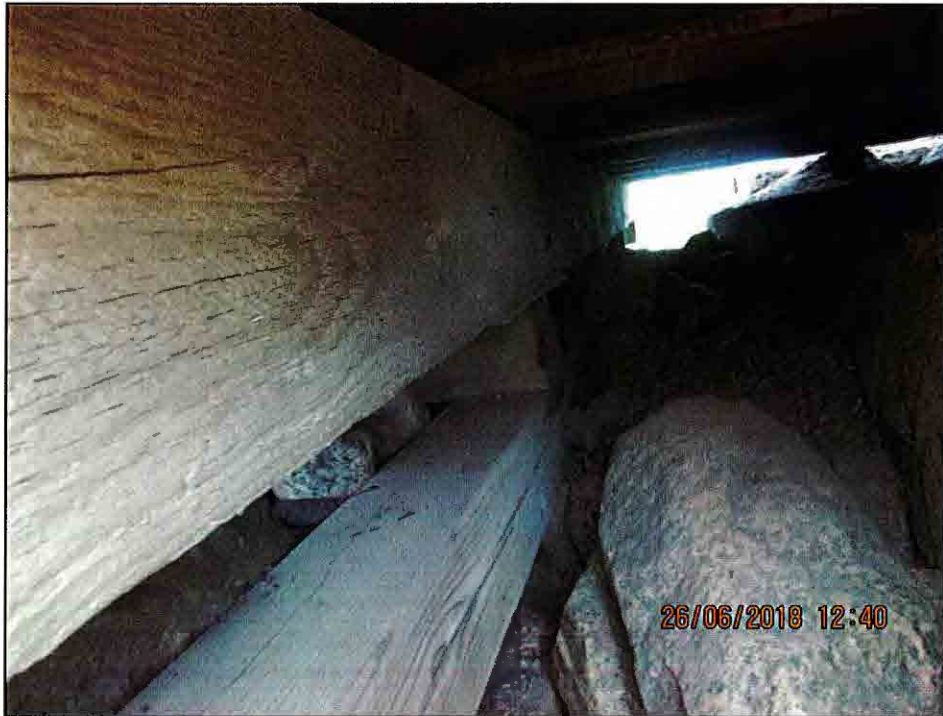
West abutment

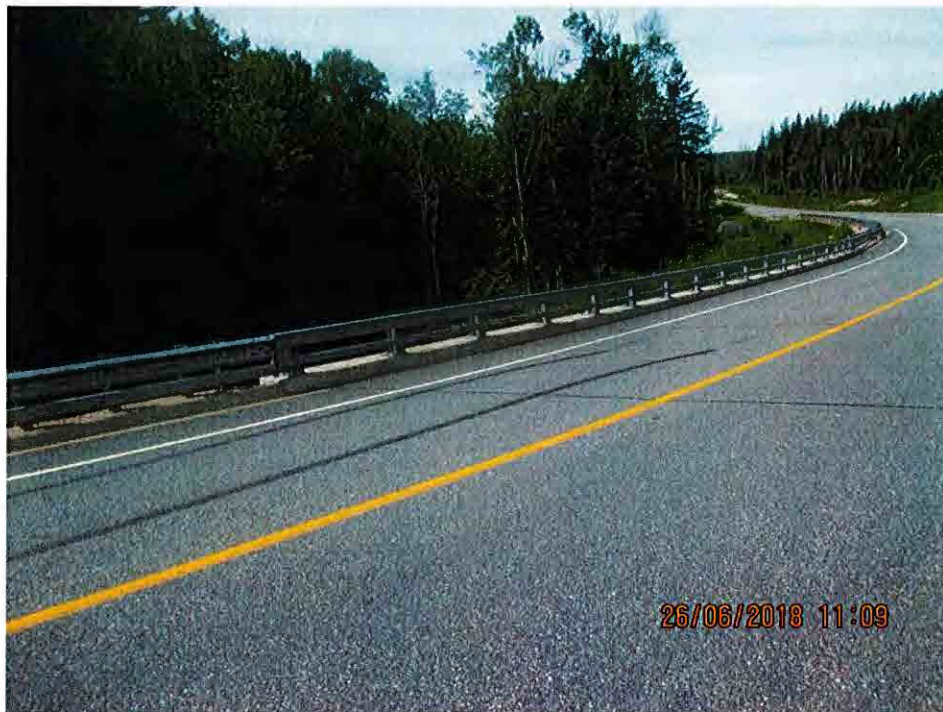
South railing

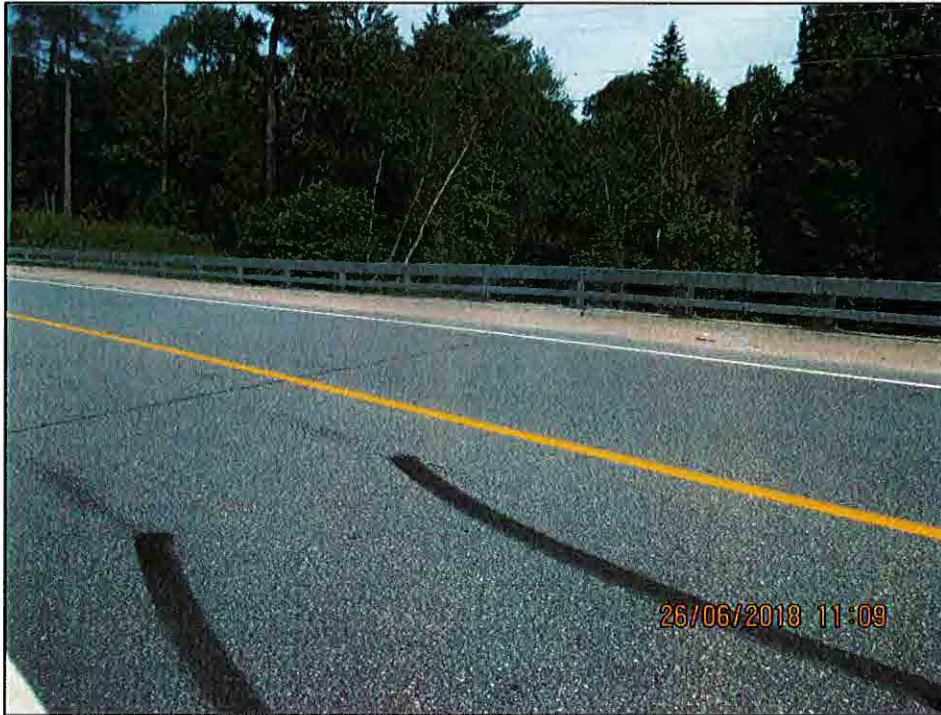
North railing

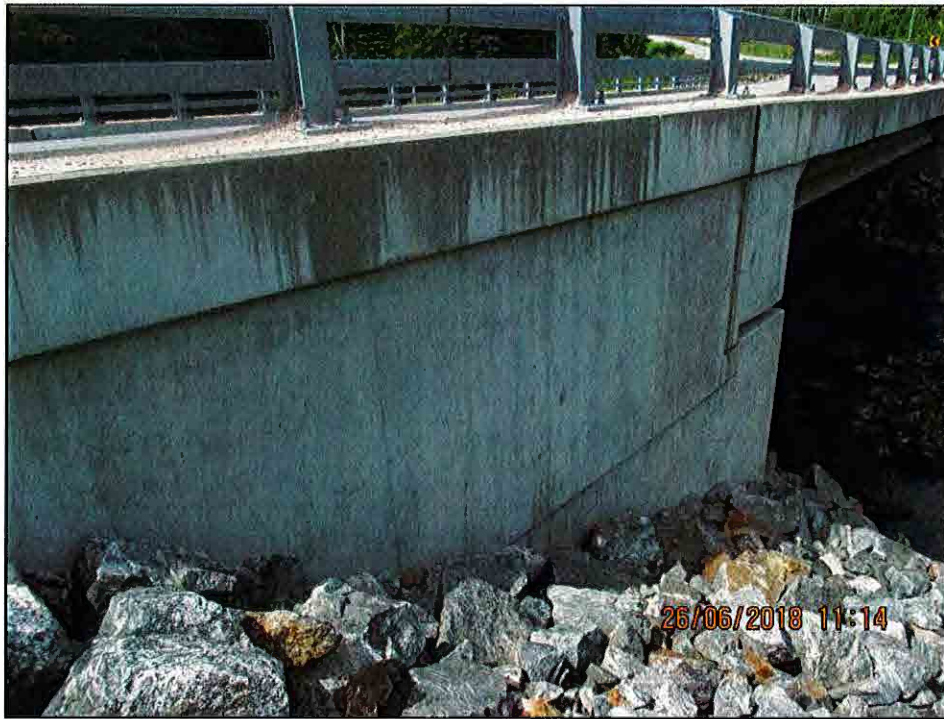
Northeast wing wall (Typ.)

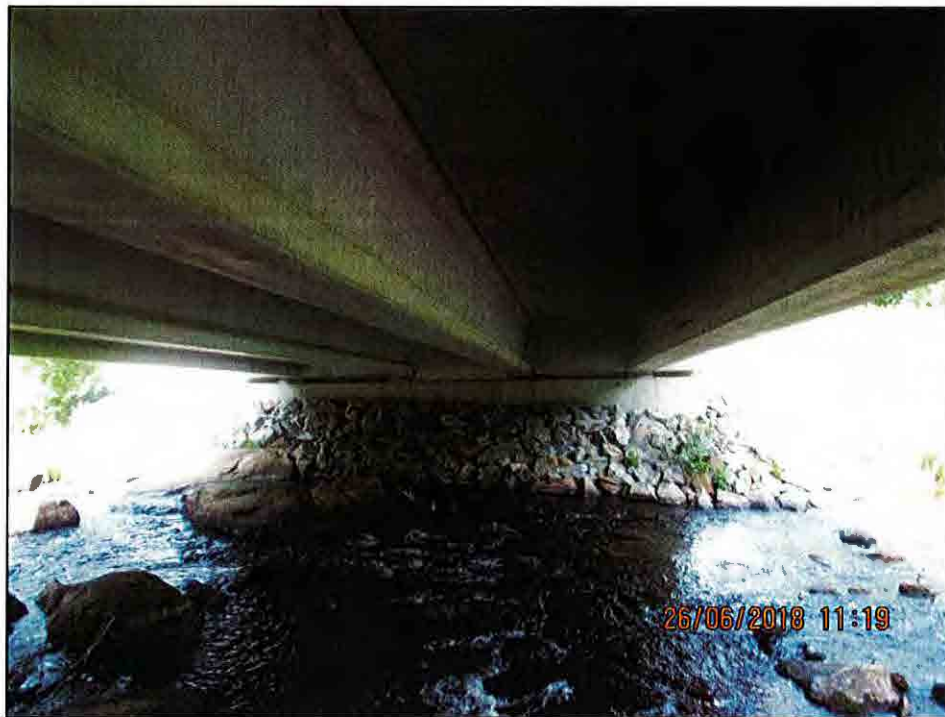
West abutment

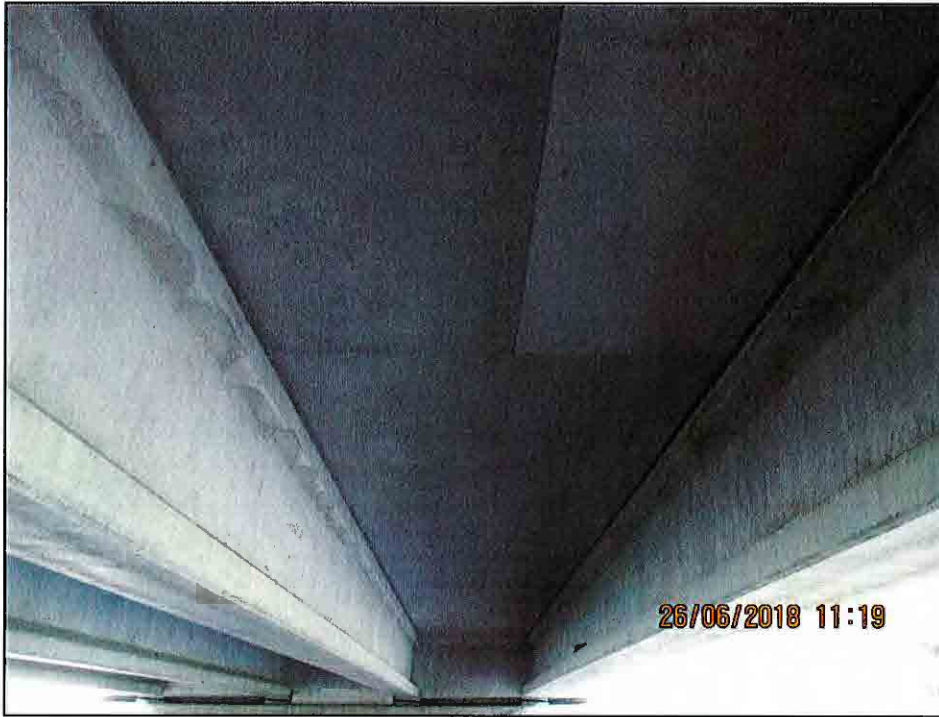
Interior soffit (Typ.)

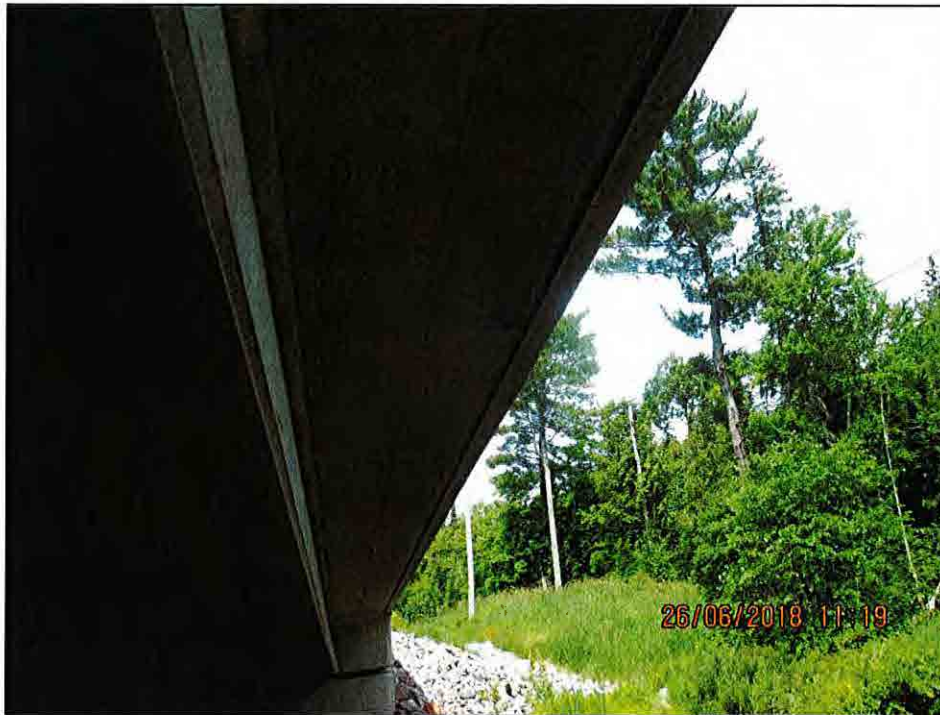
Exterior soffit (Typ.)

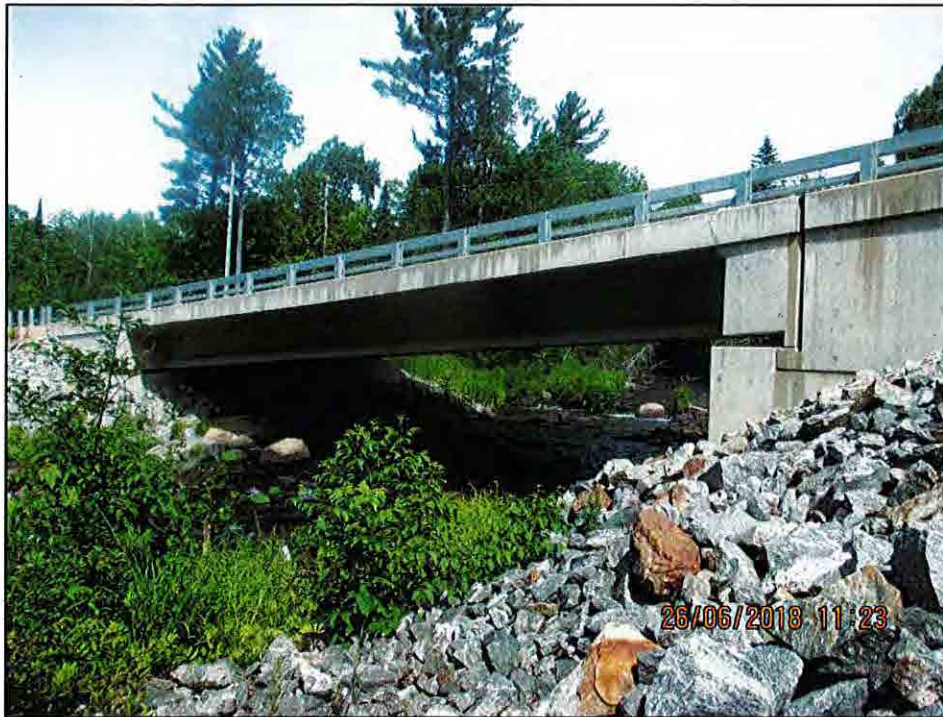
South elevation

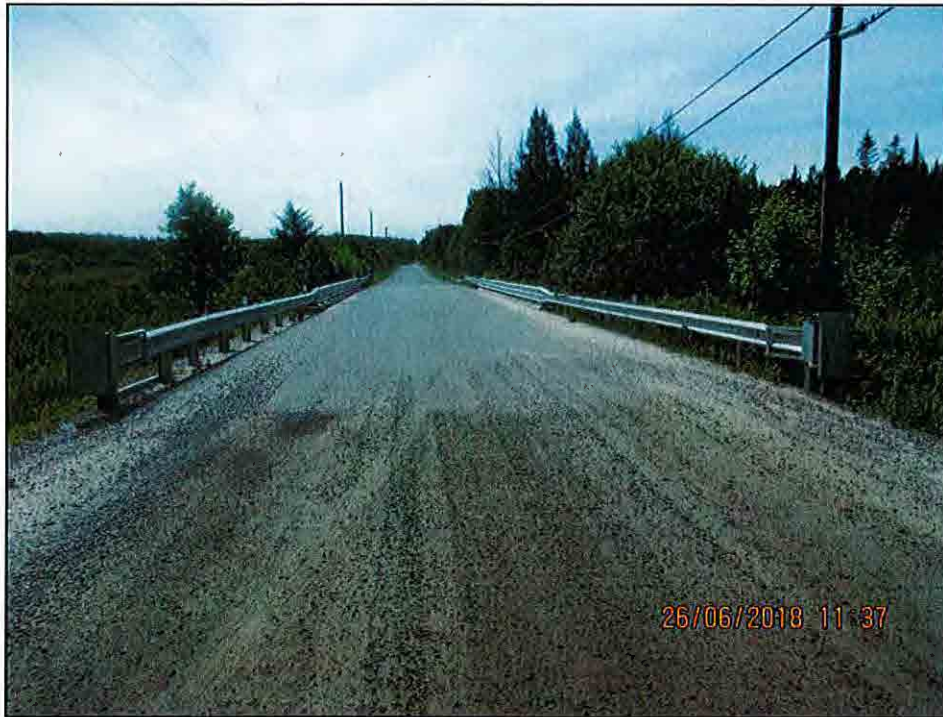
Roadway looking South

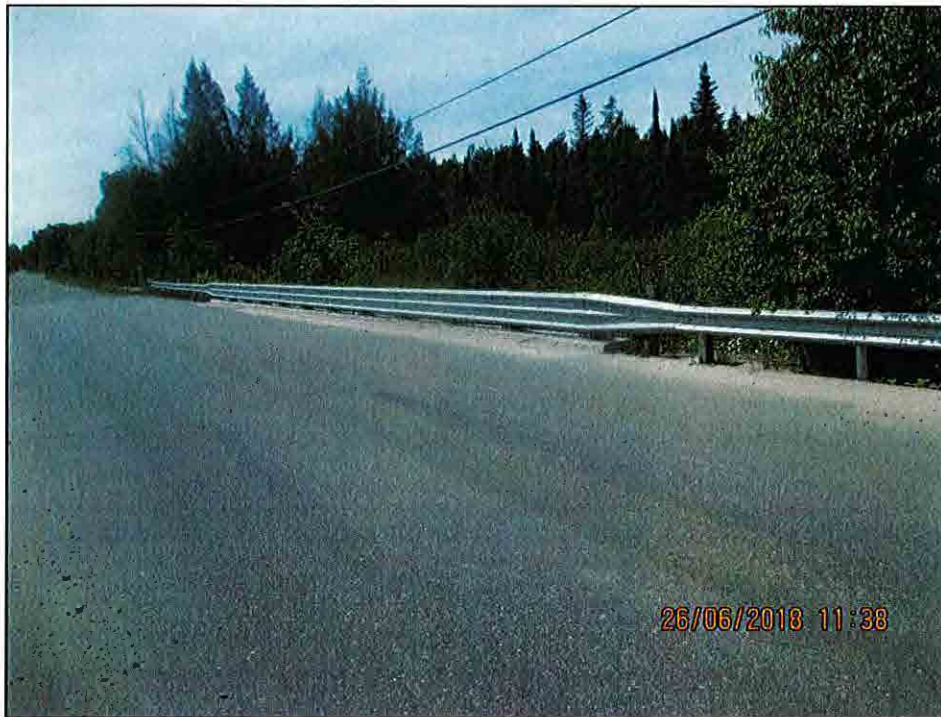
West railing

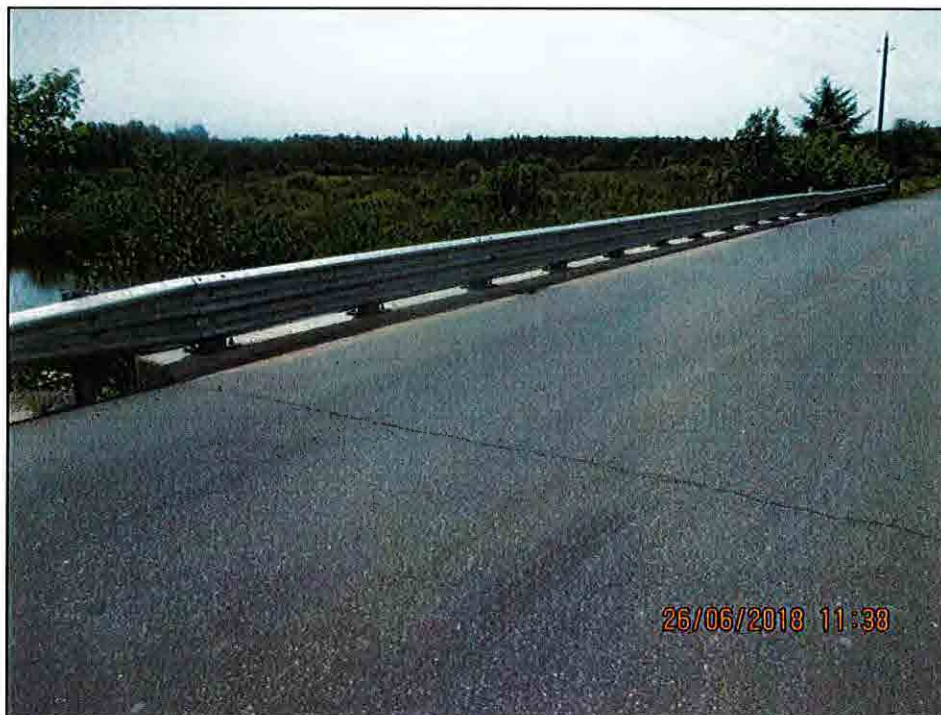
East railing

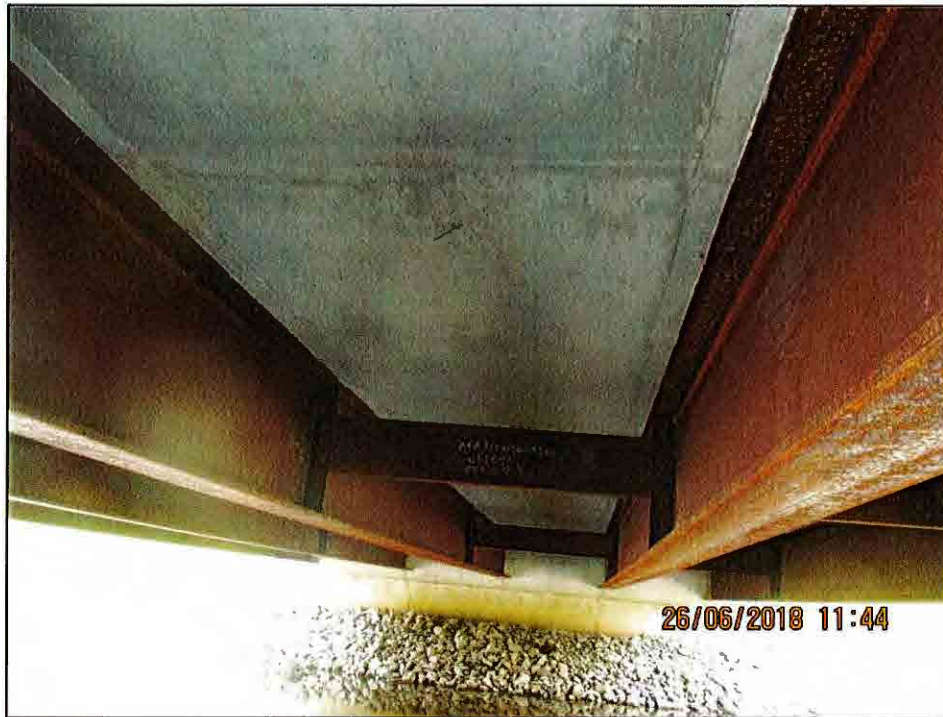
Soffit

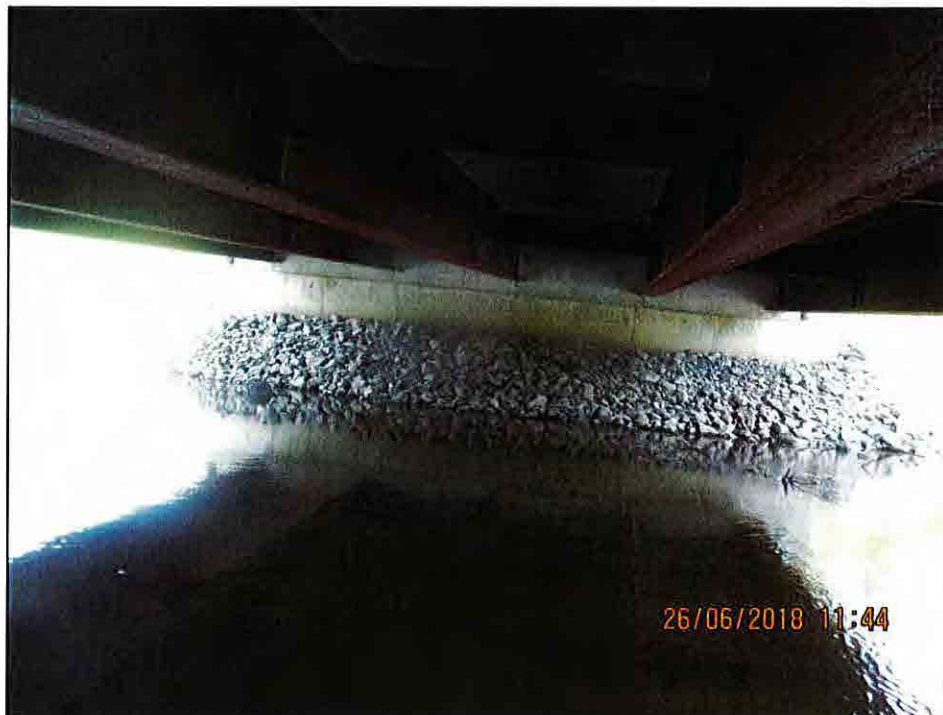
South abutment

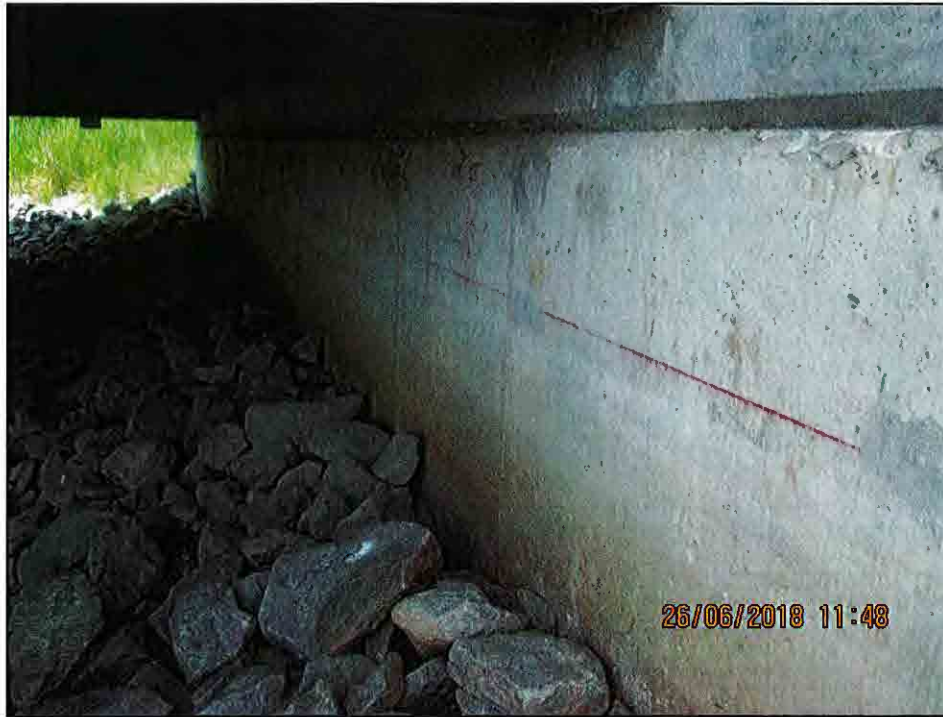
North abutment

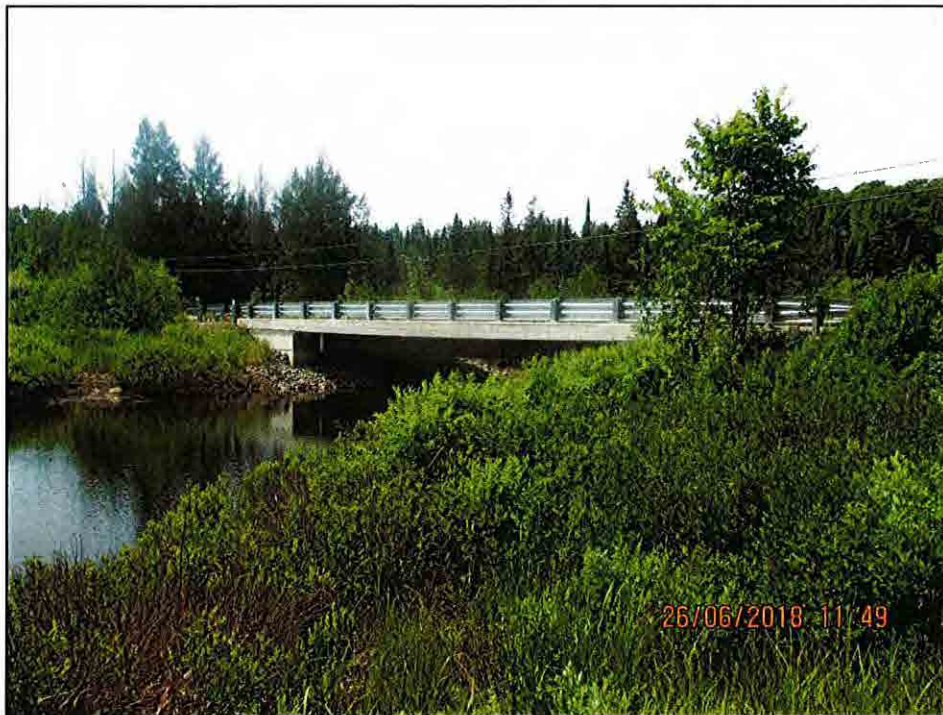
East elevation

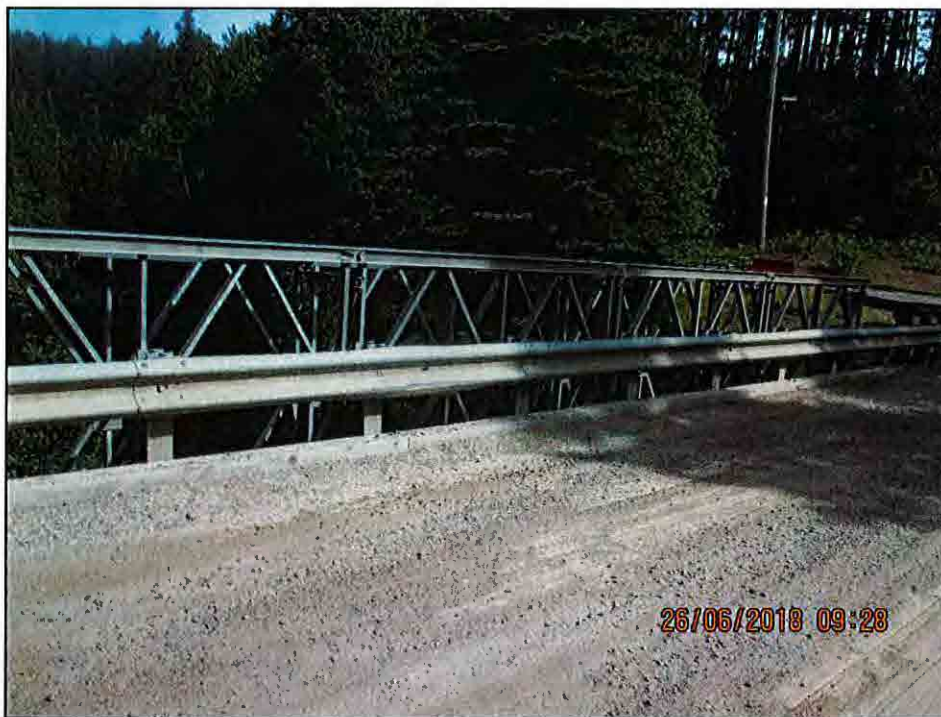
South truss

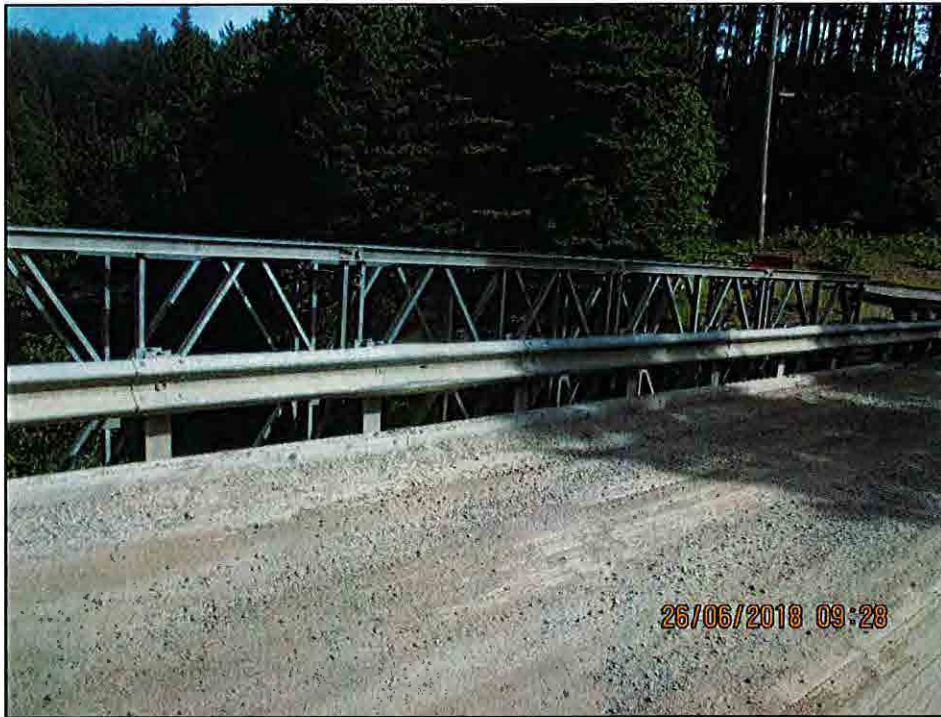
North truss

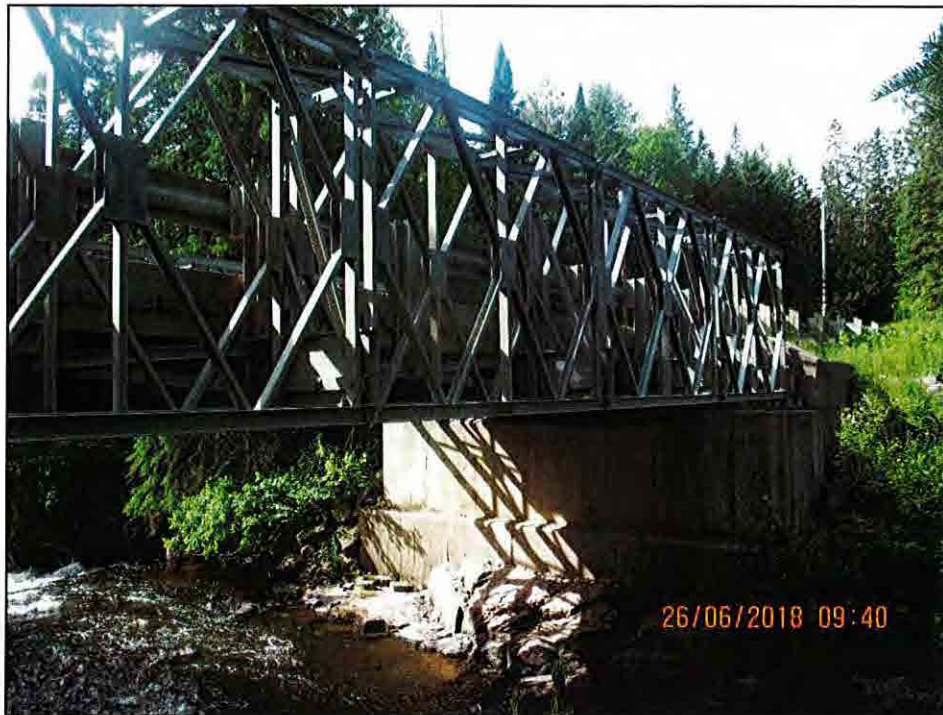
North elevation
